Annual Monitoring Report

Monitoring Year 4 of 7

Cochran Branch Stream and Wetland Restoration Site

NCDMS Project No.: 95720

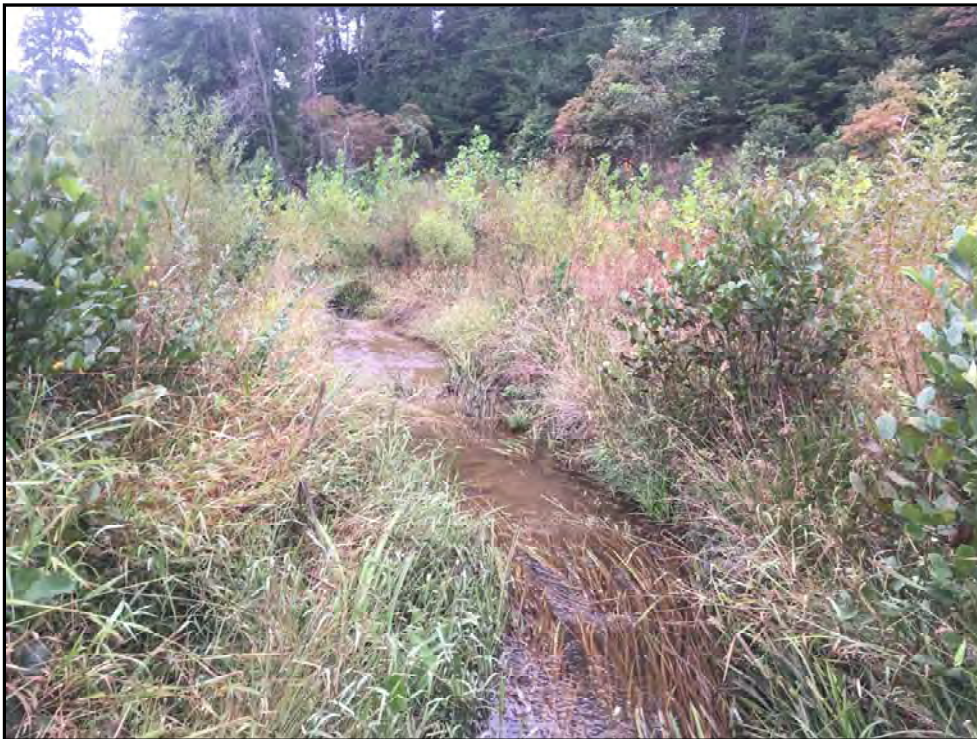
Parrish Branch – Permanent Photo Station 3
Station 108+87 – Upstream
October 3, 2018

Visual assessment of the stream channel was performed to document signs of instability, such as eroding banks, structural instability, or excessive sedimentation. Parrish Branch shows signs of aggradation in segments along the reach, likely due to dense herbaceous growth, specifically *Juncus* spp., in and around the channel that is attenuating water flow through the channel. RES plans to heavily livestock the banks of Parrish Branch as well apply herbicide to the vegetation in the channel. With the exception of Parrish Branch, no indication of instability was observed during visual assessment and all structures are functioning as designed (**Appendix A Figure 2 and Appendix B Table 5**).

[Noted. RES plans on re-livestaking the banks of Parrish Branch to help shade out the vegetation that is trapping the sediment in the channel.](#)

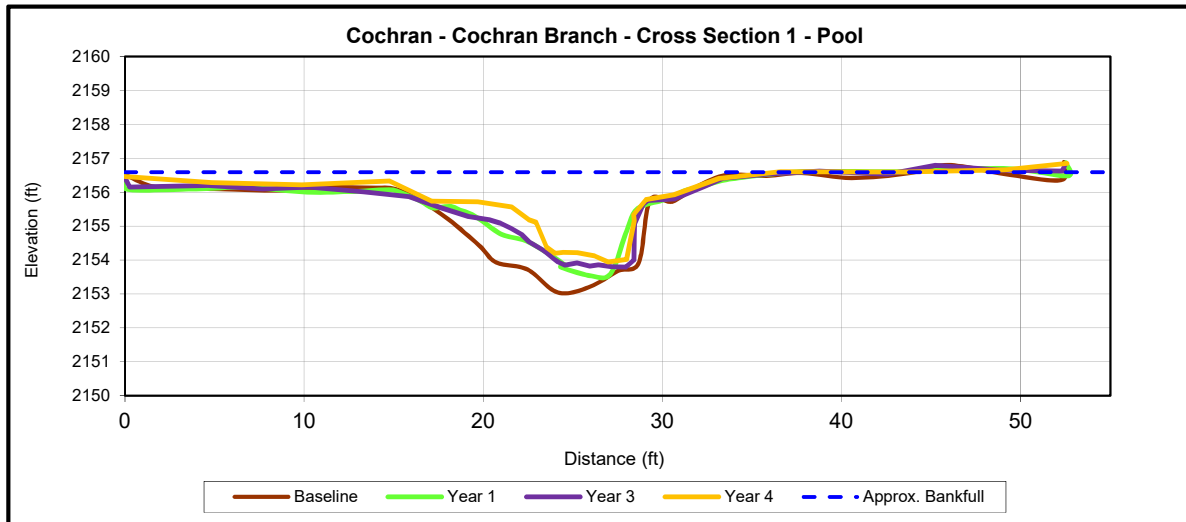
Cross Section 1 (Pool)						
Based on fixed baseline bankfull elevation	Base	MY1	MY2	MY3	MY4	MY5	MY7
Record elevation (datum) used	2156.1	2156.1	-	2156.1	2156.6		
Bankfull Width (ft)	16.7	16.8	-	20.6	36.3		
Floodprone Width (ft)	>217.0	>217.0	-	>52.5	>52.6		
Bankfull Mean Depth (ft)	1.6	1.1	-	0.9	0.8		
Bankfull Max Depth (ft)	3.1	2.6	-	2.3	2.7		
Bankfull Cross Sectional Area (ft ²)	27.5	19.2	-	19.5	27.5		
Bankfull Width/Depth Ratio	10.2	14.7	-	21.8	48.0		
Bankfull Entrenchment Ratio	>13.0	>12.9	-	N/A	N/A		
Bankfull Bank Height Ratio	1.0	1.0	-	N/A	N/A

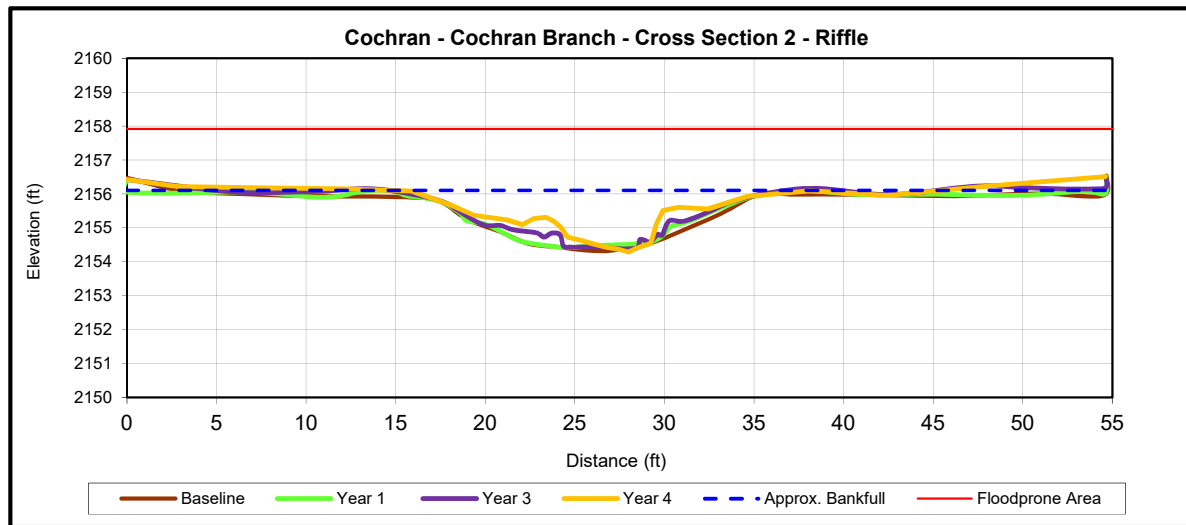
Cross Section 2 (Riffle)						
Based on fixed baseline bankfull elevation	Base	MY1	MY2	MY3	MY4	MY5	MY7
Record elevation (datum) used	2155.8	2155.8	-	2155.8	2156.1		
Bankfull Width (ft)	17.3	17.1	-	16.9	23.4		
Floodprone Width (ft)	>173.5	>173.5	-	>54.7	>54.6		
Bankfull Mean Depth (ft)	1.0	0.9	-	0.8	0.7		
Bankfull Max Depth (ft)	1.5	1.4	-	1.4	1.8		
Bankfull Cross Sectional Area (ft ²)	16.6	15.2	-	14.0	16.6		
Bankfull Width/Depth Ratio	18.1	19.2	-	20.4	33.0		
Bankfull Entrenchment Ratio	>10.0	>10.2	-	>3.2	>2.3		
Bankfull Bank Height Ratio	1.0	1.0	-	0.9	<1.0

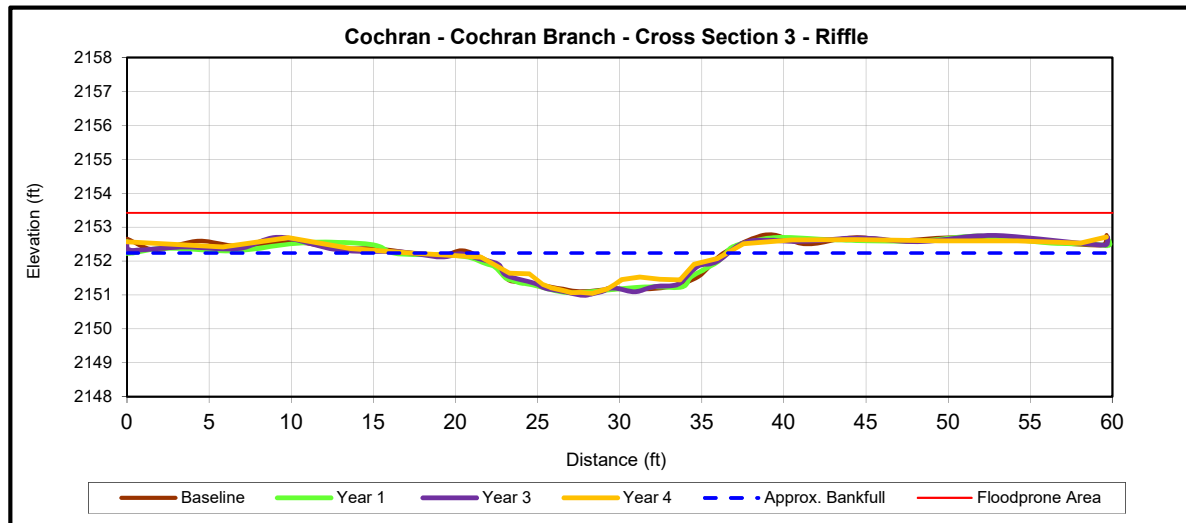
Cross Section 3 (Riffle)						
Based on fixed baseline bankfull elevation	Base	MY1	MY2	MY3	MY4	MY5	MY7
Record elevation (datum) used	2152.1	2152.1	-	2152.1	2152.2		
Bankfull Width (ft)	14.6	15.4	-	15.3	19.3		
Floodprone Width (ft)	>135.0	>135	-	>59.7	>59.6		
Bankfull Mean Depth (ft)	0.8	0.7	-	0.7	0.6		
Bankfull Max Depth (ft)	1.0	1.1	-	1.1	1.2		
Bankfull Cross Sectional Area (ft ²)	11.0	11.3	-	10.8	11.0		
Bankfull Width/Depth Ratio	19.2	20.8	-	21.6	33.9		
Bankfull Entrenchment Ratio	>9.3	>8.8	-	>3.9	>3.1		
Bankfull Bank Height Ratio	1.0	1.0	-	1.1	<1.0
