**Coddle Creek Tributary
(Indian Run) Stream Restoration
Project # 94**

Baseline Monitoring Document and As Built Baseline Report

Cabarrus County, North Carolina

Report Submission: September 2011

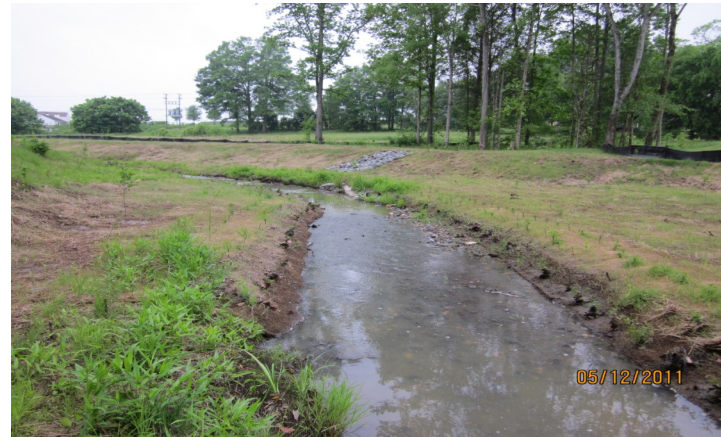
Reach	Indian Run, Upper Reach
River Basin	Yadkin / Pee Dee
Cross Section ID	XSC-1, Riffle, Upper Reach, 18+40
Drainage Area (Sq Mi)	1.5
Date	5/12/2011
Observers	V. Miller, C. Myers, W. Yelverton

SUMMARY DATA	
Bankfull Elevation, ft	542.62
Bankfull Cross Sectional Area, ft ²	19.87
Bankfull Width, ft	19.31
Max Depth at Bankfull, ft	1.64
Mean Depth at Bankfull, ft	1.03
Width/Depth Ratio	18.77
Flood Prone Width, ft	88.70
Flood Prone Area Elevation	544.26
Entrenchment Ratio	4.60
Bank Height Ratio	1.00

Stream Type C4

Sta. 18+40 Looking Downstream

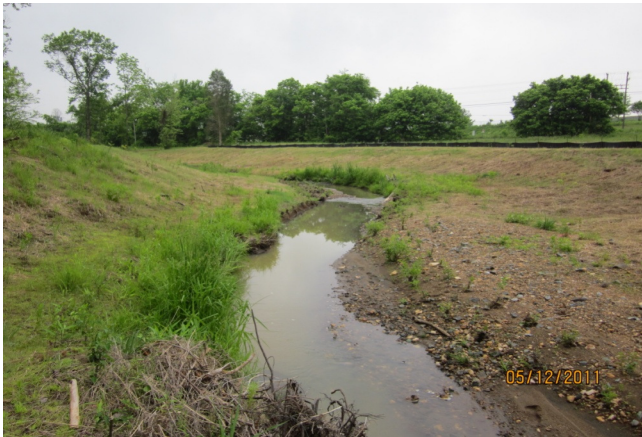
Reach	Indian Run, Upper Reach
River Basin	Yadkin / Pee Dee
Cross Section ID	XSC-2, Pool, Upper Reach, 20+62
Drainage Area (Sq Mi)	1.5
Date	5/12/2011
Observers	V. Miller, C. Myers, W. Yelverton

SUMMARY DATA	
Bankfull Elevation, ft	541.18
Bankfull Cross Sectional Area, ft ²	39.43
Bankfull Width, ft	34.10
Max Depth at Bankfull, ft	3.30
Mean Depth at Bankfull, ft	1.16
Width/Depth Ratio	29.49
Flood Prone Width, ft	56.20
Flood Prone Area Elevation	543.07
Entrenchment Ratio	1.60
Bank Height Ratio	1.00

Stream Type C4

Sta. 20+62 Looking Downstream, foreground

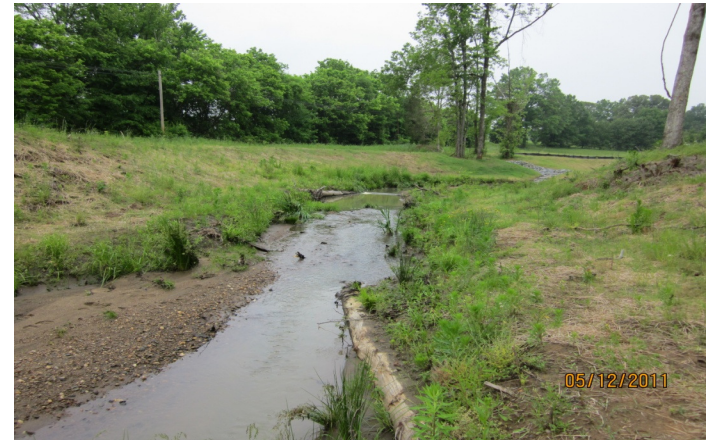
Reach	Indian Run, Upper Reach
River Basin	Yadkin / Pee Dee
Cross Section ID	XSC-3, Riffle, Upper Reach, 25+40
Drainage Area (Sq Mi)	1.5
Date	5/12/2011
Observers	V. Miller, C. Myers, W. Yelverton

SUMMARY DATA	
Bankfull Elevation, ft	539.00
Bankfull Cross Sectional Area, ft ²	29.49
Bankfull Width, ft	20.81
Max Depth at Bankfull, ft	2.13
Mean Depth at Bankfull, ft	1.42
Width/Depth Ratio	14.68
Flood Prone Width, ft	35.40
Flood Prone Area Elevation	541.13
Entrenchment Ratio	1.70
Bank Height Ratio	1.00

Stream Type C4

Sta. 25+40, Looking Upstream

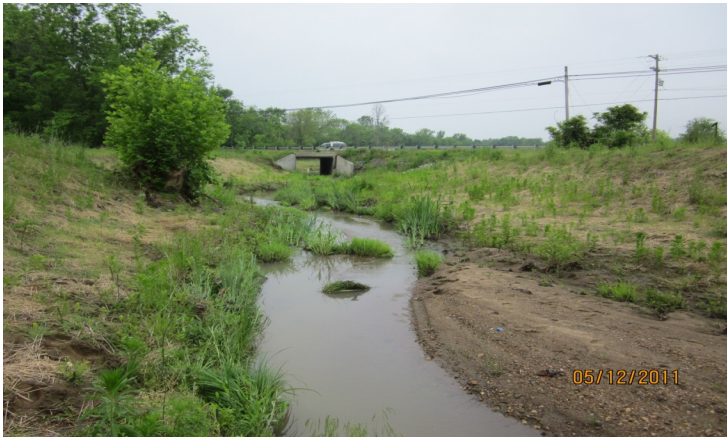
Reach	Indian Run, Upper Reach
River Basin	Yadkin / Pee Dee
Cross Section ID	XSC-4, Pool, Upper Reach, 25+92
Drainage Area (Sq Mi)	1.5
Date	5/12/2011
Observers	V. Miller, C. Myers, W. Yelverton

SUMMARY DATA	
Bankfull Elevation, ft	538.77
Bankfull Cross Sectional Area, ft ²	43.47
Bankfull Width, ft	32.95
Max Depth at Bankfull, ft	2.58
Mean Depth at Bankfull, ft	1.32
Width/Depth Ratio	24.98
Flood Prone Width, ft	45.70
Flood Prone Area Elevation	540.66
Entrenchment Ratio	1.40
Bank Height Ratio	1.00

Stream Type C4

Sta. 25+92 Looking Downstream, foreground

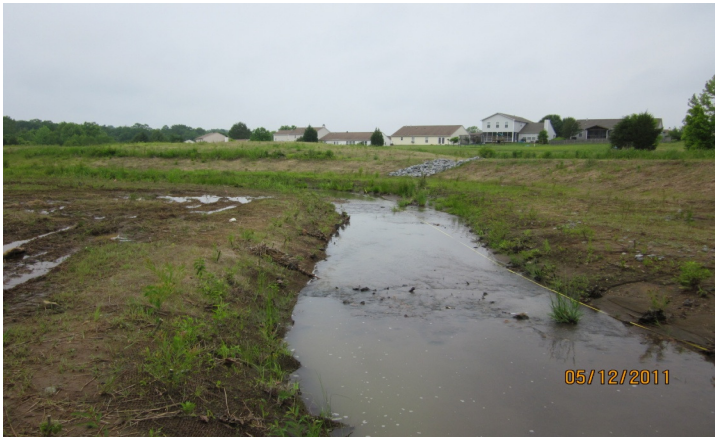
Reach	Indian Run, Lower Reach
River Basin	Yadkin / Pee Dee
Cross Section ID	XSC-5, Riffle, Lower Reach, 11+15
Drainage Area (Sq Mi)	1.5
Date	5/12/2011
Observers	V. Miller, C. Myers, W. Yelverton

SUMMARY DATA	
Bankfull Elevation, ft	536.34
Bankfull Cross Sectional Area, ft ²	28.84
Bankfull Width, ft	22.91
Max Depth at Bankfull, ft	2.08
Mean Depth at Bankfull, ft	1.26
Width/Depth Ratio	18.20
Flood Prone Width, ft	150.30
Flood Prone Area Elevation	538.42
Entrenchment Ratio	6.60
Bank Height Ratio	1.00

Stream Type C4

Sta. 11+15 Looking Downstream

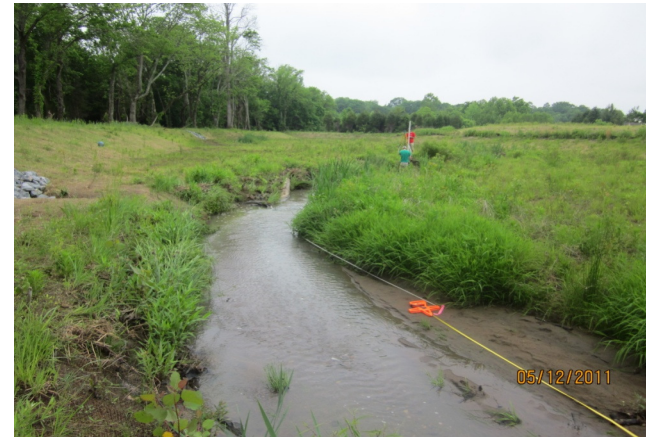
Reach	Indian Run, Lower Reach
River Basin	Yadkin / Pee Dee
Cross Section ID	XSC-6, Pool, Lower Reach, 13+10
Drainage Area (Sq Mi)	1.5
Date	5/12/2011
Observers	V. Miller, C. Myers, W. Yelverton

SUMMARY DATA	
Bankfull Elevation, ft	535.56
Bankfull Cross Sectional Area, ft²	28.22
Bankfull Width, ft	19.26
Max Depth at Bankfull, ft	2.40
Mean Depth at Bankfull, ft	1.47
Width/Depth Ratio	13.14
Flood Prone Width, ft	95.20
Flood Prone Area Elevation	537.71
Entrenchment Ratio	5.00
Bank Height Ratio	1.00

Stream Type C4

Sta. 13+10 Looking Downstream

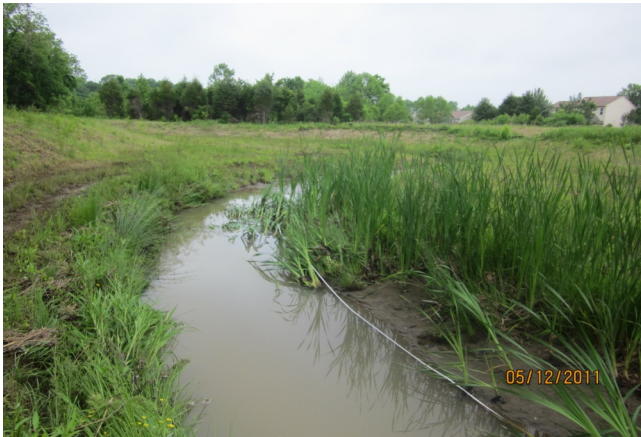
Reach	Indian Run, Lower Reach
River Basin	Yadkin / Pee Dee
Cross Section ID	XSC-7, Pool, Lower Reach, 15+89
Drainage Area (Sq Mi)	1.5
Date	5/12/2011
Observers	V. Miller, C. Myers, W. Yelverton

SUMMARY DATA	
Bankfull Elevation, ft	534.62
Bankfull Cross Sectional Area, ft²	48.92
Bankfull Width, ft	69.30
Max Depth at Bankfull, ft	3.00
Mean Depth at Bankfull, ft	0.71
Width/Depth Ratio	98.17
Flood Prone Width, ft	93.00
Flood Prone Area Elevation	536.77
Entrenchment Ratio	1.30
Bank Height Ratio	1.00

Stream Type C4

Sta. 15+89 Looking Downstream

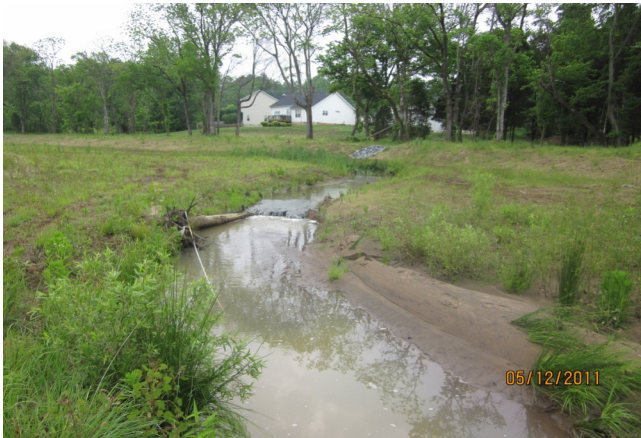
Reach	Indian Run, Lower Reach
River Basin	Yadkin / Pee Dee
Cross Section ID	XSC-8, Riffle, Lower Reach, 16+50
Drainage Area (Sq Mi)	1.5
Date	5/12/2011
Observers	V. Miller, C. Myers, W. Yelverton

SUMMARY DATA	
Bankfull Elevation, ft	534.36
Bankfull Cross Sectional Area, ft ²	27.10
Bankfull Width, ft	20.38
Max Depth at Bankfull, ft	2.20
Mean Depth at Bankfull, ft	1.33
Width/Depth Ratio	15.33
Flood Prone Width, ft	96.40
Flood Prone Area Elevation	536.58
Entrenchment Ratio	4.70
Bank Height Ratio	1.00

Stream Type C4

Sta. 16+50 Looking Upstream, above log struc.

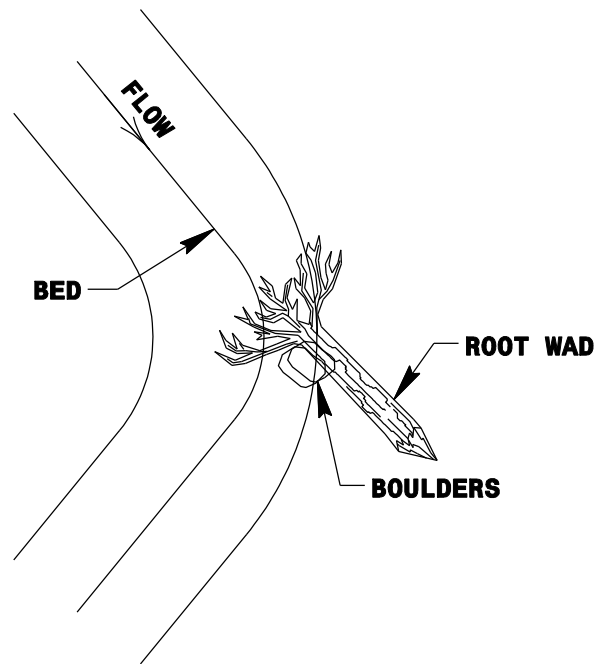
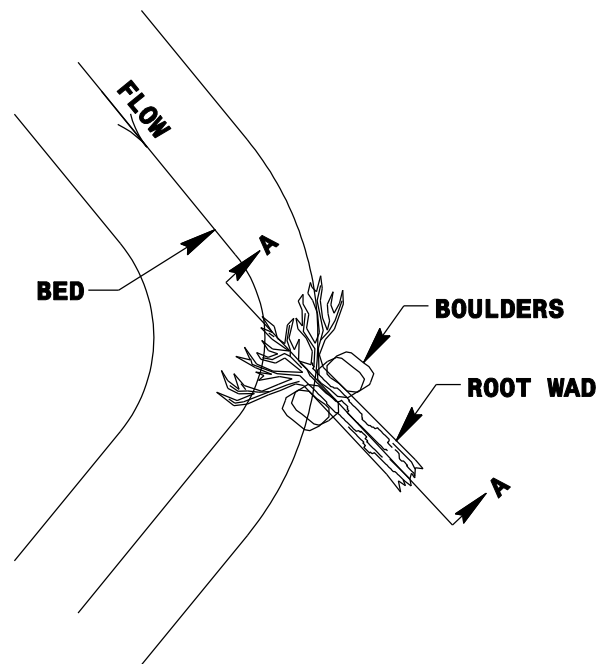
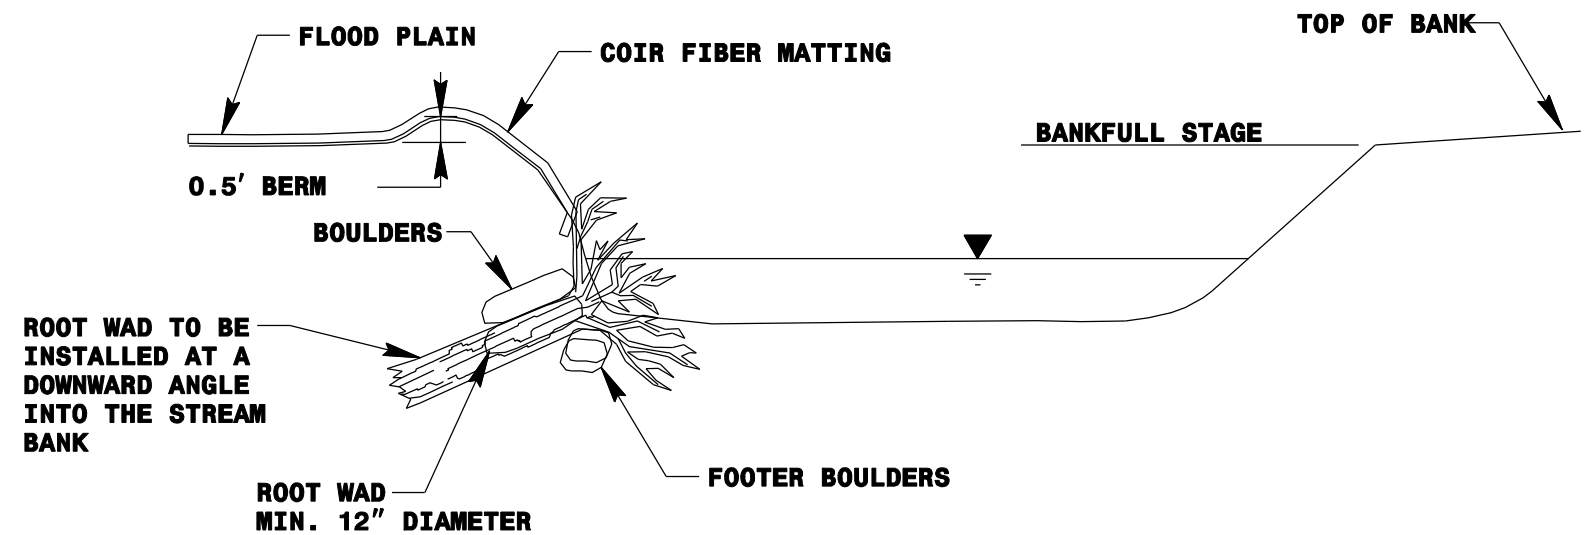
ROOT WAD

SHEET ADDED WHEN ROOTWADS REPLACED BRUSH MATTRESSES DUE TO BEING OUT OF PLANTING SEASON

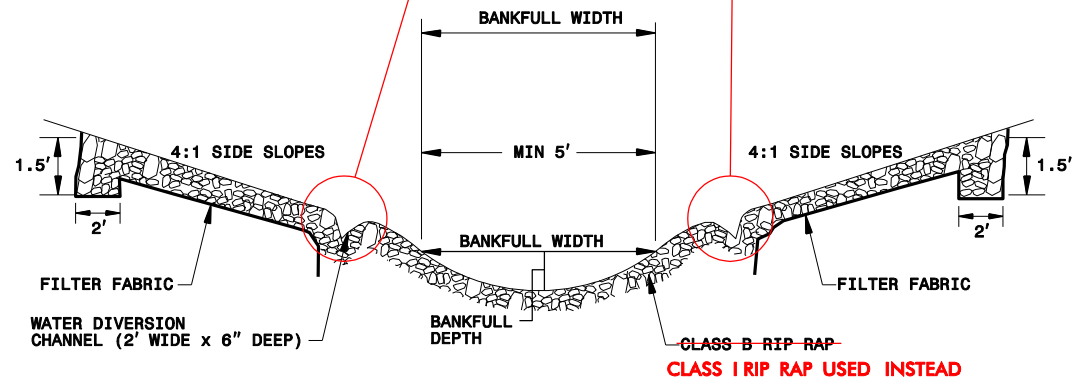
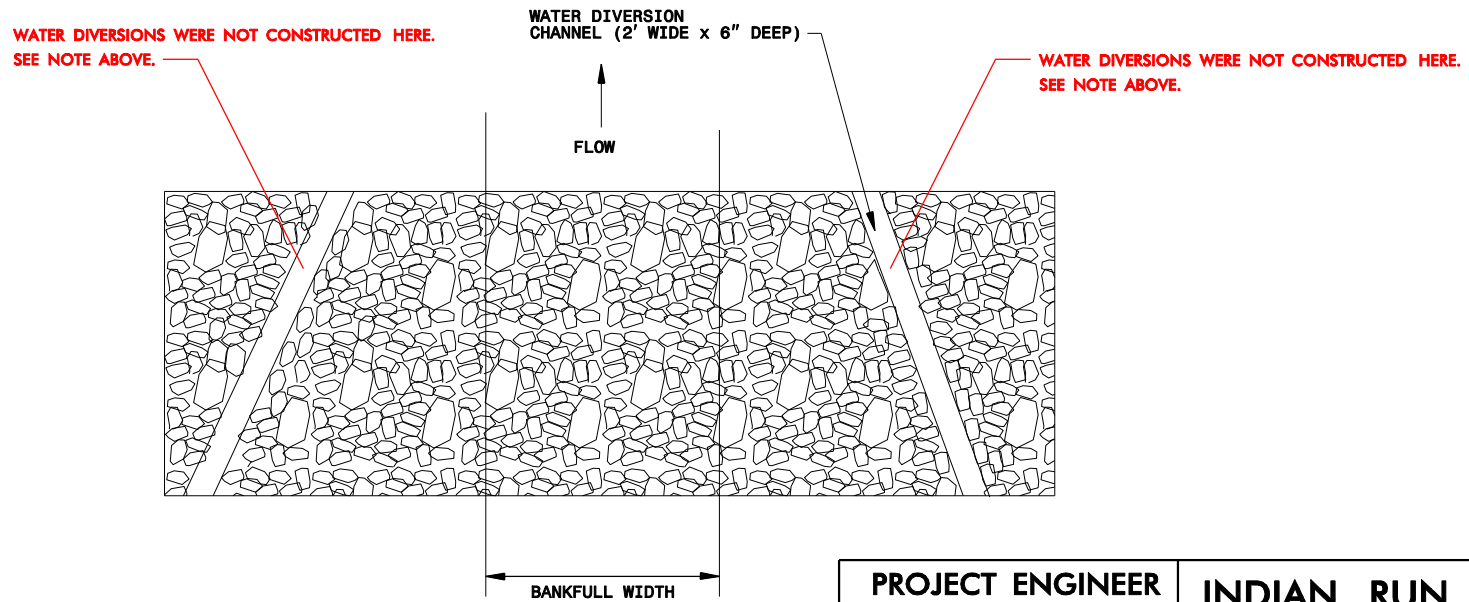
PERMANENT STREAM CROSSING TYPE II

WATER DIVERSIONS WERE NOT CONSTRUCTED HERE
BECAUSE OF THE SIZE OF ROCK USED FOR THE CROSSING.
THE PURPOSE OF THESE DIVERSIONS WERE TO PREVENT
HIGH FLOWS WASHING OUT SMALLER ROCK FROM CROSSING.
SINCE LARGER ROCK WAS USED, THE DIVERSIONS WERE NOT NECESSARY.
