**Coddle Creek Tributary  
(Indian Run) Stream Restoration  
EEP Project # 94**

**Monitoring Report Year 1 of 5  
Cabarrus County, North Carolina**

HDR Engineering, Inc. of the Carolinas  
3733 National Drive, Suite 207  
Raleigh, NC 27612-4845

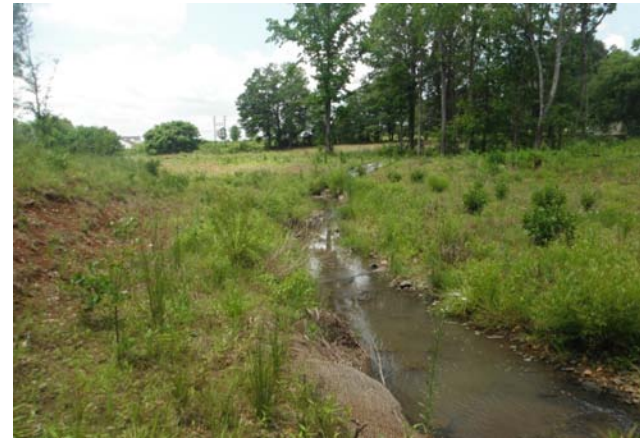
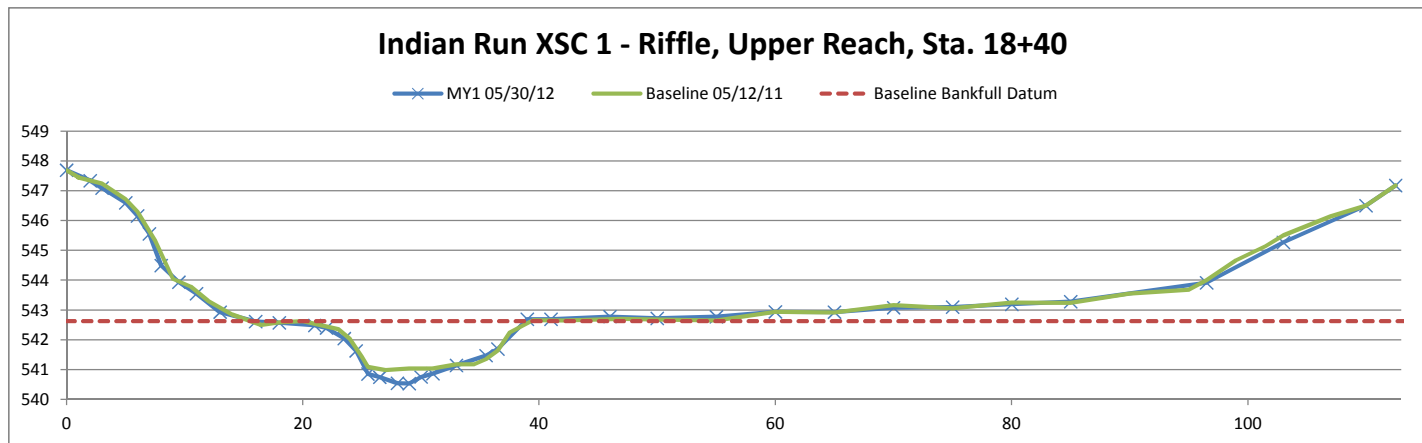
Sta. 18+40 Looking Downstream

Reach	Indian Run, Upper Reach
River Basin	Yadkin / Pee Dee
Cross Section ID	XSC-1, Riffle, Upper Reach, 18+40
Drainage Area (Sq Mi)	1.5
Date	5/29/2012
Observers	V. Miller, C. Myers, W. Yelverton

SUMMARY DATA	
Bankfull Elevation, ft	542.62
Bankfull Cross Sectional Area, ft <sup>2</sup>	22.60
Bankfull Width, ft	22.90
Max Depth at Bankfull, ft	2.09
Mean Depth at Bankfull, ft	0.99
Width/Depth Ratio	23.20
Flood Prone Width, ft	92.50
Flood Prone Area Elevation	544.71
Entrenchment Ratio	4.04
Bank Height Ratio	0.98

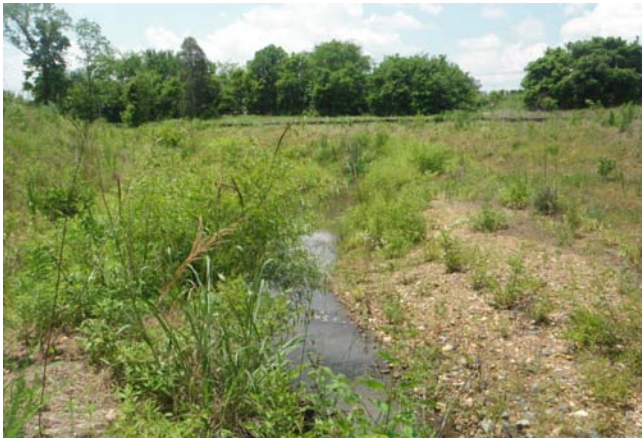
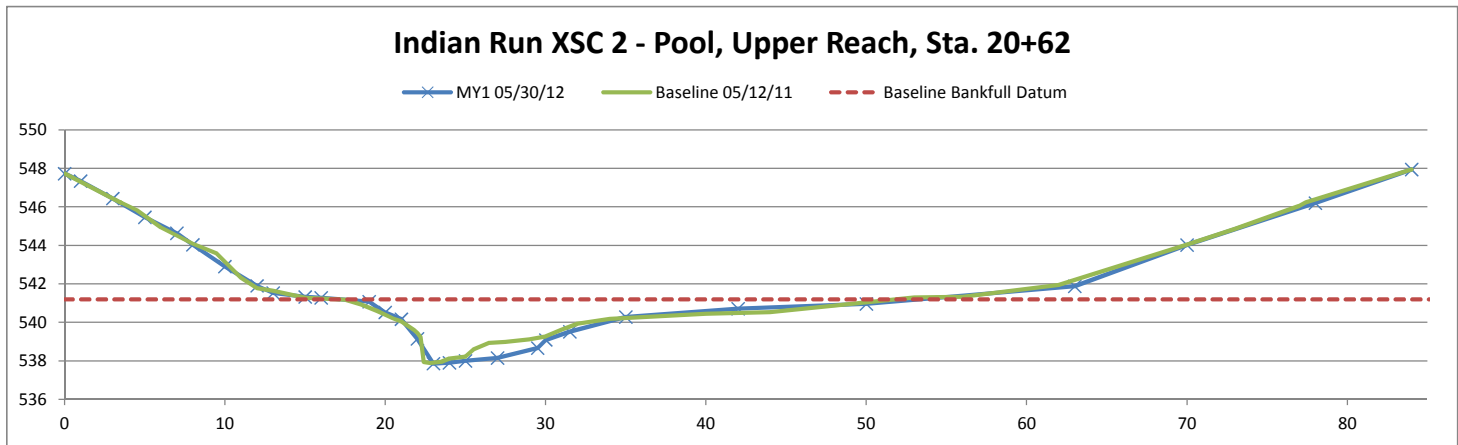
Sta. 20+62 Looking Downstream, foreground

Reach	Indian Run, Upper Reach
River Basin	Yadkin / Pee Dee
Cross Section ID	XSC-2, Pool, Upper Reach, 20+62
Drainage Area (Sq Mi)	1.5
Date	5/29/2012
Observers	V. Miller, C. Myers, W. Yelverton

SUMMARY DATA	
Bankfull Elevation, ft	541.18
Bankfull Cross Sectional Area, ft <sup>2</sup>	41.46
Bankfull Width, ft	35.59
Max Depth at Bankfull, ft	3.32
Mean Depth at Bankfull, ft	1.16
Width/Depth Ratio	30.55
Flood Prone Width, ft	60.70
Flood Prone Area Elevation	544.50
Entrenchment Ratio	1.71
Bank Height Ratio	1.00

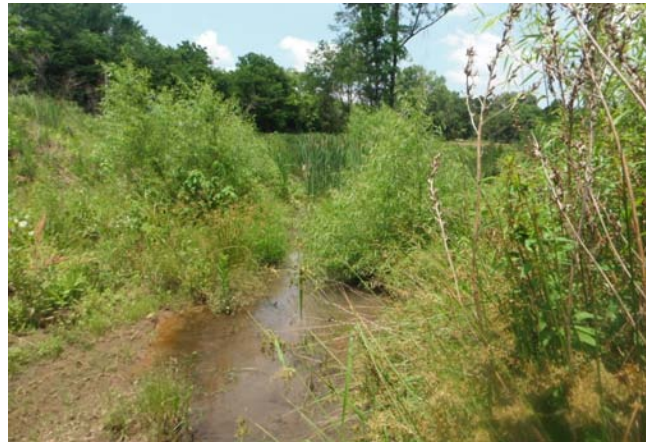
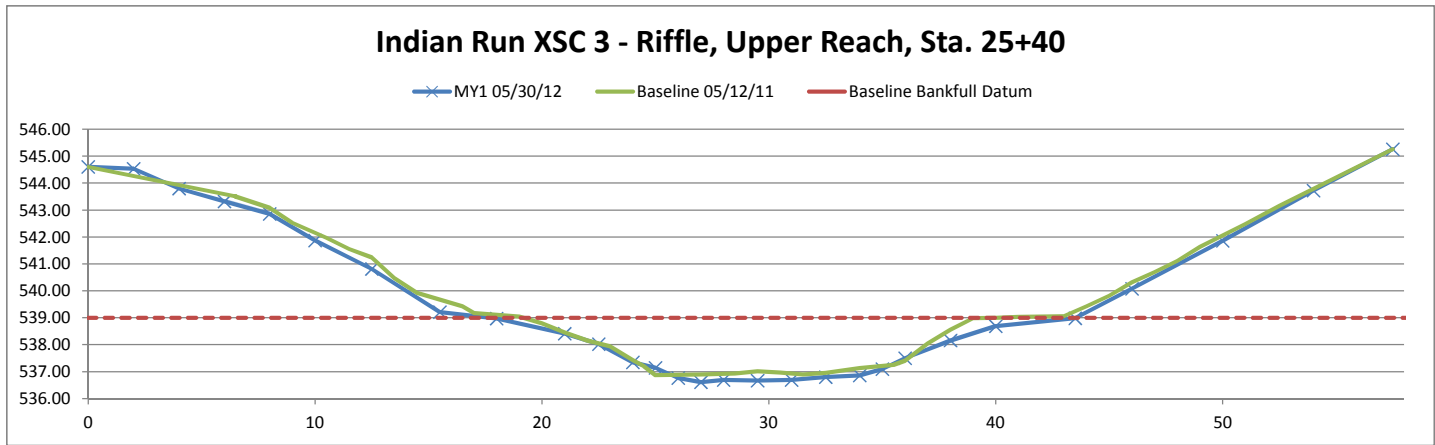
Sta. 25+40, Looking Upstream

Reach	Indian Run, Upper Reach
River Basin	Yadkin / Pee Dee
Cross Section ID	XSC-3, Riffle, Upper Reach, 25+40
Drainage Area (Sq Mi)	1.5
Date	5/29/2012
Observers	V. Miller, C. Myers, W. Yelverton

SUMMARY DATA	
Bankfull Elevation, ft	539.00
Bankfull Cross Sectional Area, ft <sup>2</sup>	33.89
Bankfull Width, ft	25.86
Max Depth at Bankfull, ft	2.39
Mean Depth at Bankfull, ft	1.31
Width/Depth Ratio	19.73
Flood Prone Width, ft	37.80
Flood Prone Area Elevation	541.39
Entrenchment Ratio	1.46
Bank Height Ratio	1.00

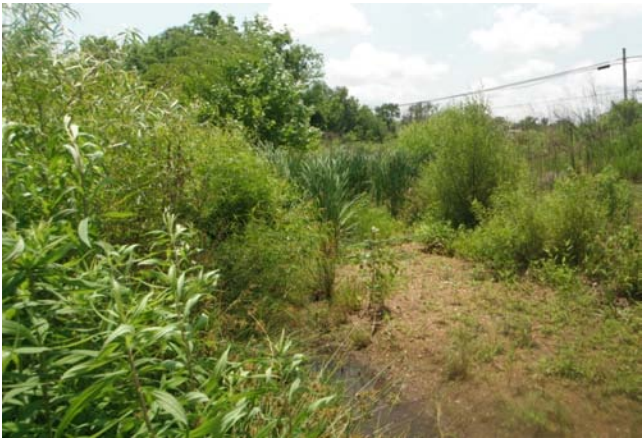
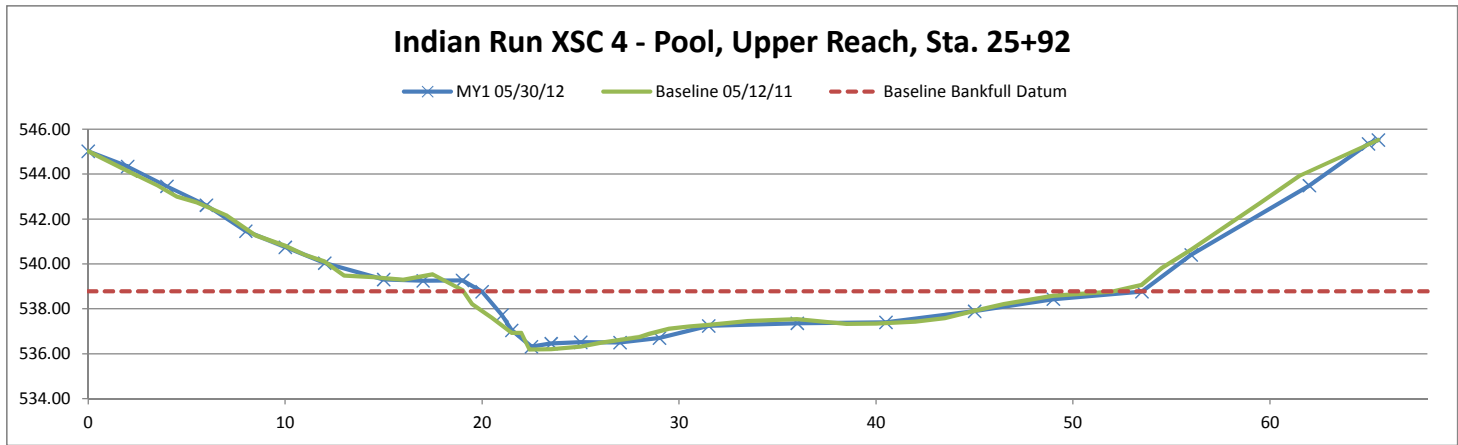
Sta. 25+92 Looking Downstream, foreground

Reach	Indian Run, Upper Reach
River Basin	Yadkin / Pee Dee
Cross Section ID	XSC-4, Pool, Upper Reach, 25+92
Drainage Area (Sq Mi)	1.5
Date	5/29/2012
Observers	V. Miller, C. Myers, W. Yelverton

SUMMARY DATA	
Bankfull Elevation, ft	538.77
Bankfull Cross Sectional Area, ft <sup>2</sup>	43.72
Bankfull Width, ft	33.51
Max Depth at Bankfull, ft	2.46
Mean Depth at Bankfull, ft	1.30
Width/Depth Ratio	25.68
Flood Prone Width, ft	47.90
Flood Prone Area Elevation	541.23
Entrenchment Ratio	1.43
Bank Height Ratio	1.00

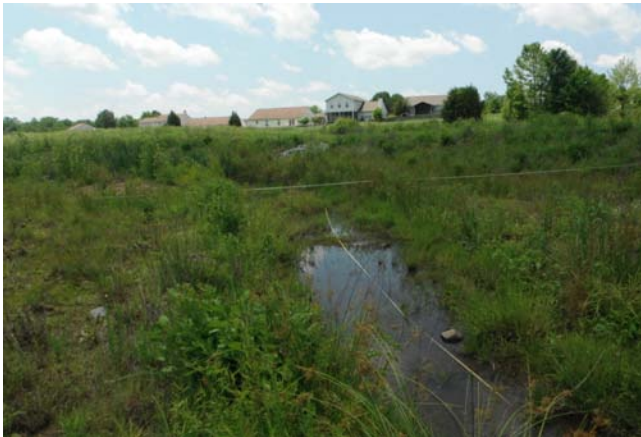
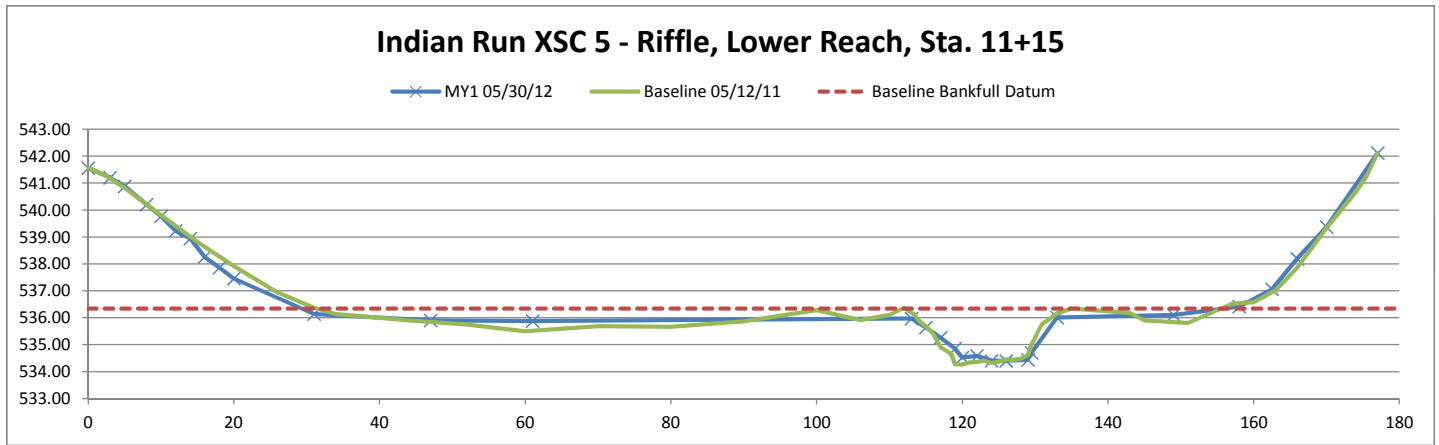
Sta. 11+15 Looking Downstream

Reach	Indian Run, Lower Reach
River Basin	Yadkin / Pee Dee
Cross Section ID	XSC-5, Riffle, Lower Reach, 11+15
Drainage Area (Sq Mi)	1.5
Date	5/30/2012
Observers	V. Miller, C. Myers, W. Yelverton

SUMMARY DATA	
Bankfull Elevation, ft	536.34
Bankfull Cross Sectional Area, ft <sup>2</sup>	27.92
Bankfull Width, ft	19.98
Max Depth at Bankfull, ft	1.94
Mean Depth at Bankfull, ft	1.40
Width/Depth Ratio	14.30
Flood Prone Width, ft	150.10
Flood Prone Area Elevation	538.28
Entrenchment Ratio	7.51
Bank Height Ratio	0.83

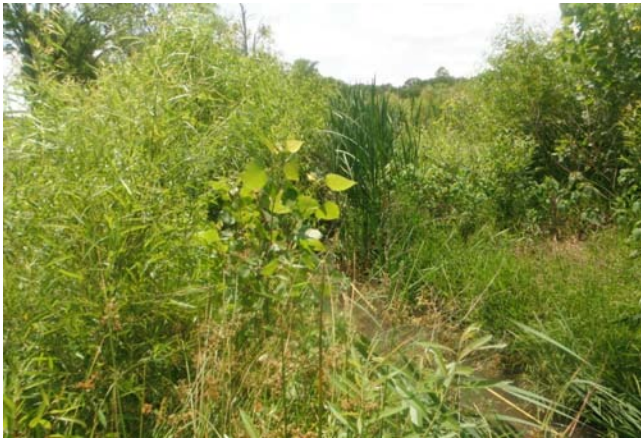
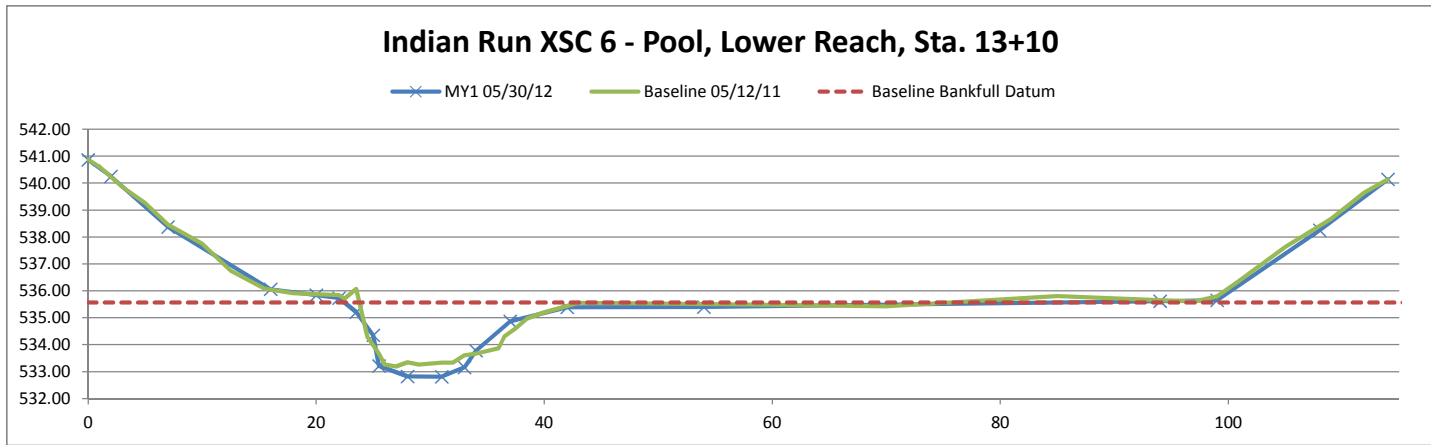
Sta. 13+10 Looking Downstream

Reach	Indian Run, Lower Reach
River Basin	Yadkin / Pee Dee
Cross Section ID	XSC-6, Pool, Lower Reach, 13+10
Drainage Area (Sq Mi)	1.5
Date	5/30/2012
Observers	V. Miller, C. Myers, W. Yelverton

SUMMARY DATA	
Bankfull Elevation, ft	535.56
Bankfull Cross Sectional Area, ft <sup>2</sup>	26.71
Bankfull Width, ft	19.03
Max Depth at Bankfull, ft	2.75
Mean Depth at Bankfull, ft	1.40
Width/Depth Ratio	13.56
Flood Prone Width, ft	104.40
Flood Prone Area Elevation	538.31
Entrenchment Ratio	5.49
Bank Height Ratio	0.94

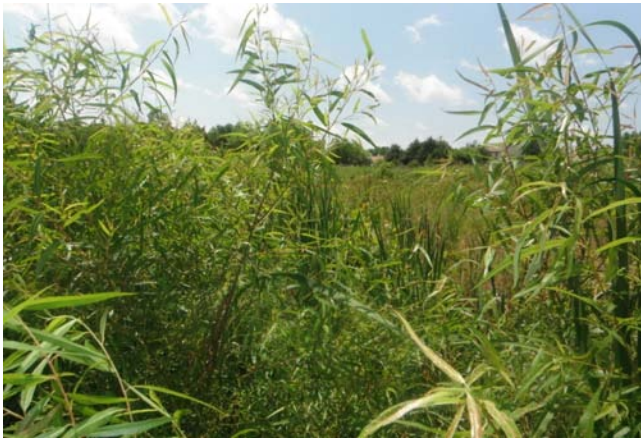
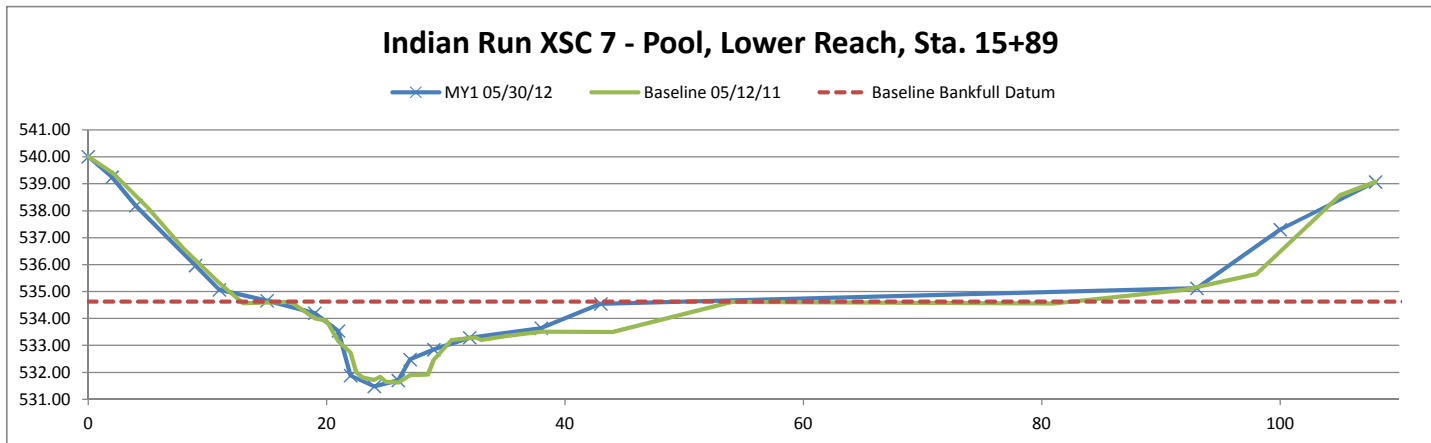
Sta. 15+89 Looking Downstream

Reach	Indian Run, Lower Reach
River Basin	Yadkin / Pee Dee
Cross Section ID	XSC-7, Pool, Lower Reach, 15+89
Drainage Area (Sq Mi)	1.5
Date	5/30/2012
Observers	V. Miller, C. Myers, W. Yelverton

SUMMARY DATA	
Bankfull Elevation, ft	534.62
Bankfull Cross Sectional Area, ft <sup>2</sup>	37.08
Bankfull Width, ft	34.53
Max Depth at Bankfull, ft	3.14
Mean Depth at Bankfull, ft	1.07
Width/Depth Ratio	32.16
Flood Prone Width, ft	99.00
Flood Prone Area Elevation	537.76
Entrenchment Ratio	2.87
Bank Height Ratio	1.00

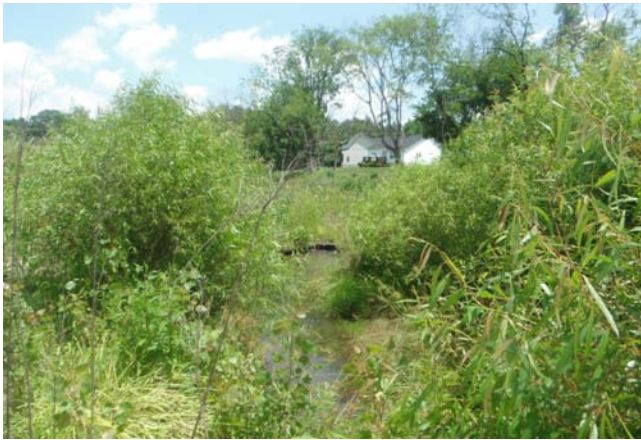
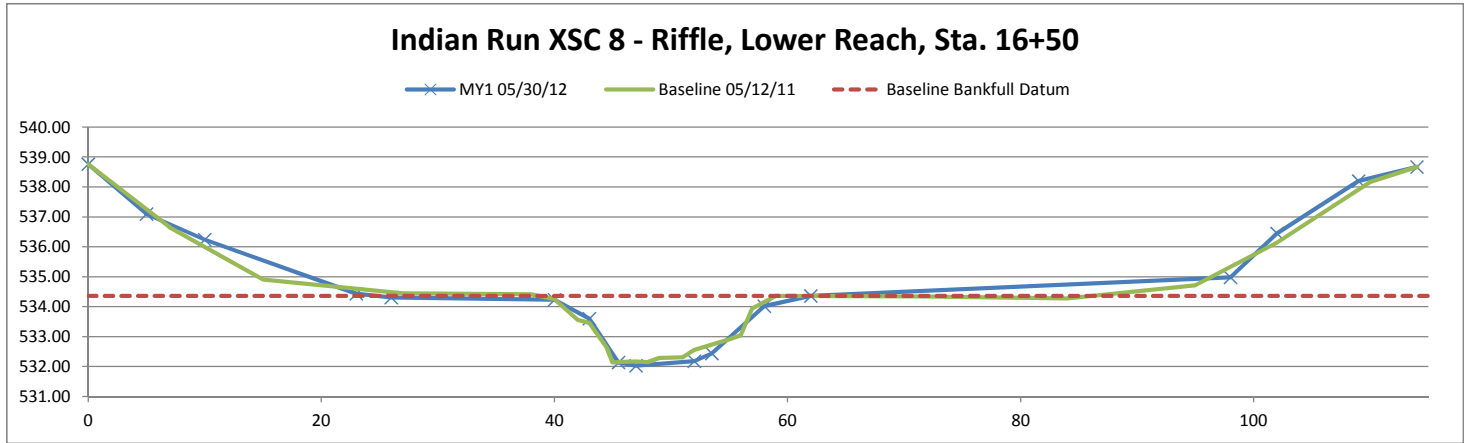
Sta. 16+50 Looking Upstream, above log struc.

Reach	Indian Run, Lower Reach
River Basin	Yadkin / Pee Dee
Cross Section ID	XSC-8, Riffle, Lower Reach, 16+50
Drainage Area (Sq Mi)	1.5
Date	5/30/2012
Observers	V. Miller, C. Myers, W. Yelverton

SUMMARY DATA	
Bankfull Elevation, ft	534.36
Bankfull Cross Sectional Area, ft <sup>2</sup>	28.64
Bankfull Width, ft	22.02
Max Depth at Bankfull, ft	2.33
Mean Depth at Bankfull, ft	1.30
Width/Depth Ratio	16.93
Flood Prone Width, ft	95.60
Flood Prone Area Elevation	536.69
Entrenchment Ratio	4.34
Bank Height Ratio	0.94

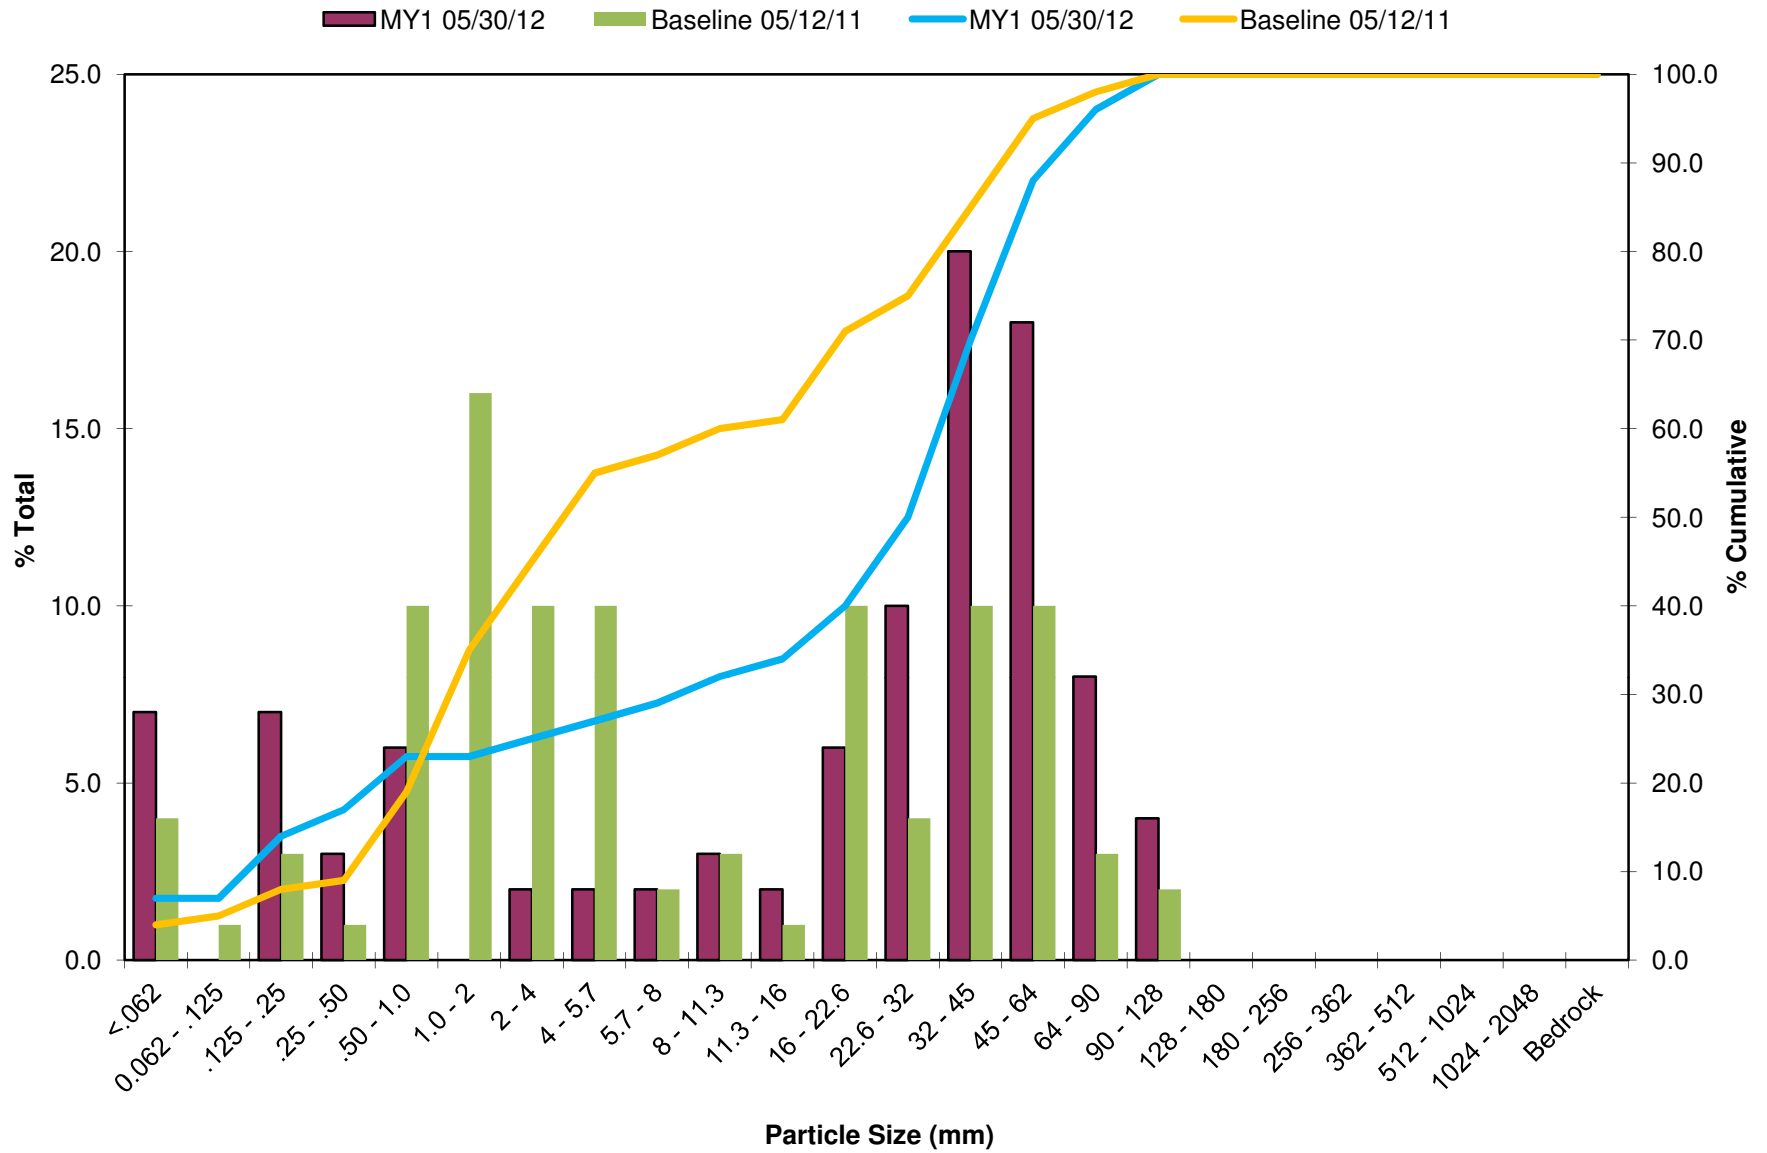
### Pebble count at XSC-1-Riffle

Summary Data	
D50	32
D84	59
D95	86

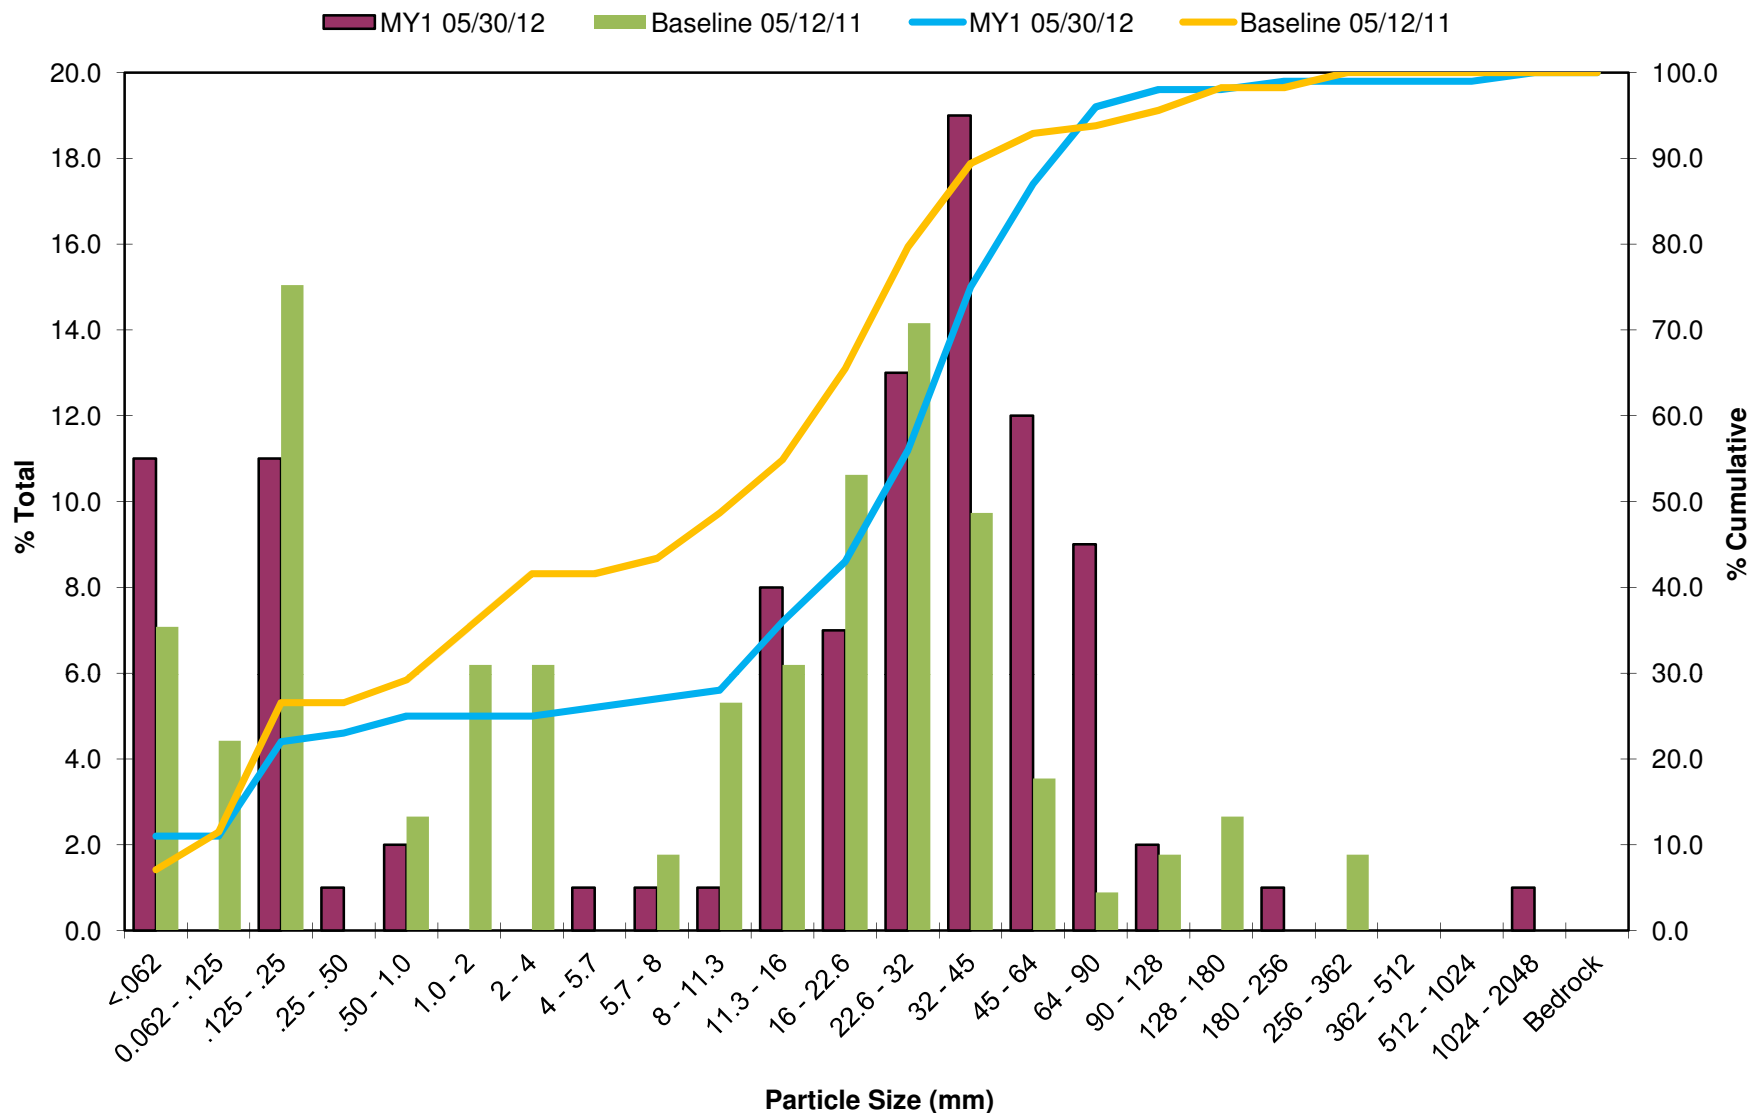
### Pebble count at XSC-2-Pool

Summary Data	
D50	27
D84	59
D95	87

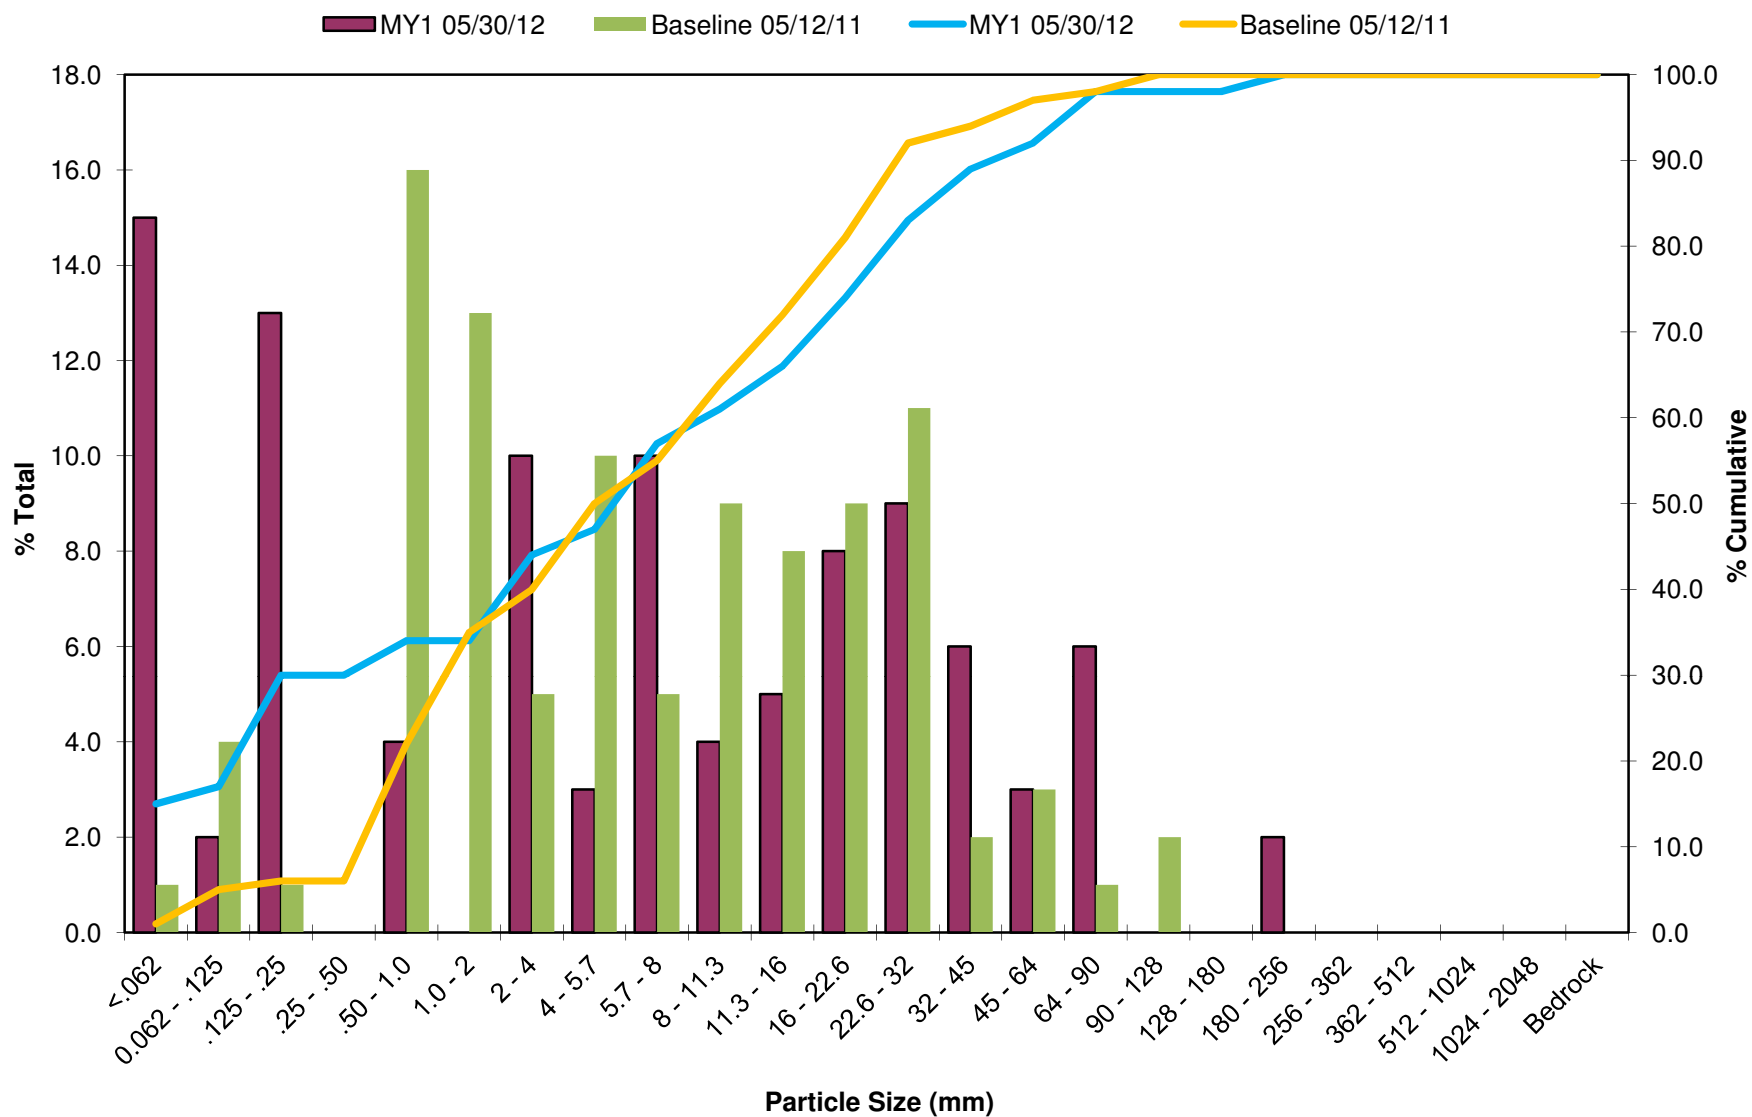
### Pebble count at XSC-3-Riffle

Summary Data	
D50	6.5
D84	34
D95	76

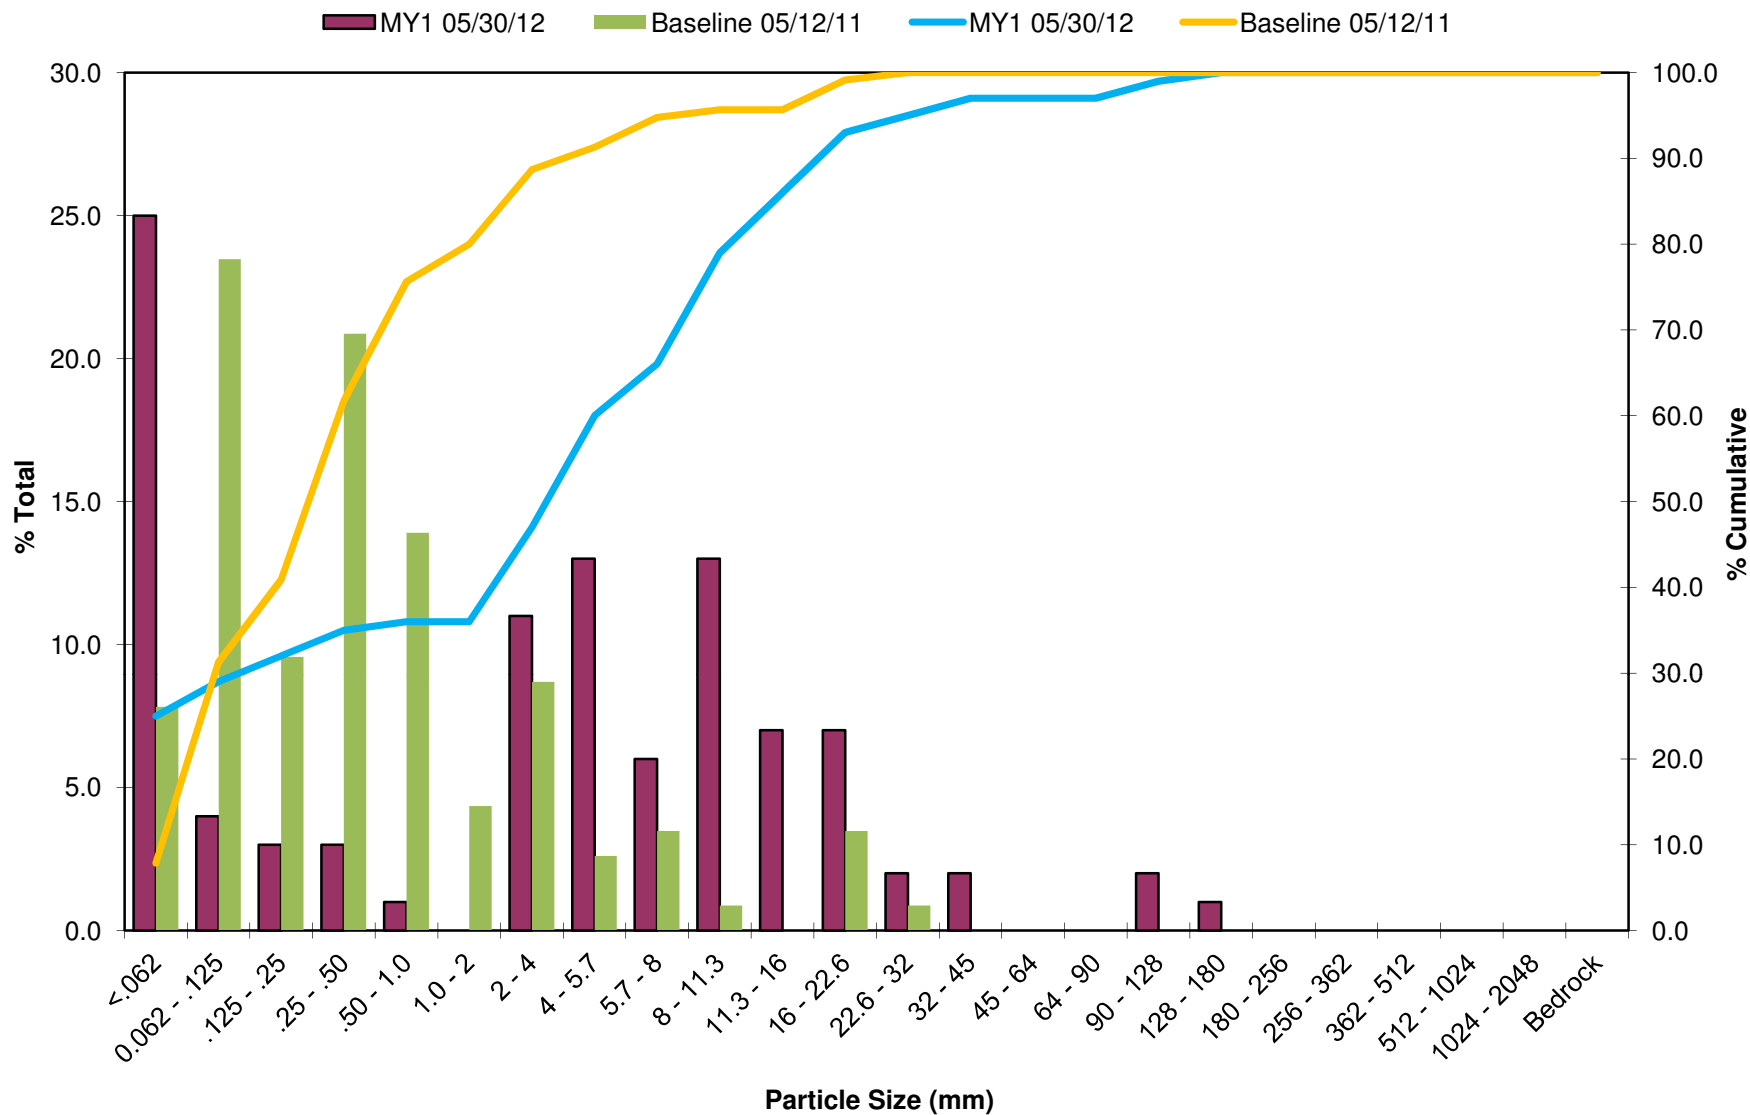
### Pebble count at XSC-4-Pool

Summary Data	
D50	4.4
D84	14
D95	32

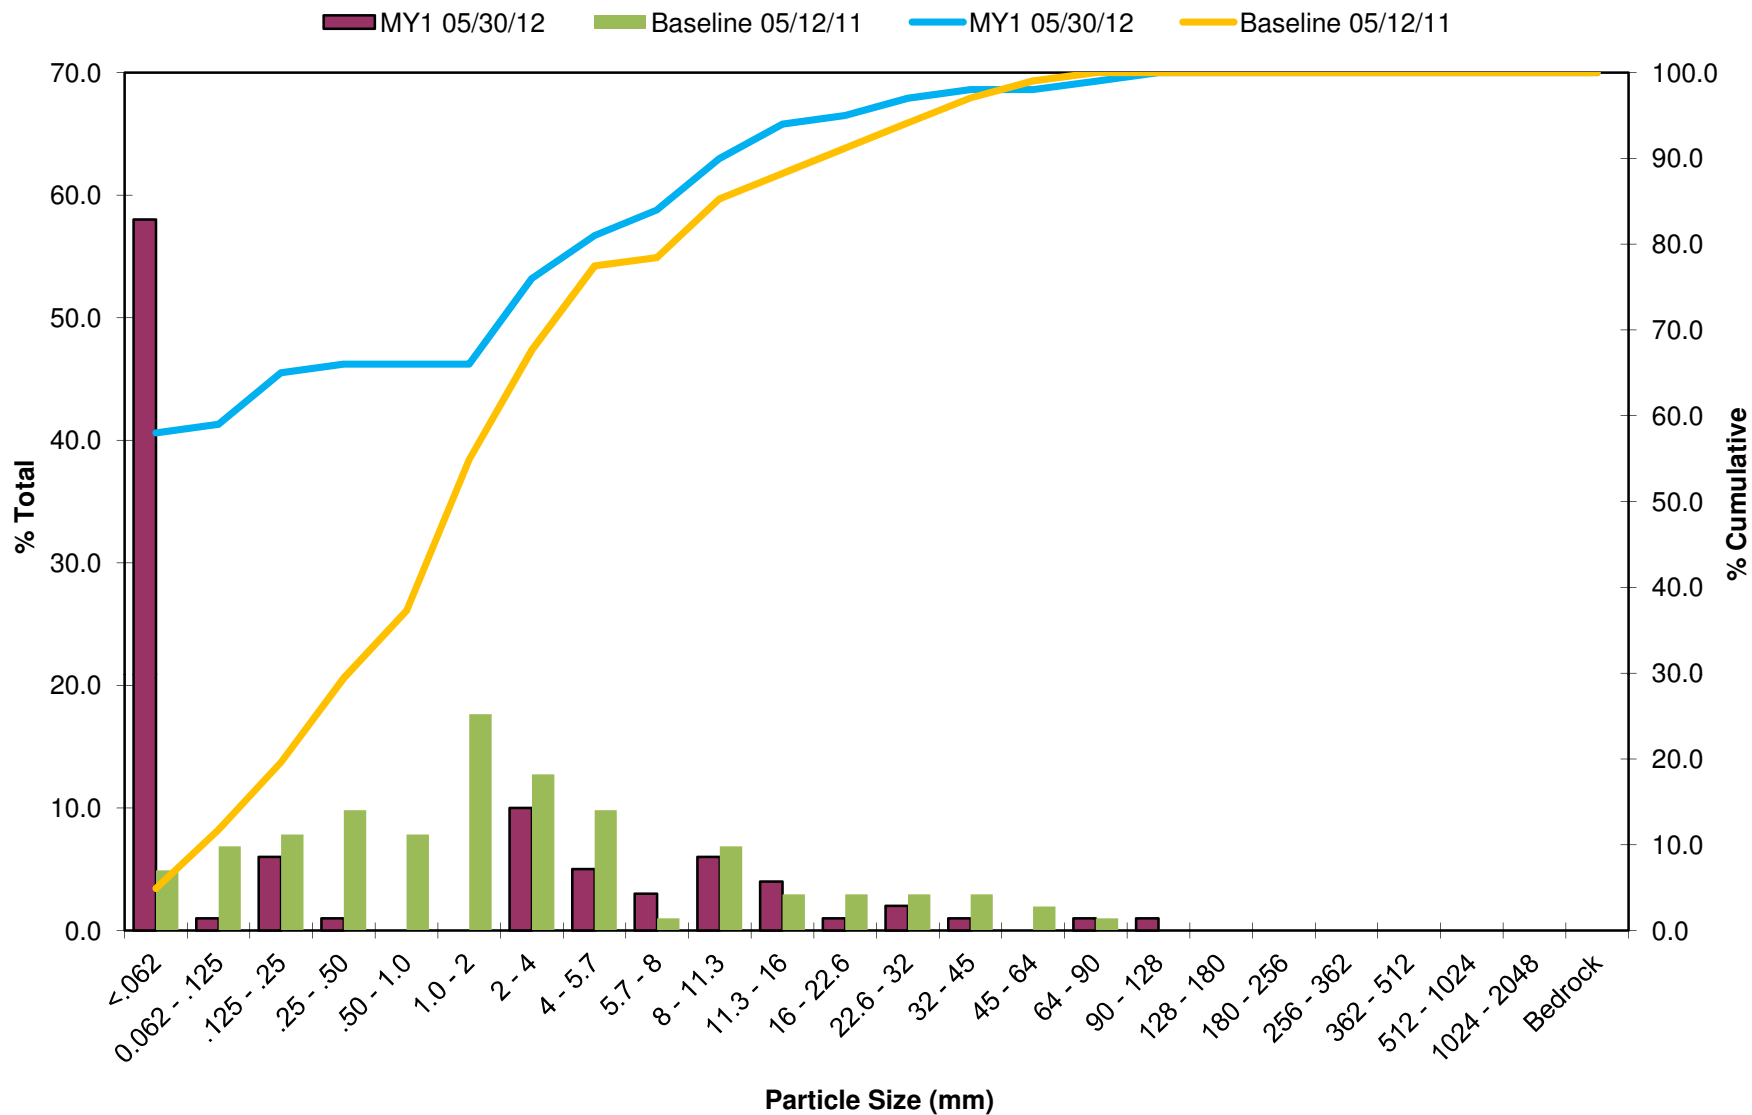
### Pebble count at XSC-5-Riffle

Summary Data	
D50	0.062
D84	8
D95	22

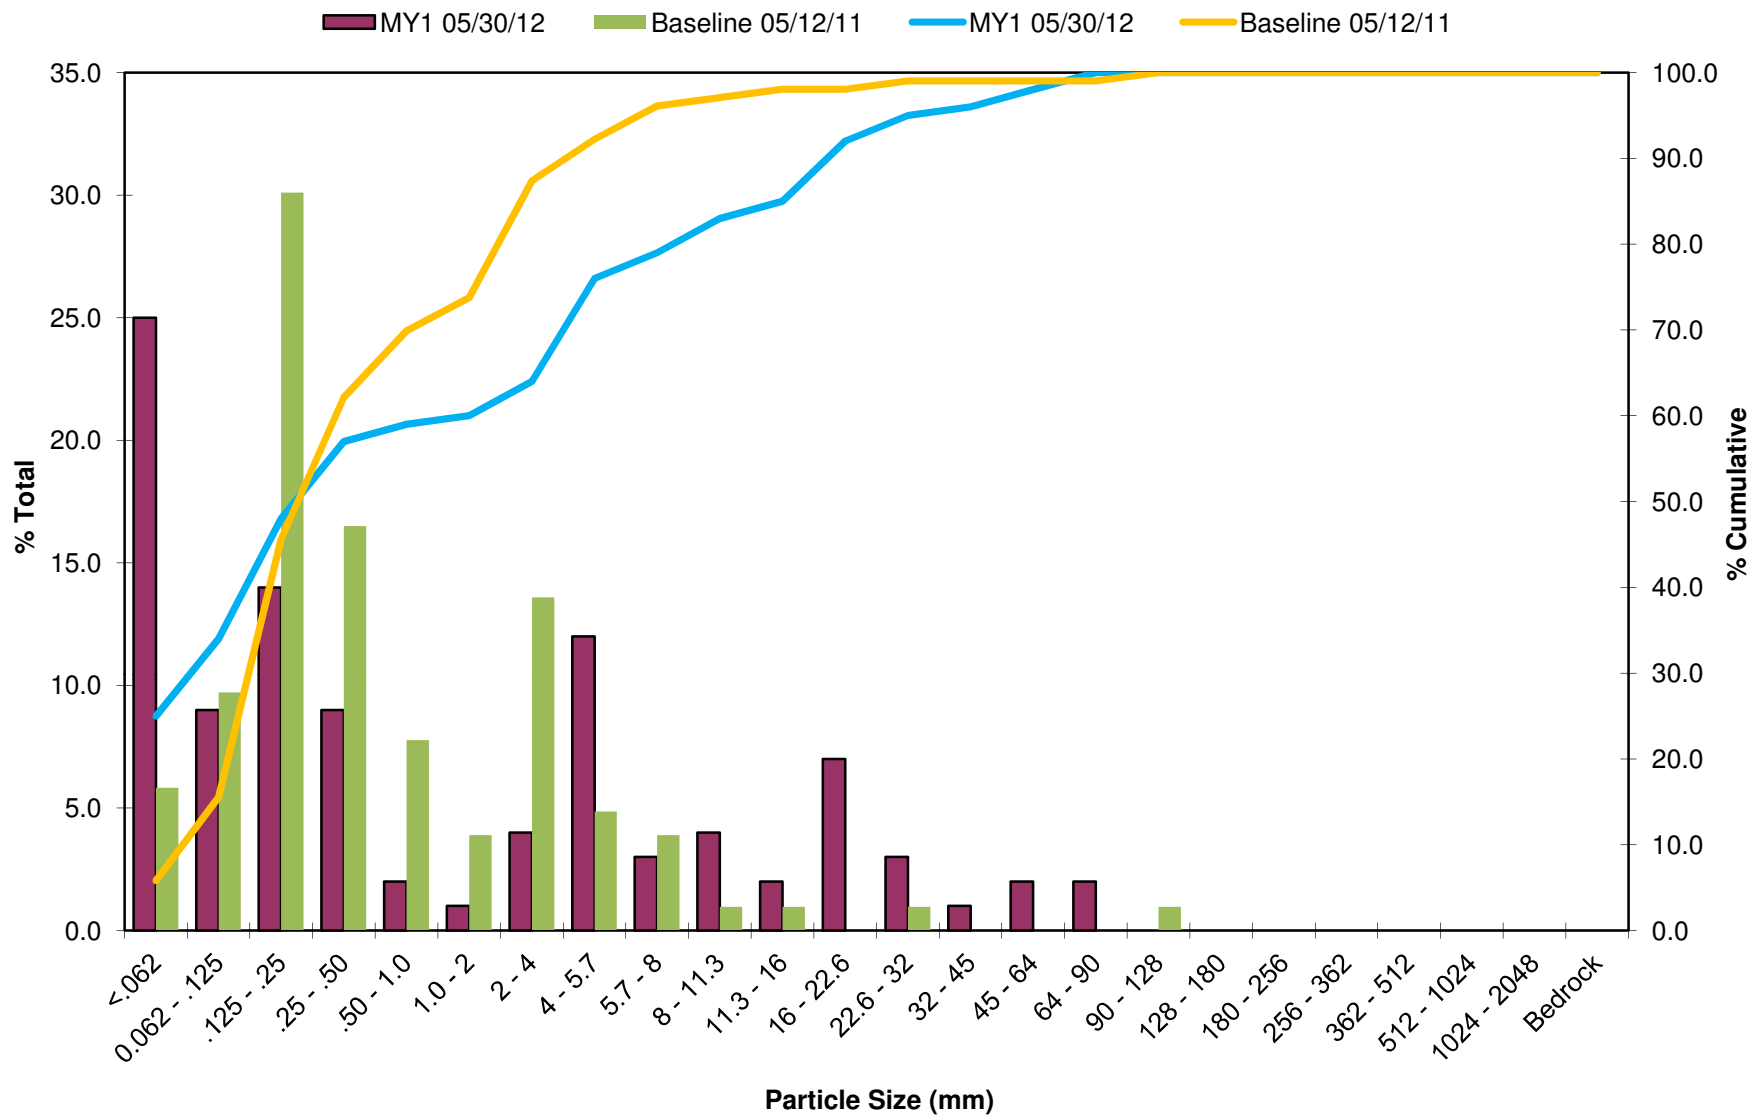
### Pebble count at XSC-6-Pool

Summary Data	
D50	0.29
D84	13
D95	32

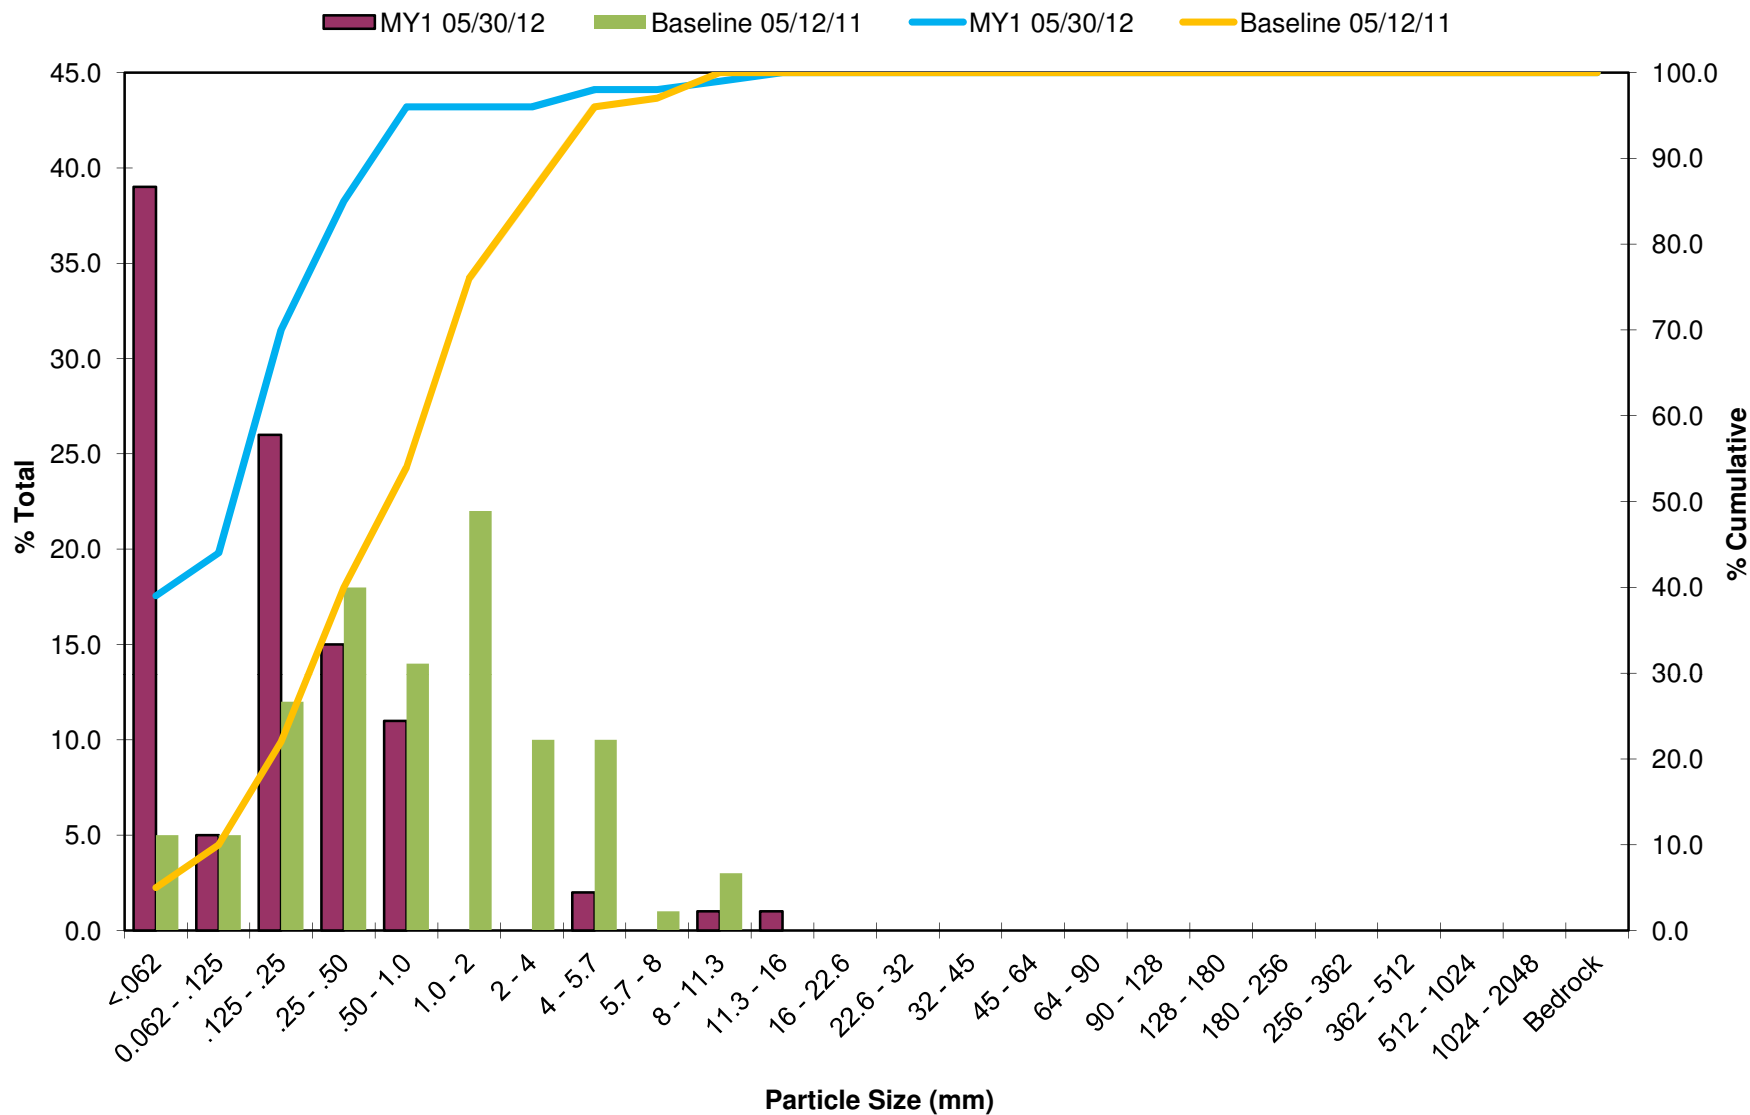
### Pebble count at XSC-7-Pool

Summary Data	
D50	0.15
D84	0.48
D95	0.94
