**Coddle Creek Tributary  
(Indian Run) Stream Restoration  
EEP Project # 94**

**Monitoring Report Year 1 of 5  
Cabarrus County, North Carolina**

HDR Engineering, Inc. of the Carolinas  
3733 National Drive, Suite 207  
Raleigh, NC 27612-4845

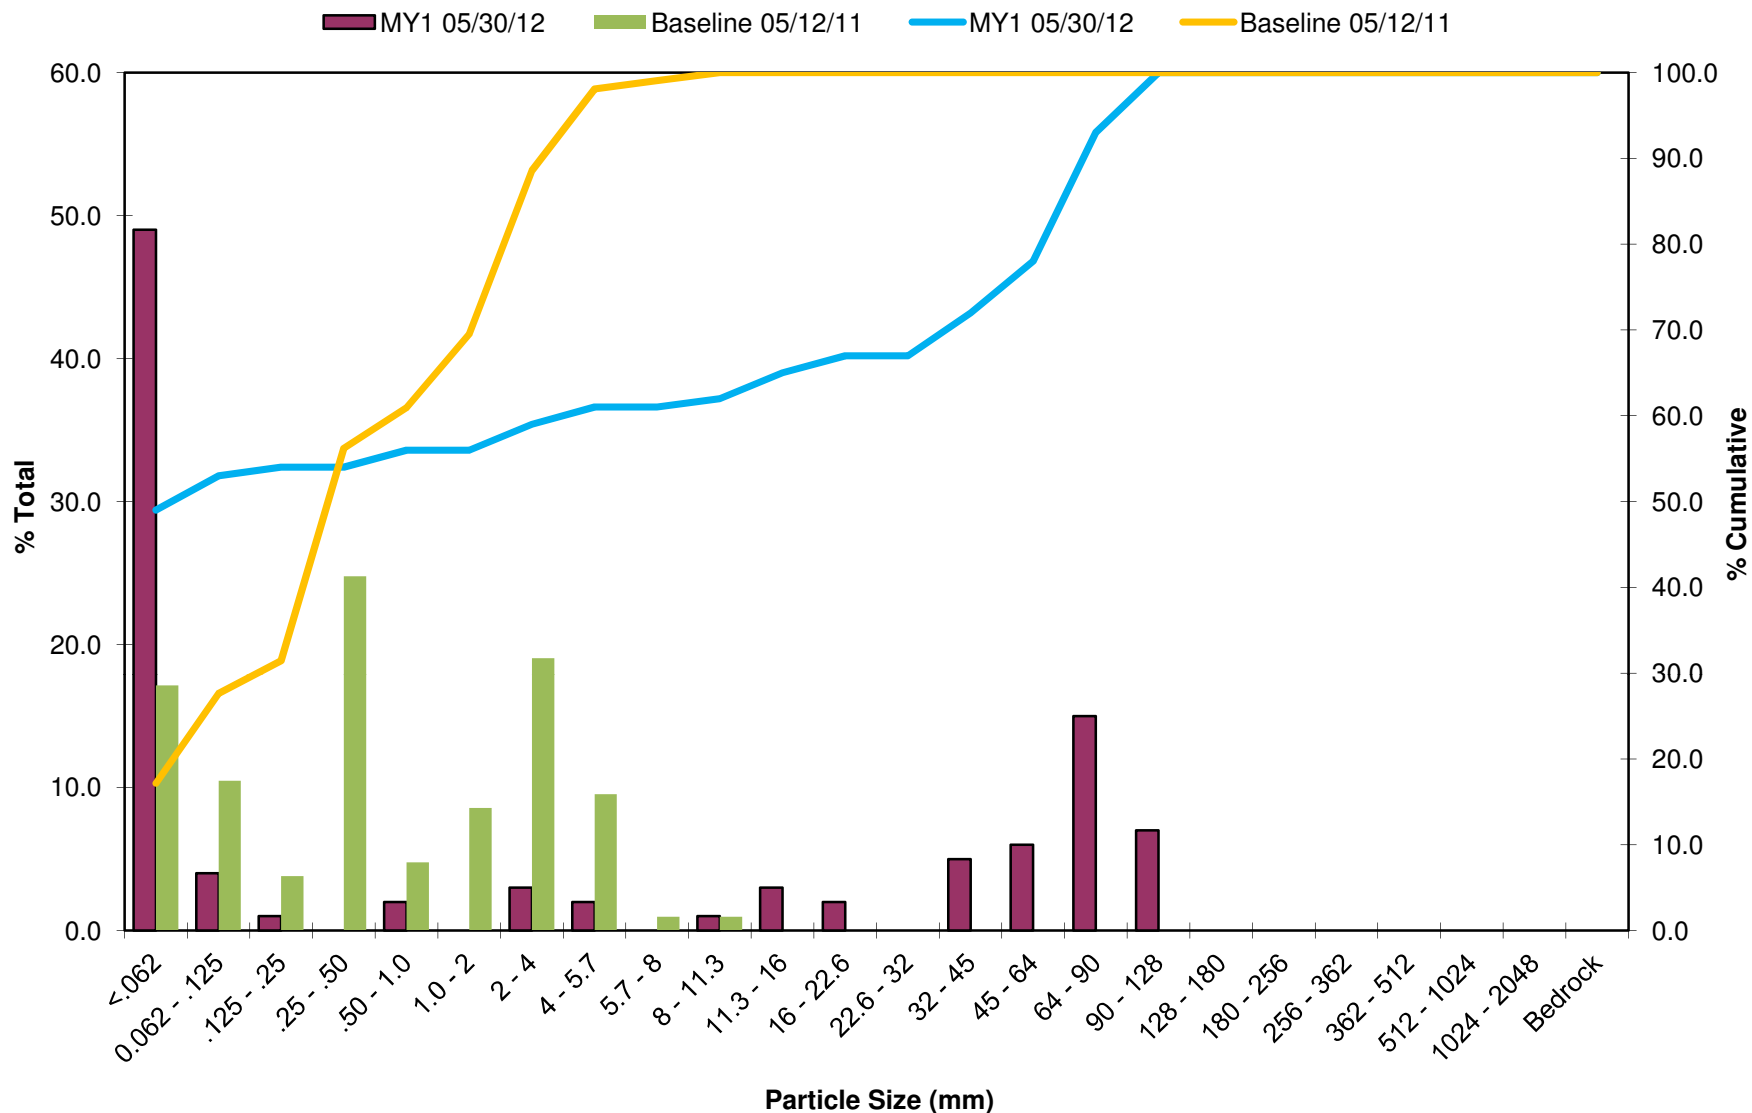
### Pebble count at XSC-8-Riffle

Summary Data	
D50	0.074
D84	73
D95	100

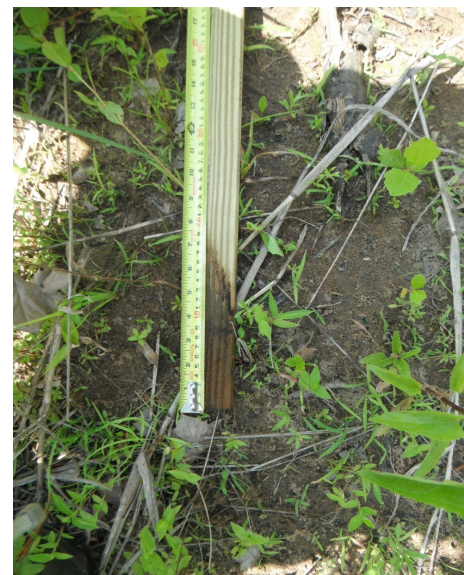
Table 12 – Verification of Bankfull Events

No groundwater monitoring gauges were installed onsite; however, a crest gauge was installed and evidence of a bankfull event was noted at the gauge as well as wrack lines noted in the floodplain.

<b>Table 12. Verification of Bankfull Events</b>			
<b>Coddle Creek Tributary (Indian Run)/ 94 Segment/Reach: 2270 feet</b>			
<b>Date of Data Collection</b>	<b>Date of Occurrence</b>	<b>Method</b>	<b>Photo</b>
5/30/2012	Between 5/11/2011 - 5/30/2012	Visual observation of wrack lines; stream gauge	See below
