**Coddle Creek Tributary  
(Indian Run) Stream Restoration  
EEP Project # 94  
DENR Contract # 5360**

**Monitoring Report Year 2 of 5  
Cabarrus County, North Carolina**

**Construction Completed: March 27, 2011  
Data Collected: December 2013  
Report Submission: March 2014**

SEPI Engineering and Construction  
1025 Wade Avenue  
Raleigh, NC 27605

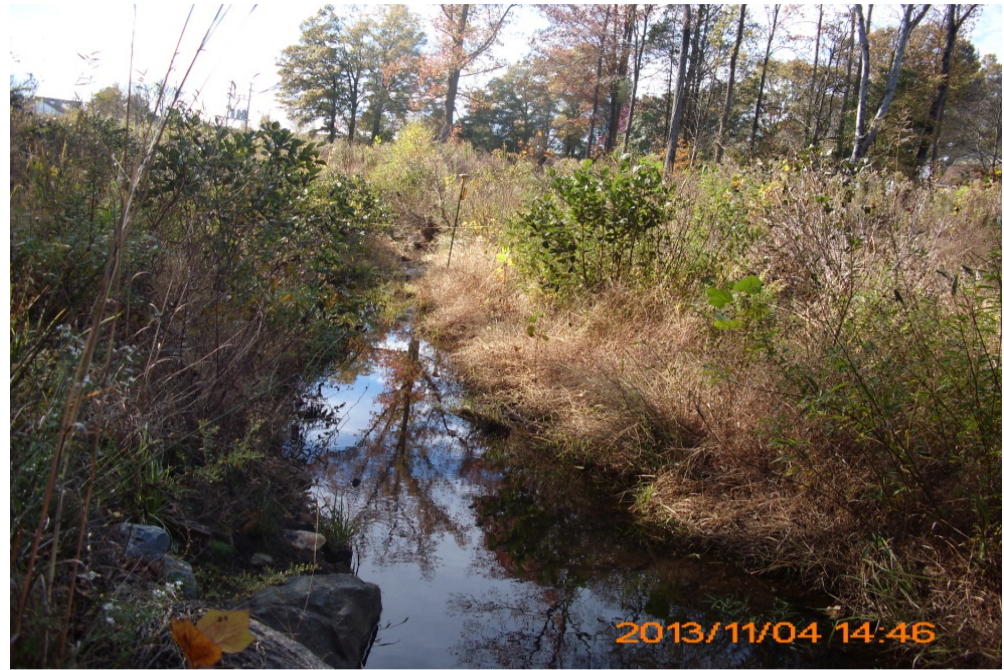
Sta. 18+40 Looking Downstream

Reach	Indian Run, Upper Reach
River Basin	Yadkin/Pee Dee
Cross Section ID	XSC-1, Riffle, Upper Reach, 18+40
Drainage Area (Sq Mi)	1.5
Date	11/6/2013
Observers	H. Anthony, P. Beach, C. Flowers, K. Hamlin

SUMMARY DATA	
Baseline Bankfull Datum, ft	542.62
Bankfull Cross Sectional Area, ft <sup>2</sup>	27.3
Bankfull Width, ft	16
Max Depth at Bankfull, ft	2.16
Mean Depth at Bankfull, ft	1.71
Width/Depth Ratio	9.38
Flood Prone Width, ft	91
Flood Prone Area Elevation	544.78
Entrenchment Ratio	5.69
Bank Height Ratio	1.16

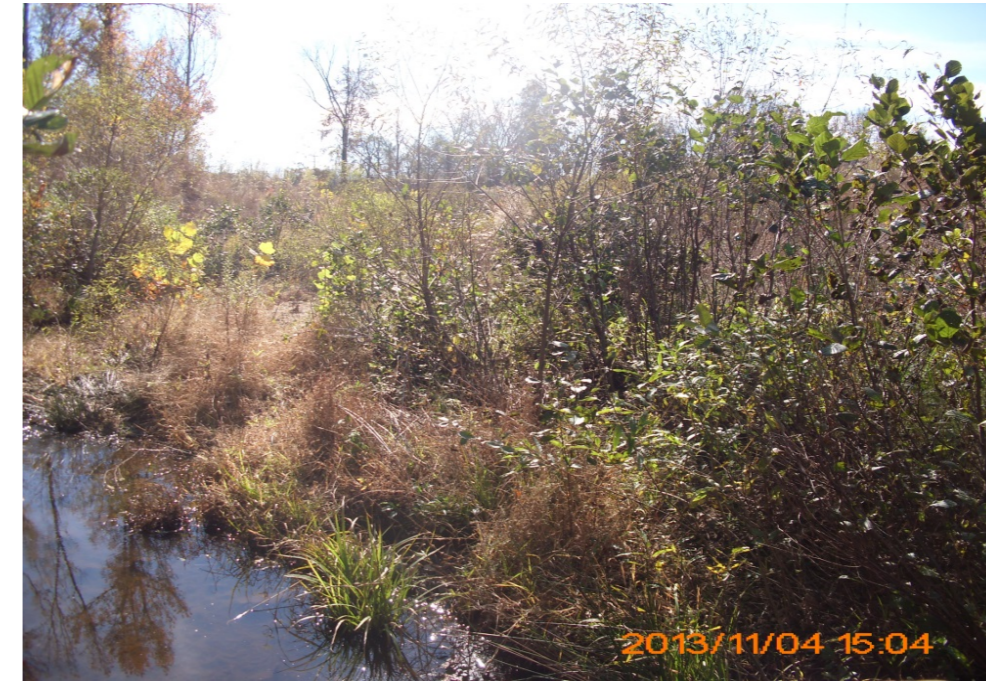
Sta. 20+62 Looking Downstream

Reach	Indian Run, Upper Reach
River Basin	Yadkin/Pee Dee
Cross Section ID	XSC-2, Pool, Upper Reach, 20+62
Drainage Area (Sq Mi)	1.5
Date	11/6/2013
Observers	H. Anthony, P. Beach, C. Flowers, K. Hamlin

SUMMARY DATA	
Baseline Bankfull Datum, ft	541.18
Bankfull Cross Sectional Area, ft <sup>2</sup>	41.97
Bankfull Width, ft	23
Max Depth at Bankfull, ft	3.5
Mean Depth at Bankfull, ft	1.82
Width/Depth Ratio	12.60
Flood Prone Width, ft	65
Flood Prone Area Elevation	544.68
Entrenchment Ratio	2.83
Bank Height Ratio	1

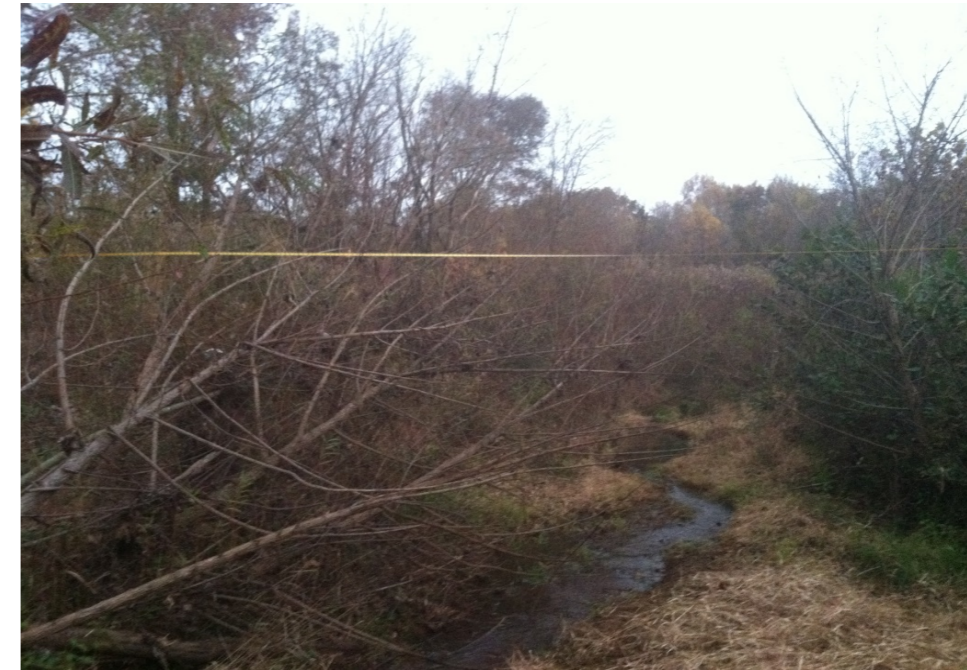
Sta. 25+40 Looking Downstream

Reach	Indian Run, Upper Reach
River Basin	Yadkin/Pee Dee
Cross Section ID	XSC-3, Riffle, Upper Reach, 25+40
Drainage Area (Sq Mi)	1.5
Date	11/6/2013
Observers	H. Anthony, P. Beach, C. Flowers, K. Hamlin

SUMMARY DATA	
Baseline Bankfull Datum, ft	539.00
Bankfull Cross Sectional Area, ft <sup>2</sup>	24.53
Bankfull Width, ft	21.66
Max Depth at Bankfull, ft	2
Mean Depth at Bankfull, ft	1.13
Width/Depth Ratio	19.13
Flood Prone Width, ft	36.9
Flood Prone Area Elevation	541
Entrenchment Ratio	1.70
Bank Height Ratio	1.04

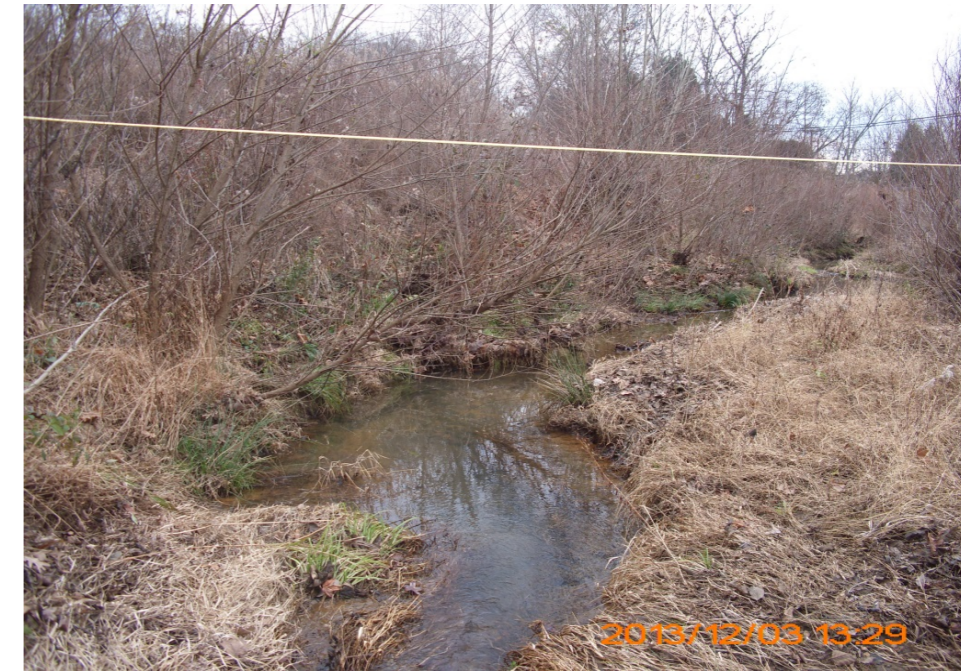
Sta. 25+92 Looking Downstream

Reach	Indian Run, Upper Reach
River Basin	Yadkin/Pee Dee
Cross Section ID	XSC-4, Pool, Upper Reach, 25+92
Drainage Area (Sq Mi)	1.5
Date	11/6/2013
Observers	H. Anthony, P. Beach, C. Flowers, K. Hamlin

SUMMARY DATA	
Baseline Bankfull Datum, ft	538.77
Bankfull Cross Sectional Area, ft <sup>2</sup>	30.99
Bankfull Width, ft	29.34
Max Depth at Bankfull, ft	3.16
Mean Depth at Bankfull, ft	1.06
Width/Depth Ratio	27.78
Flood Prone Width, ft	51.5
Flood Prone Area Elevation	541.93
Entrenchment Ratio	1.76
Bank Height Ratio	0.96

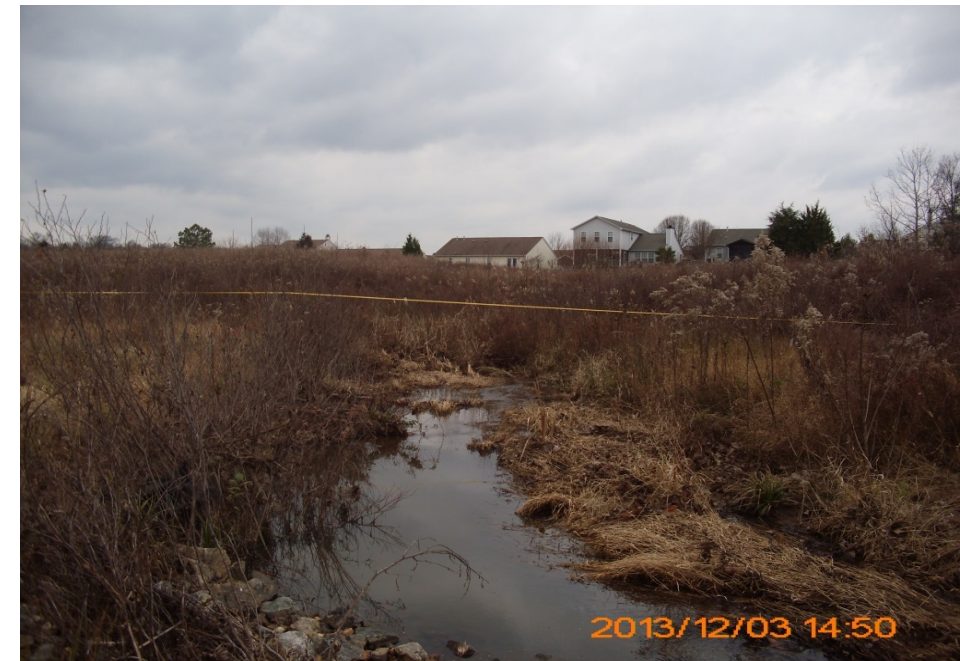
Sta. 11+15 Looking Downstream

Reach	Indian Run, Lower Reach
River Basin	Yadkin/Pee Dee
Cross Section ID	XSC-5, Riffle, Lower Reach, 11+15
Drainage Area (Sq Mi)	1.5
Date	12/3/2013
Observers	P. Beach, K. Hamlin

SUMMARY DATA	
Baseline Bankfull Datum, ft	536.34
Bankfull Cross Sectional Area, ft <sup>2</sup>	18
Bankfull Width, ft	18.49
Max Depth at Bankfull, ft	1.15
Mean Depth at Bankfull, ft	0.97
Width/Depth Ratio	18.99
Flood Prone Width, ft	138
Flood Prone Area Elevation	537.49
Entrenchment Ratio	7.46
Bank Height Ratio	0.79

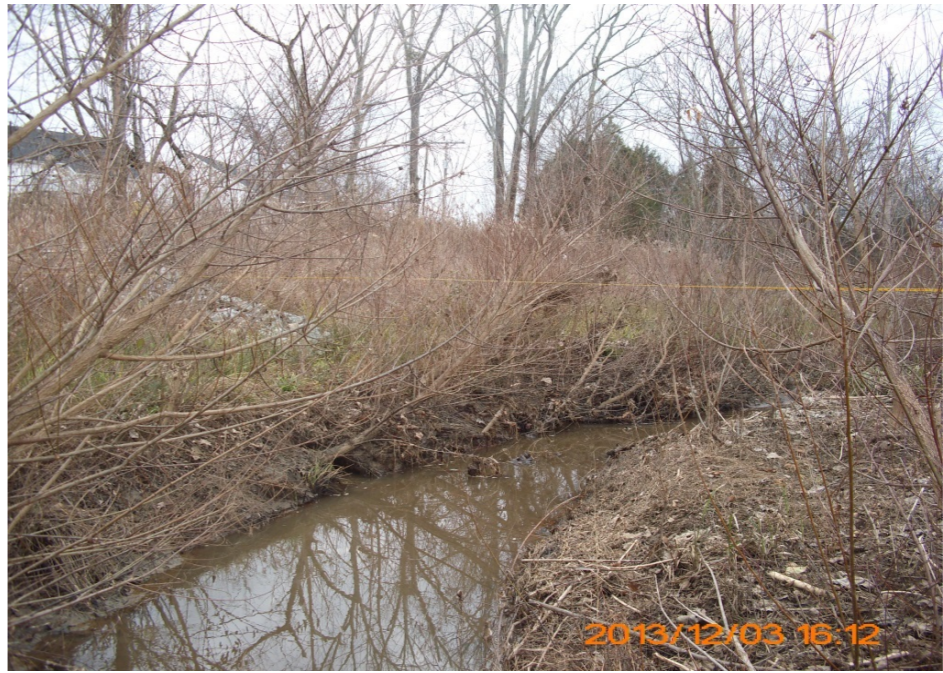
Sta. 13+10 Looking Downstream

Reach	Indian Run, Lower Reach
River Basin	Yadkin/Pee Dee
Cross Section ID	XSC-6, Pool, Lower Reach, 13+10
Drainage Area (Sq Mi)	1.5
Date	12/3/2013
Observers	P. Beach, K. Hamlin

SUMMARY DATA	
Baseline Bankfull Datum, ft	535.56
Bankfull Cross Sectional Area, ft <sup>2</sup>	34.9
Bankfull Width, ft	22.11
Max Depth at Bankfull, ft	2.71
Mean Depth at Bankfull, ft	1.58
Width/Depth Ratio	14.01
Flood Prone Width, ft	100.4
Flood Prone Area Elevation	538.27
Entrenchment Ratio	4.54
Bank Height Ratio	1

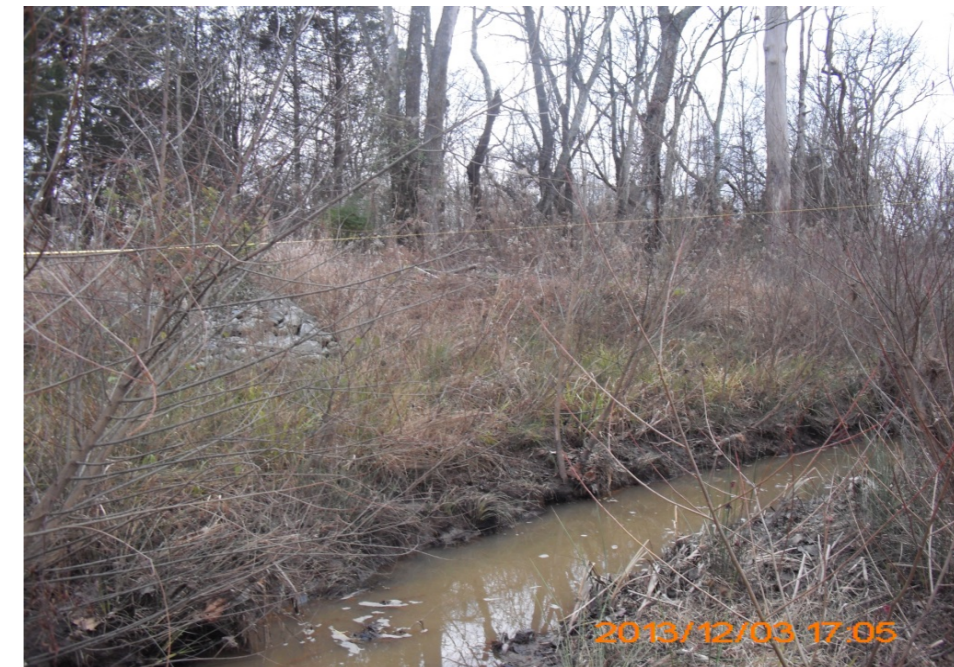
Sta. 15+89 Looking Downstream

Reach	Indian Run, Lower Reach
River Basin	Yadkin/Pee Dee
Cross Section ID	XSC-7, Pool, Lower Reach, 15+89
Drainage Area (Sq Mi)	1.5
Date	12/3/2013
Observers	P. Beach, K. Hamlin

SUMMARY DATA	
Baseline Bankfull Datum, ft	534.62
Bankfull Cross Sectional Area, ft <sup>2</sup>	37.17
Bankfull Width, ft	31.01
Max Depth at Bankfull, ft	3.11
Mean Depth at Bankfull, ft	1.20
Width/Depth Ratio	25.87
Flood Prone Width, ft	96
Flood Prone Area Elevation	537.73
Entrenchment Ratio	3.10
Bank Height Ratio	1.03

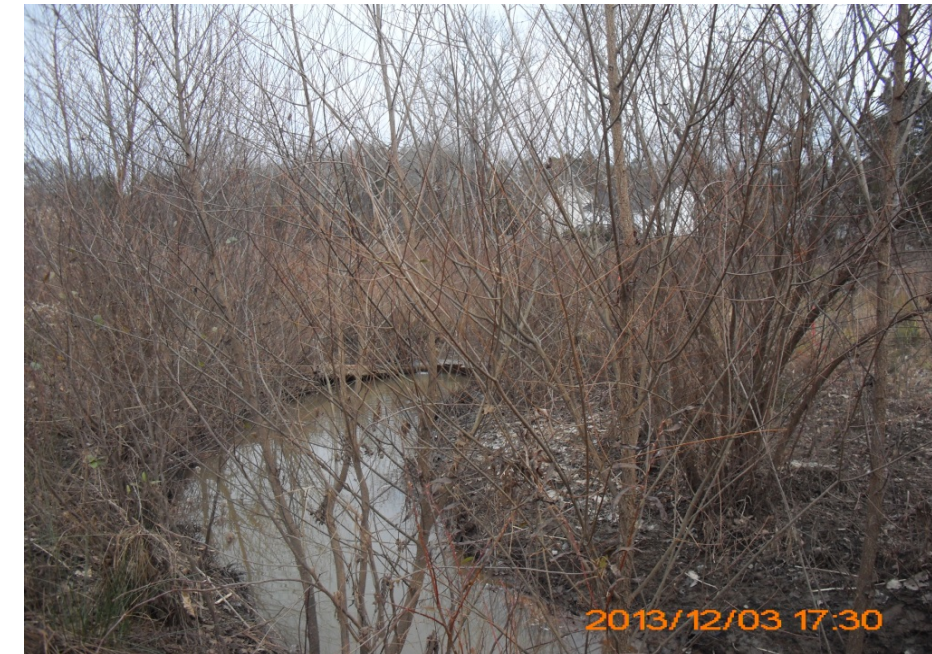
Sta. 16+50 Looking Upstream

<b>Reach</b>	Indian Run, Lower Reach
<b>River Basin</b>	Yadkin/Pee Dee
<b>Cross Section ID</b>	XSC-8, Riffle, Lower Reach, 16+50
<b>Drainage Area (Sq Mi)</b>	1.5
<b>Date</b>	12/18/2013
<b>Observers</b>	H. Anthony, K. Hamlin

SUMMARY DATA	
Baseline Bankfull Datum, ft	534.36
Bankfull Cross Sectional Area, ft <sup>2</sup>	19.72
Bankfull Width, ft	16.78
Max Depth at Bankfull, ft	2.18
Mean Depth at Bankfull, ft	1.18
Width/Depth Ratio	14.28
Flood Prone Width, ft	89.5
Flood Prone Area Elevation	536.54
Entrenchment Ratio	5.33
Bank Height Ratio	0.99

\*The pins for XS8 were not located in the field. The location of the cross section for MY2 is approximate.

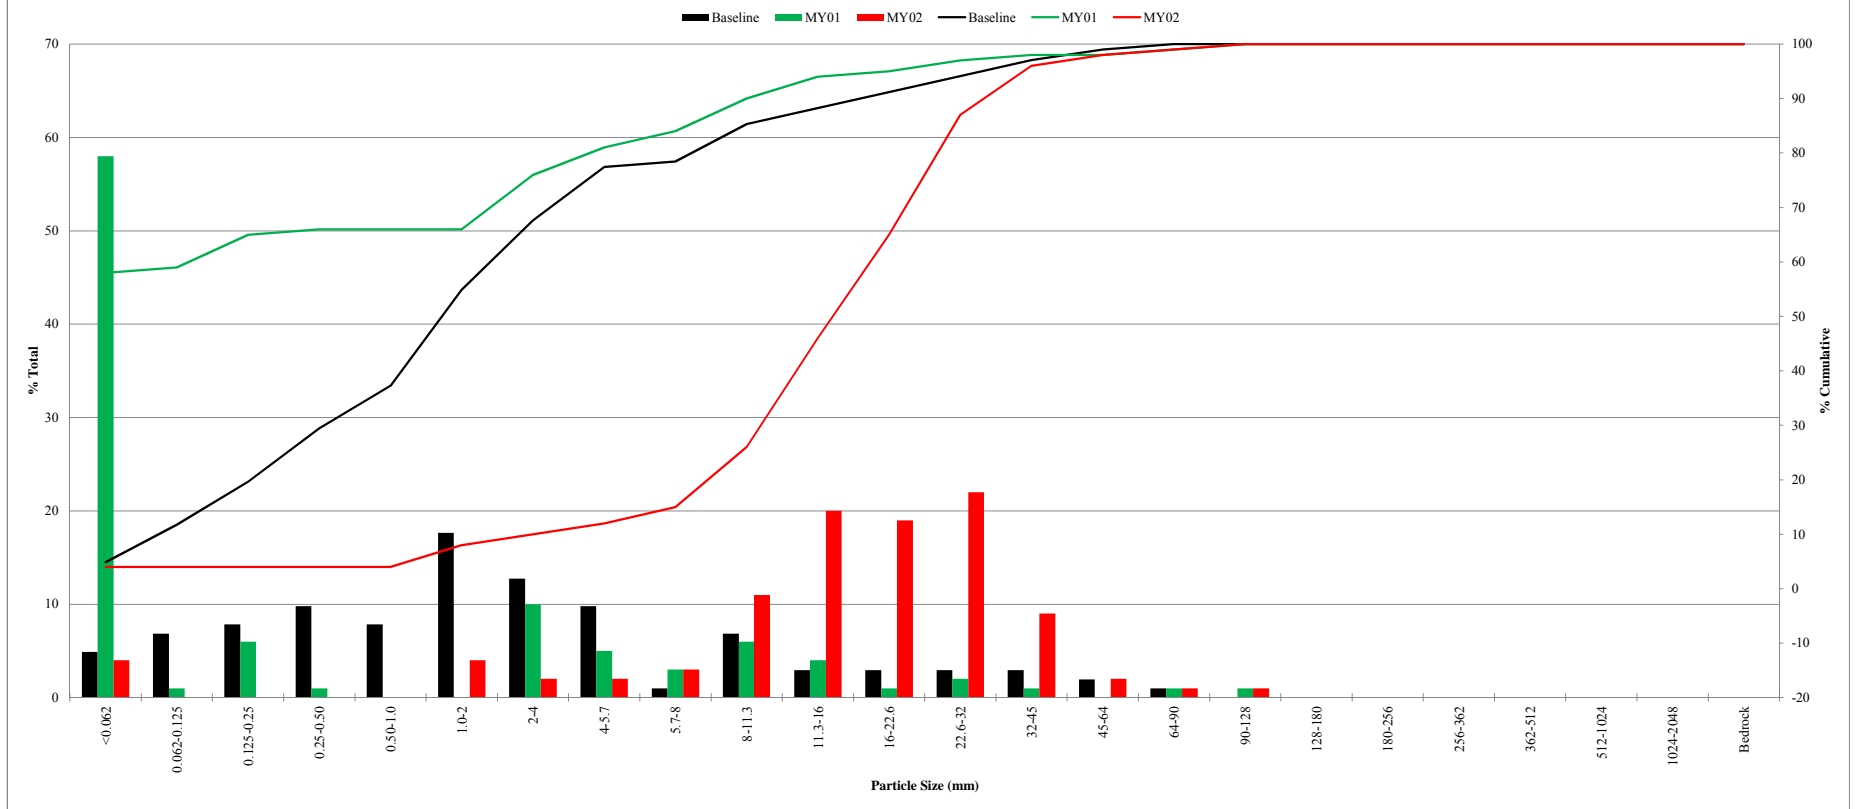
### Pebble Count - XSC5 - Riffle

Summary Data	
D50	17
D84	30
D95	42

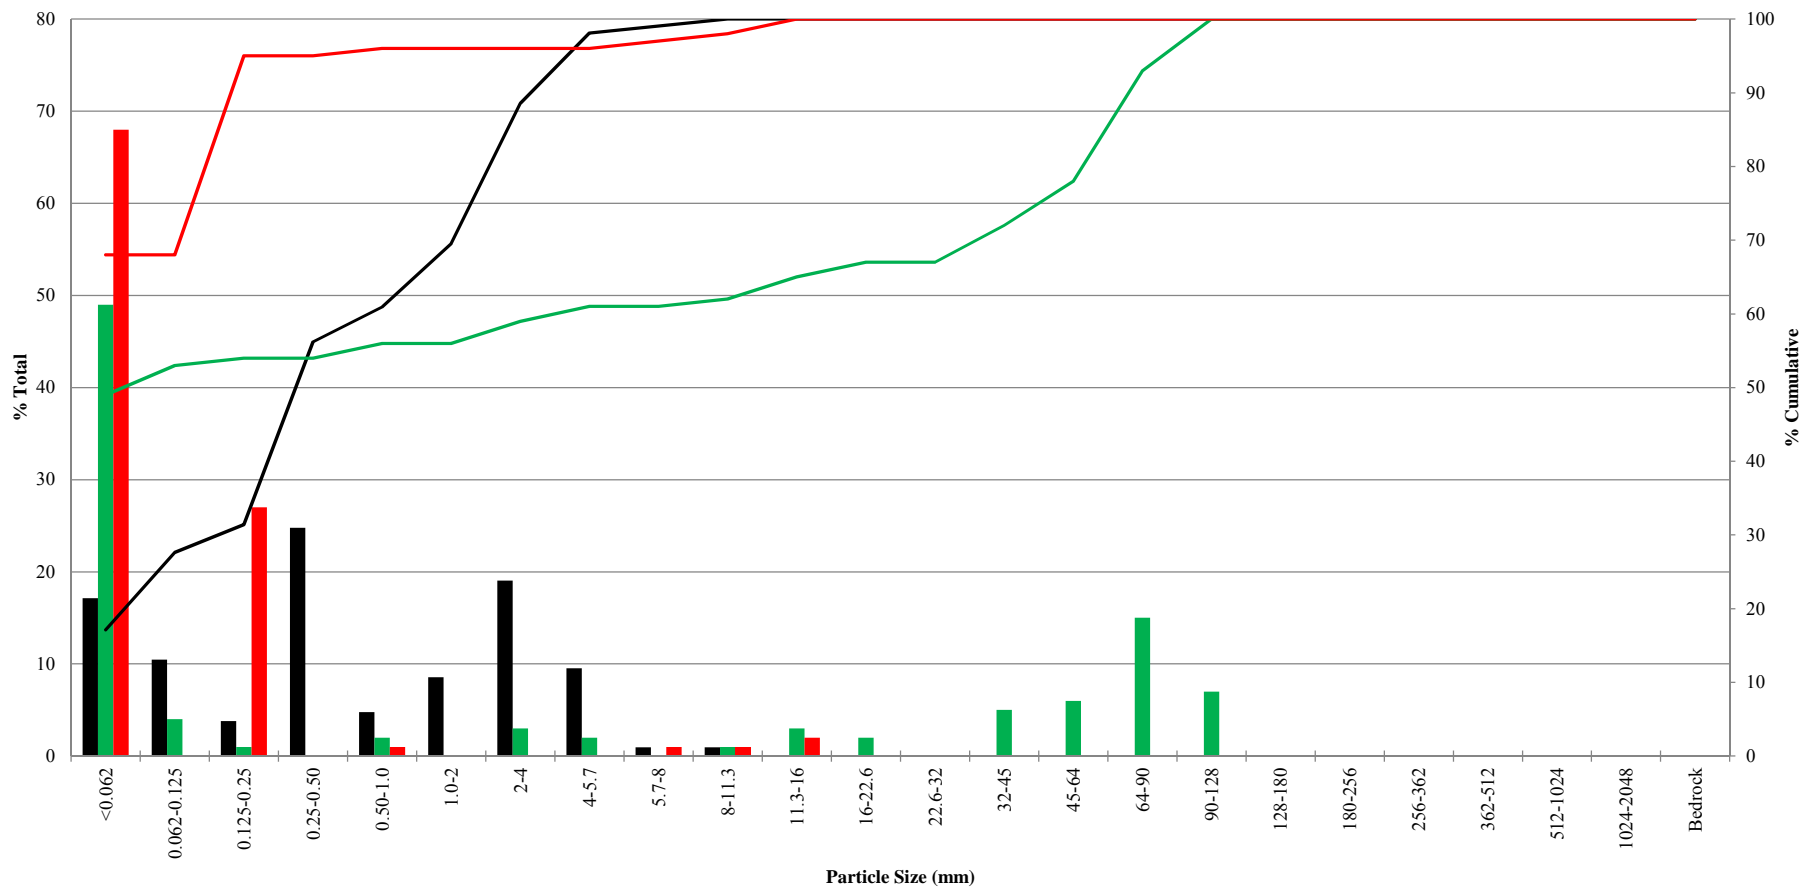
### Pebble Count - XSC8 - Riffle

Indian Run - LR - XS8 Riffle Pebble Count

Location: STA 16+50

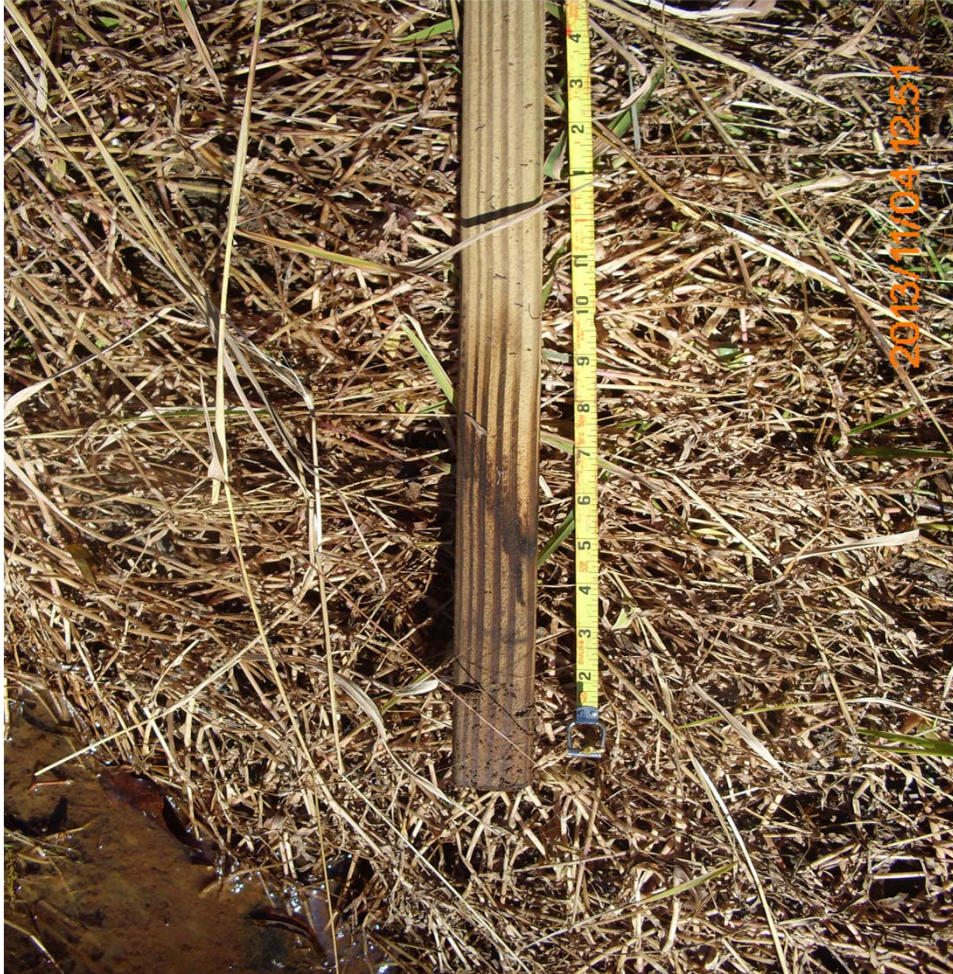
Table 12. Verification of Bankfull Events			
Coddle Creek Tributary (Indian Run)/ 94 Segment/Reach: 2270 feet			
Date of Data Collection	Date of Occurrence	Method	Photo
5/30/2012	Between 5/11/2011 - 5/30/2012	Visual observation of wrack lines; stream gauge	Photo in MY1 Report
11/4/2013	Between 5/30/2012 - 11/04/2013	Visual observation of wrack lines; stream gauge	Photo below
