**Coddle Creek Tributary
(Indian Run) Stream Restoration
EEP Project # 94
DENR Contract # 5360**

**Annual Monitoring Report Year 3 of 5
Cabarrus County, North Carolina**

**Construction Completed: March 27, 2011
Data Collected: September 2014
Report Submission: December 2014**

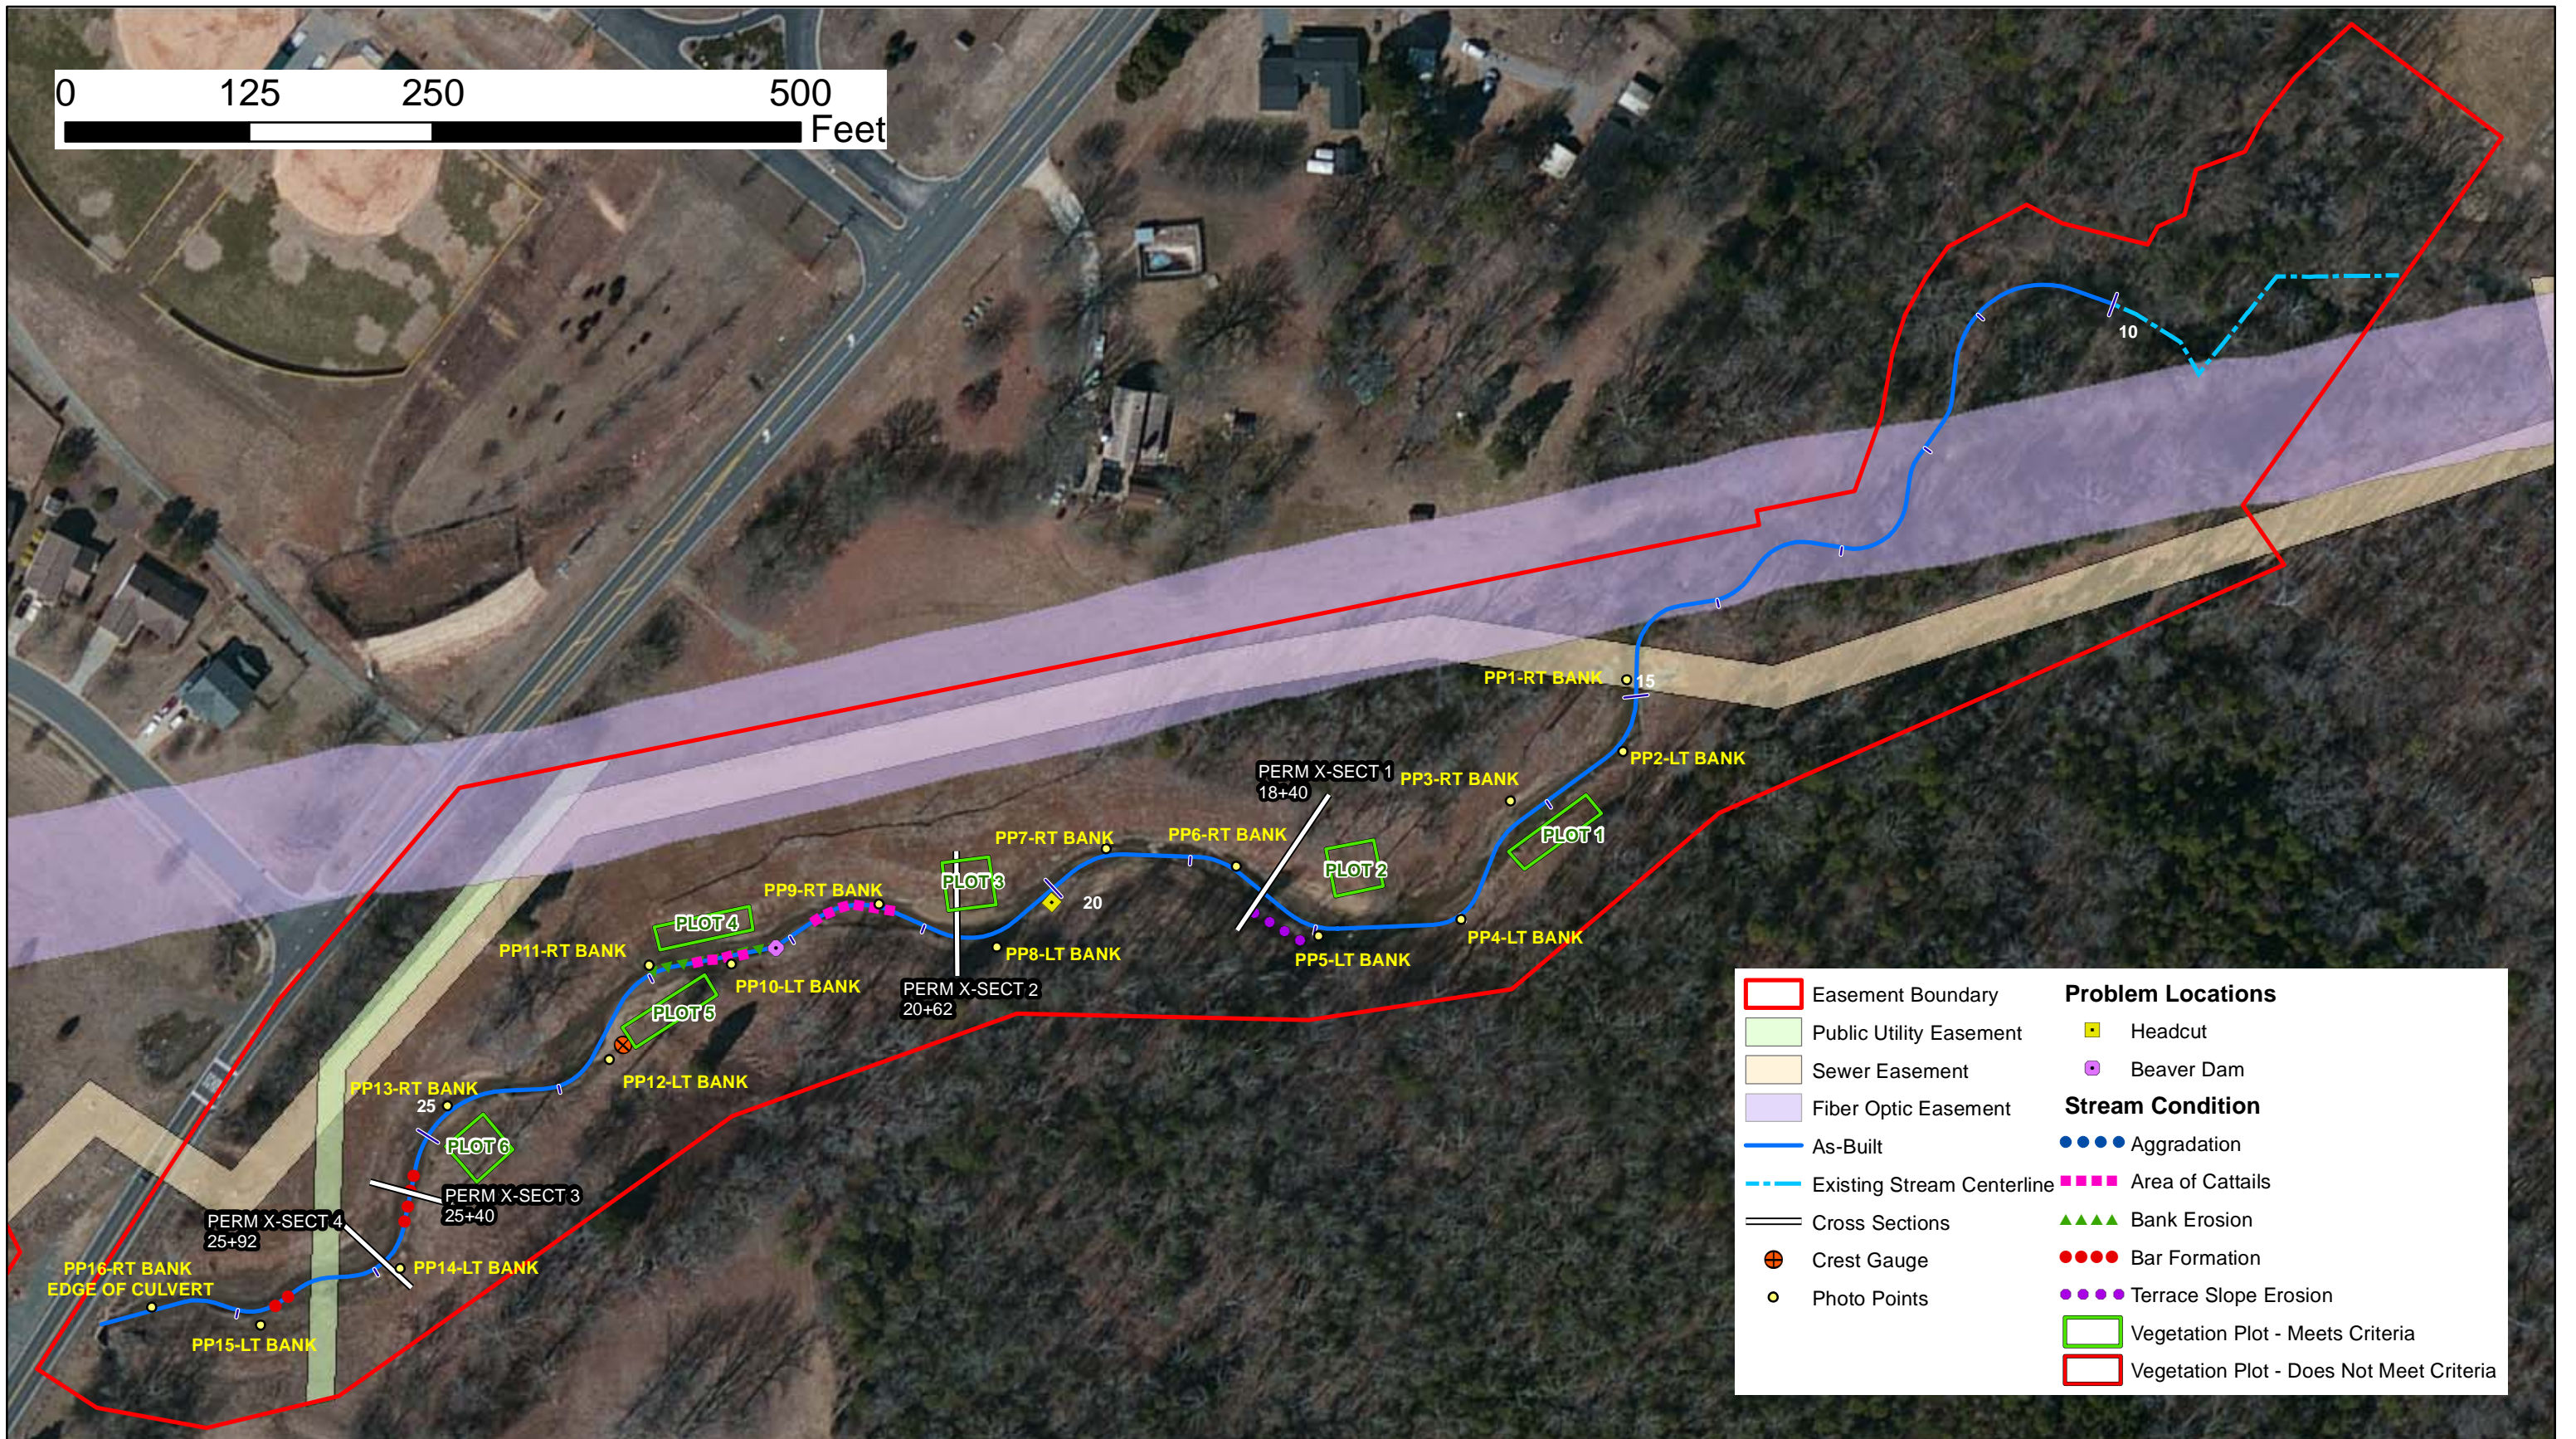
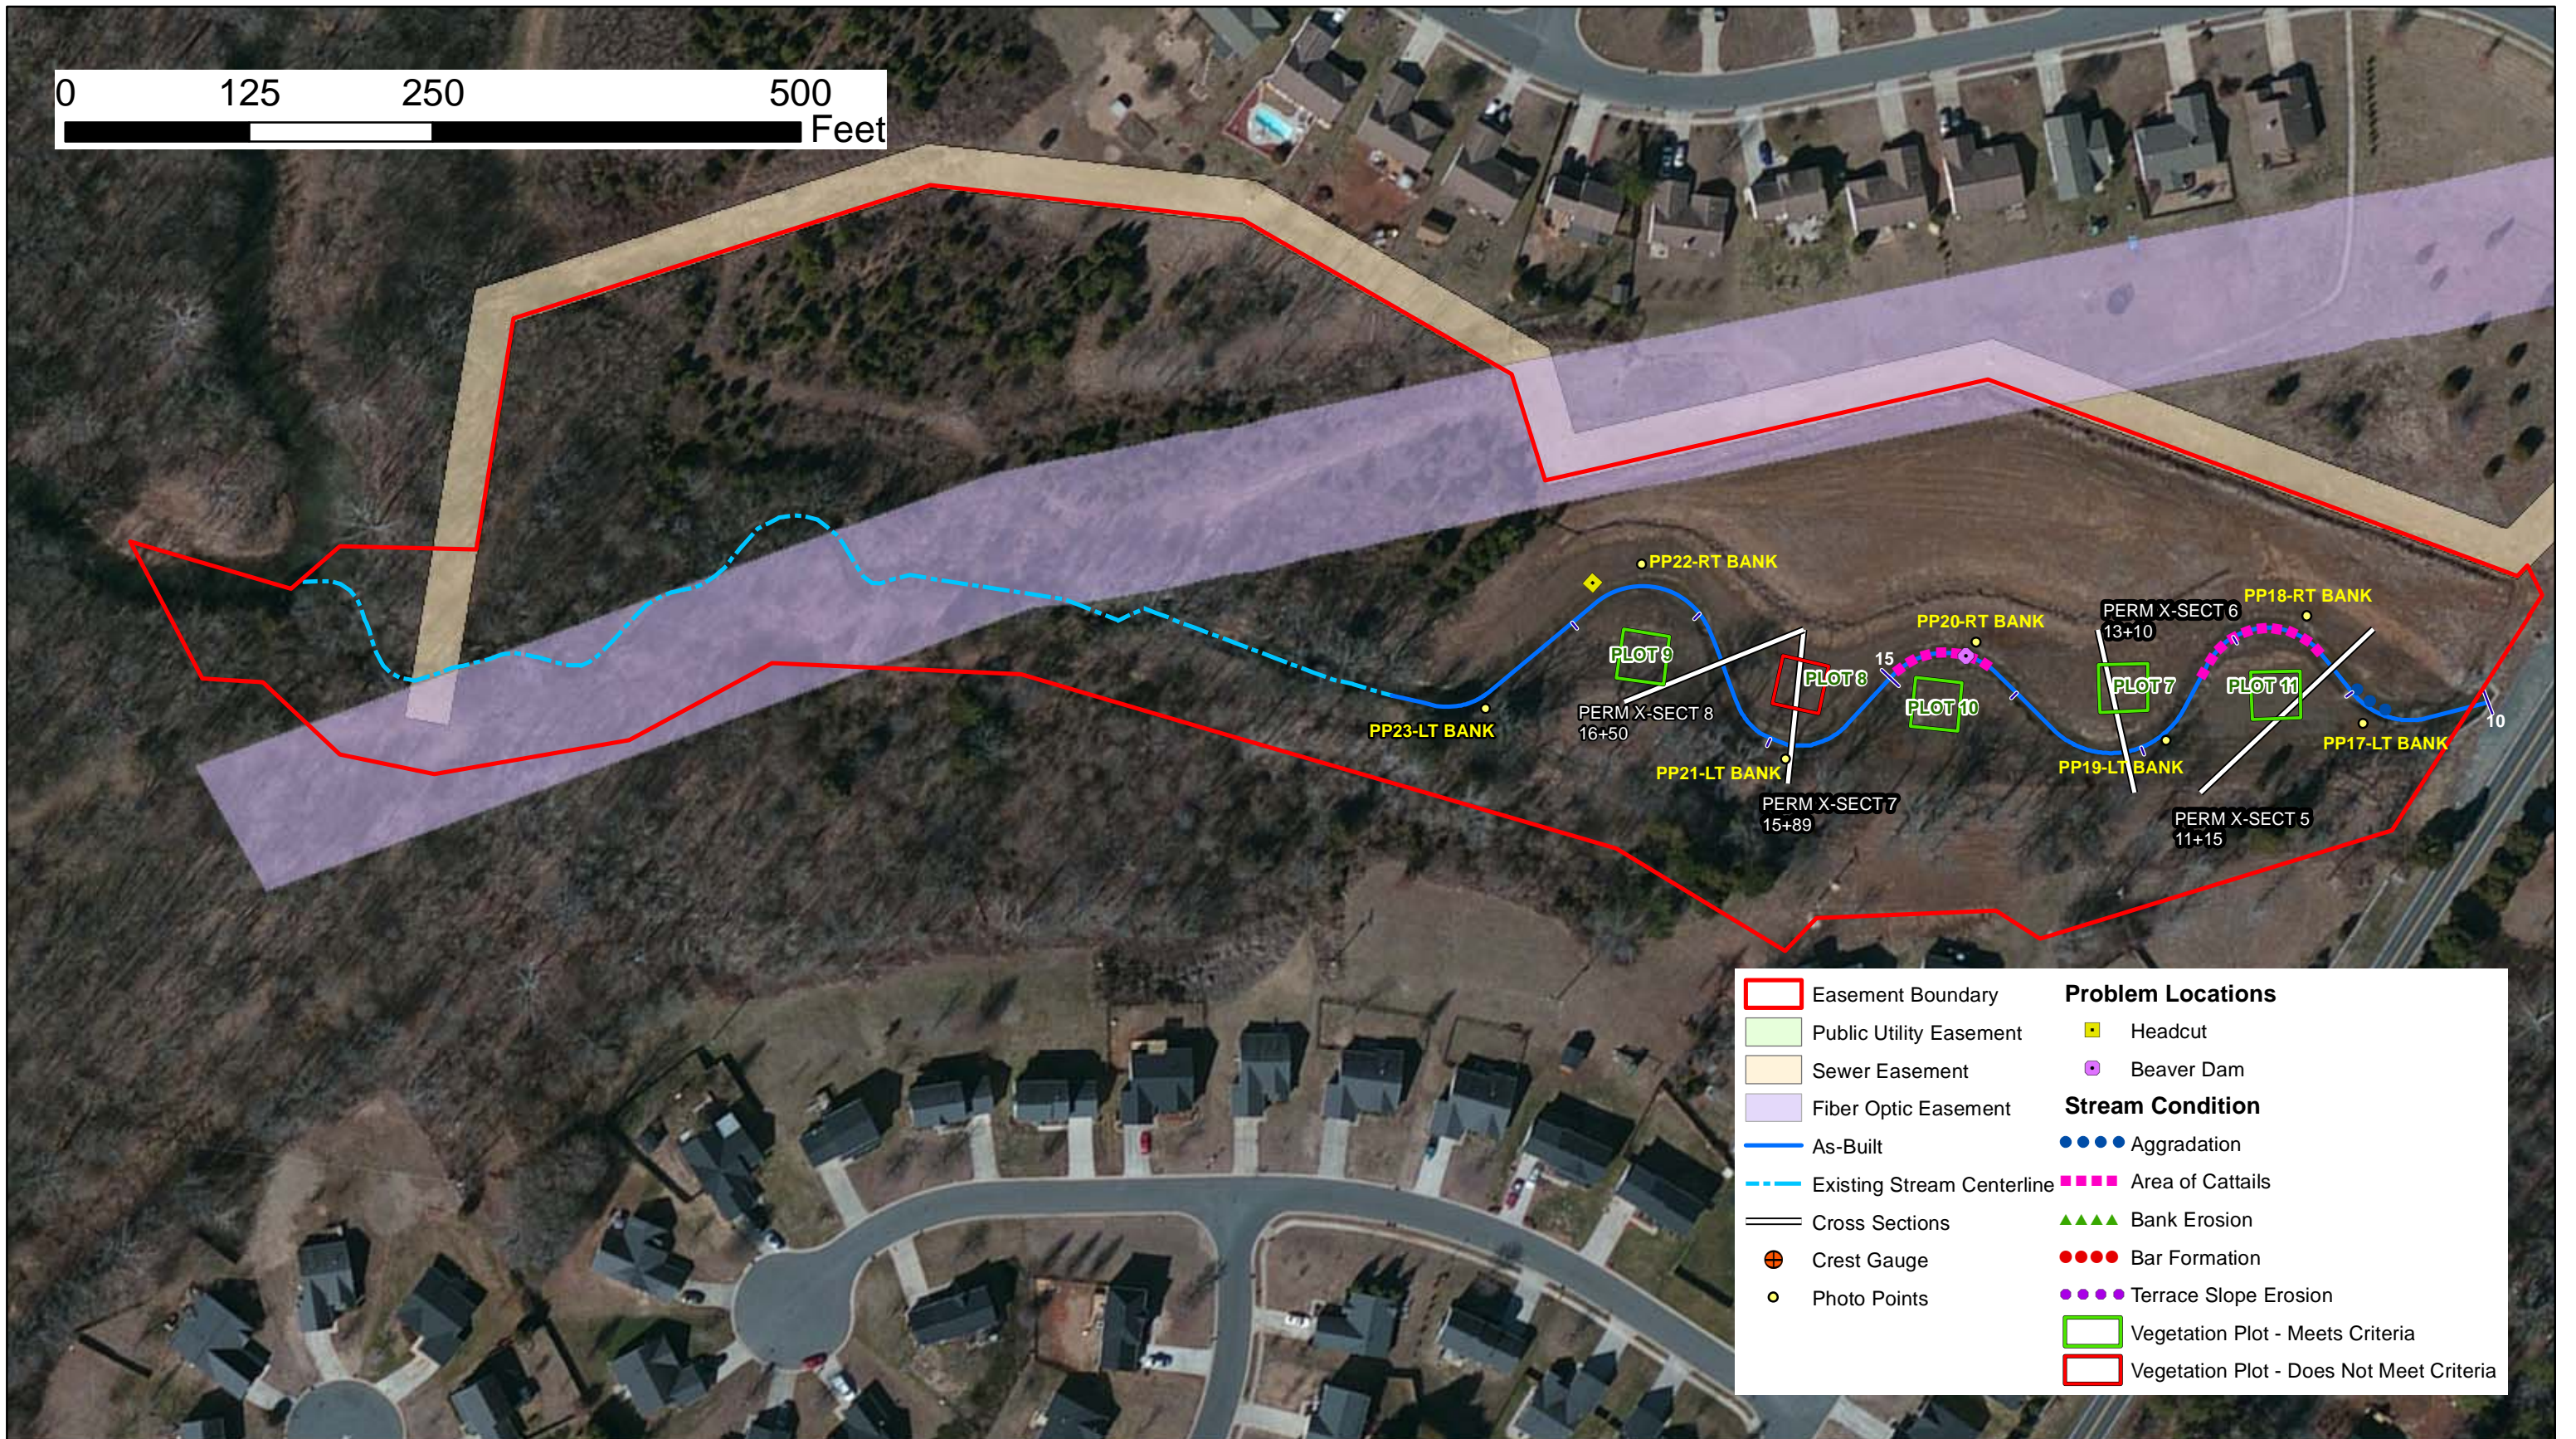
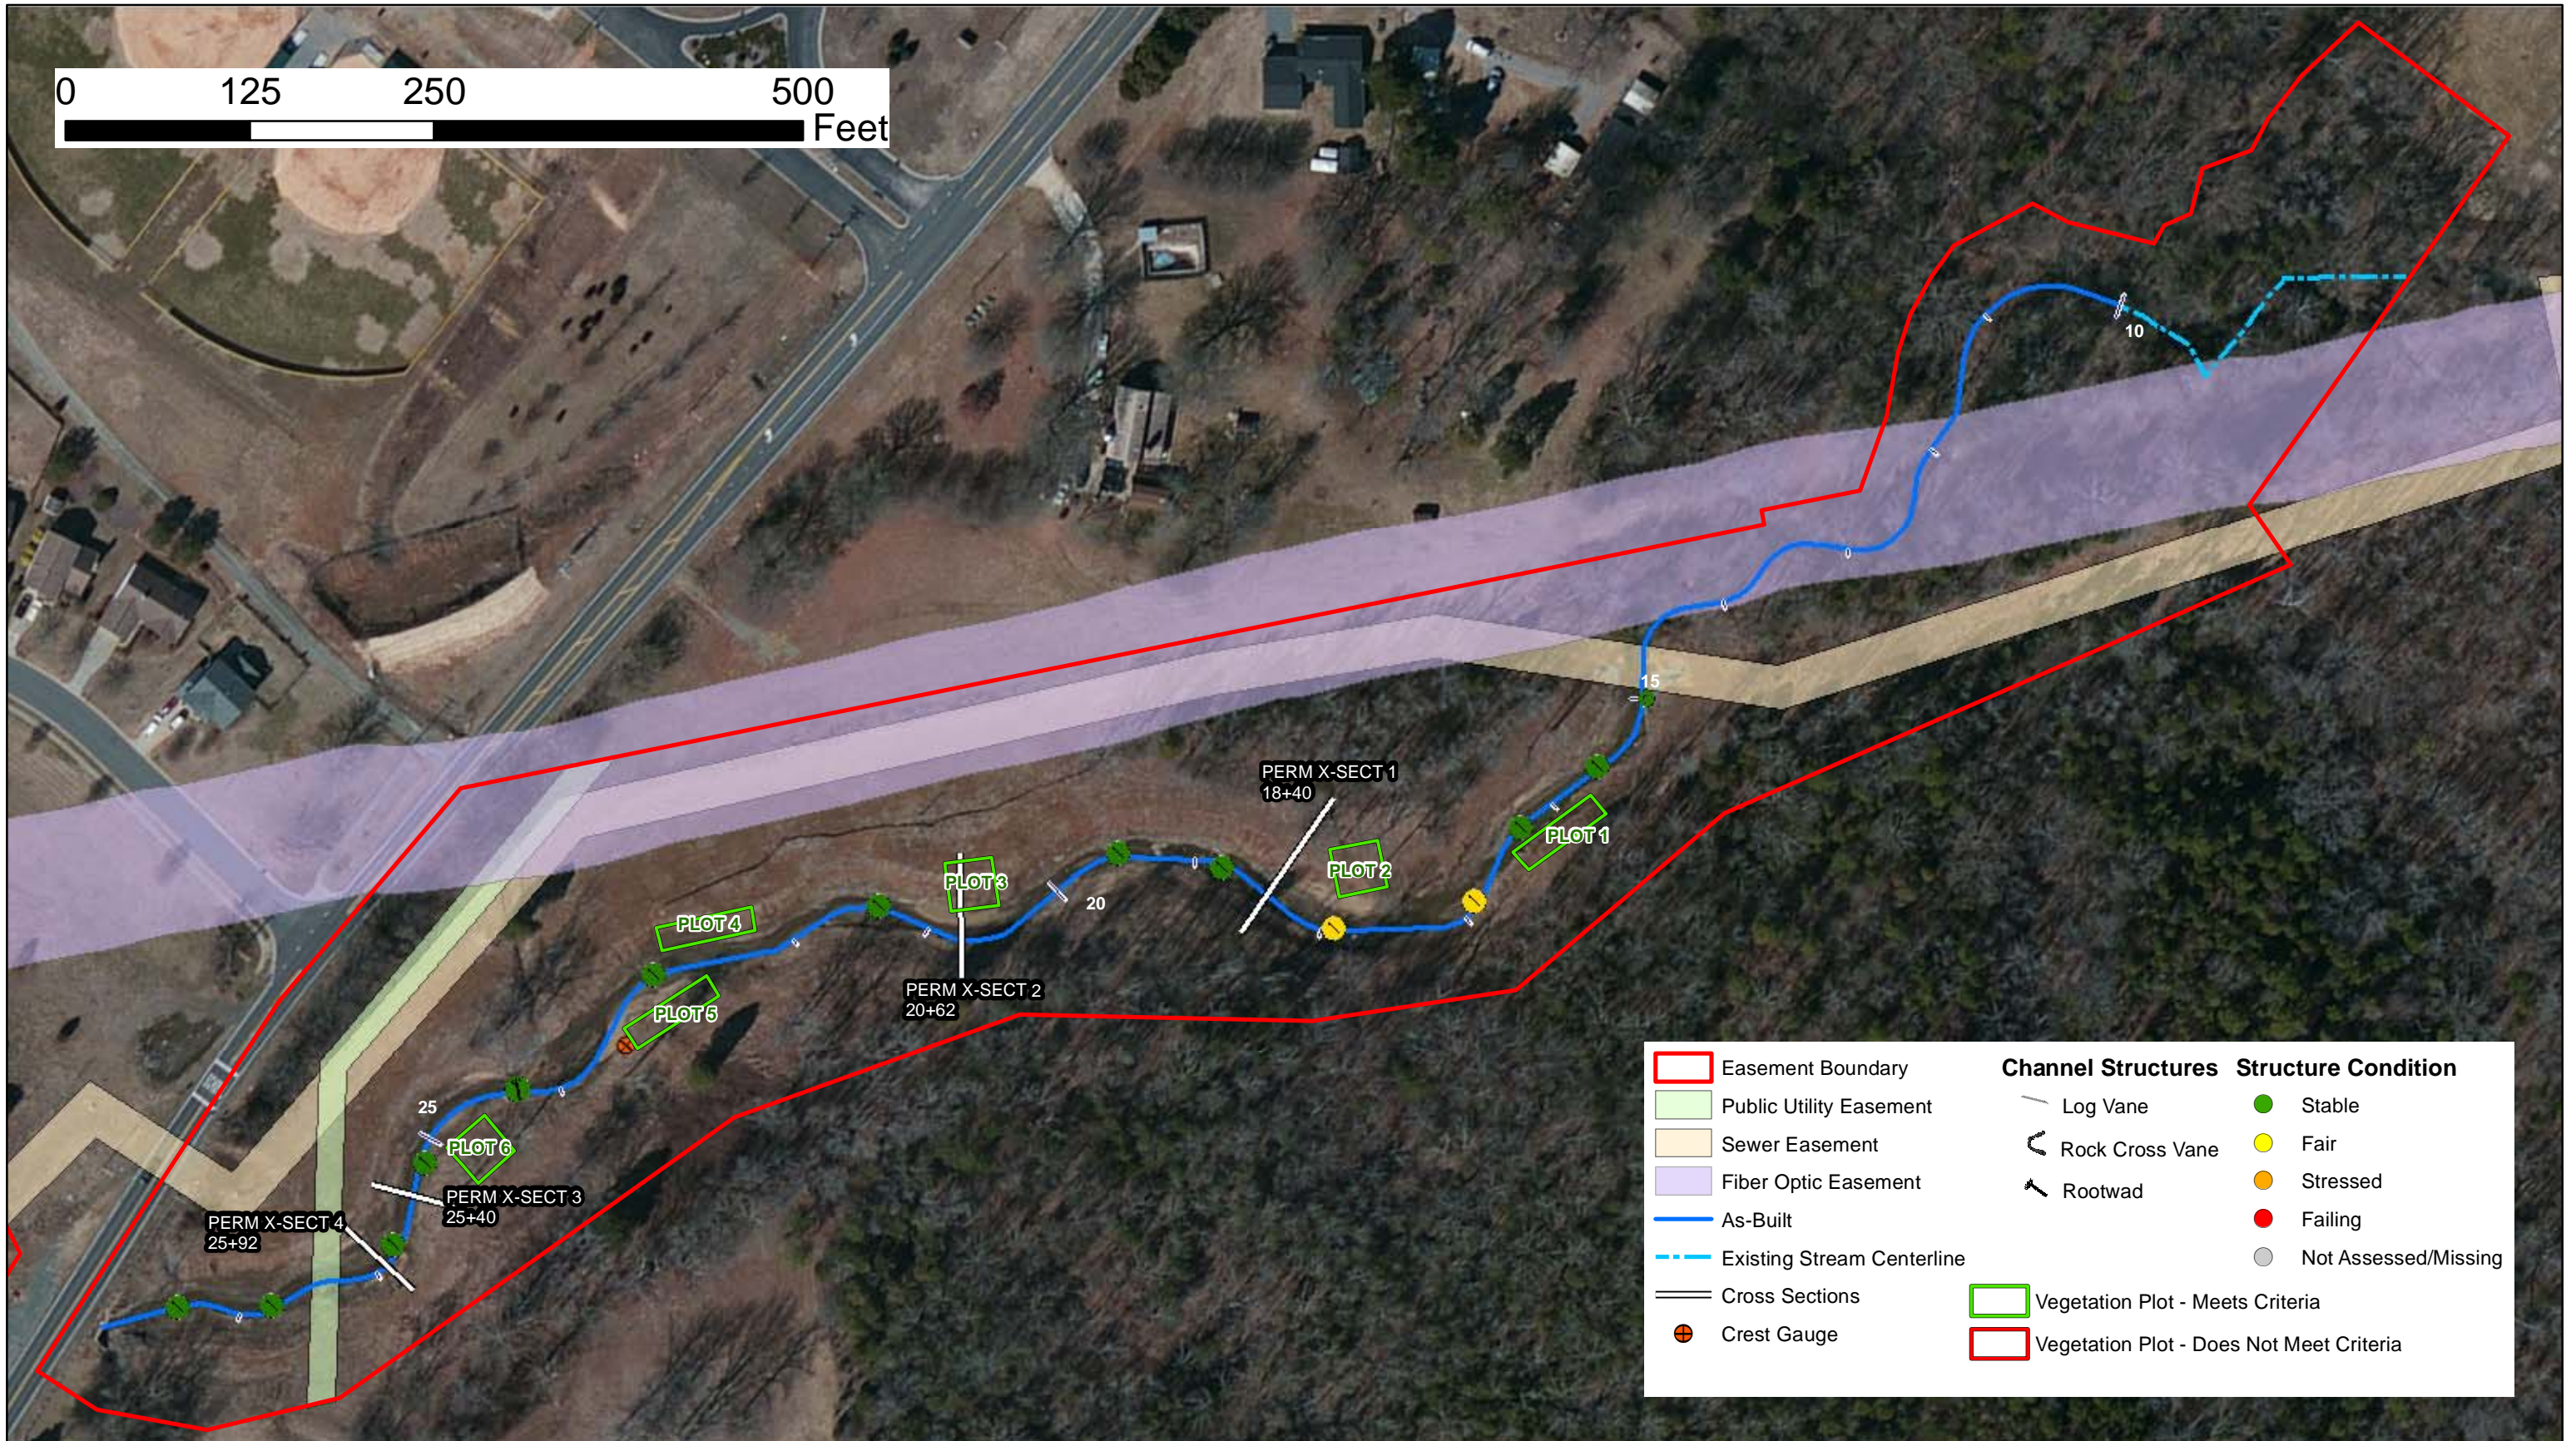
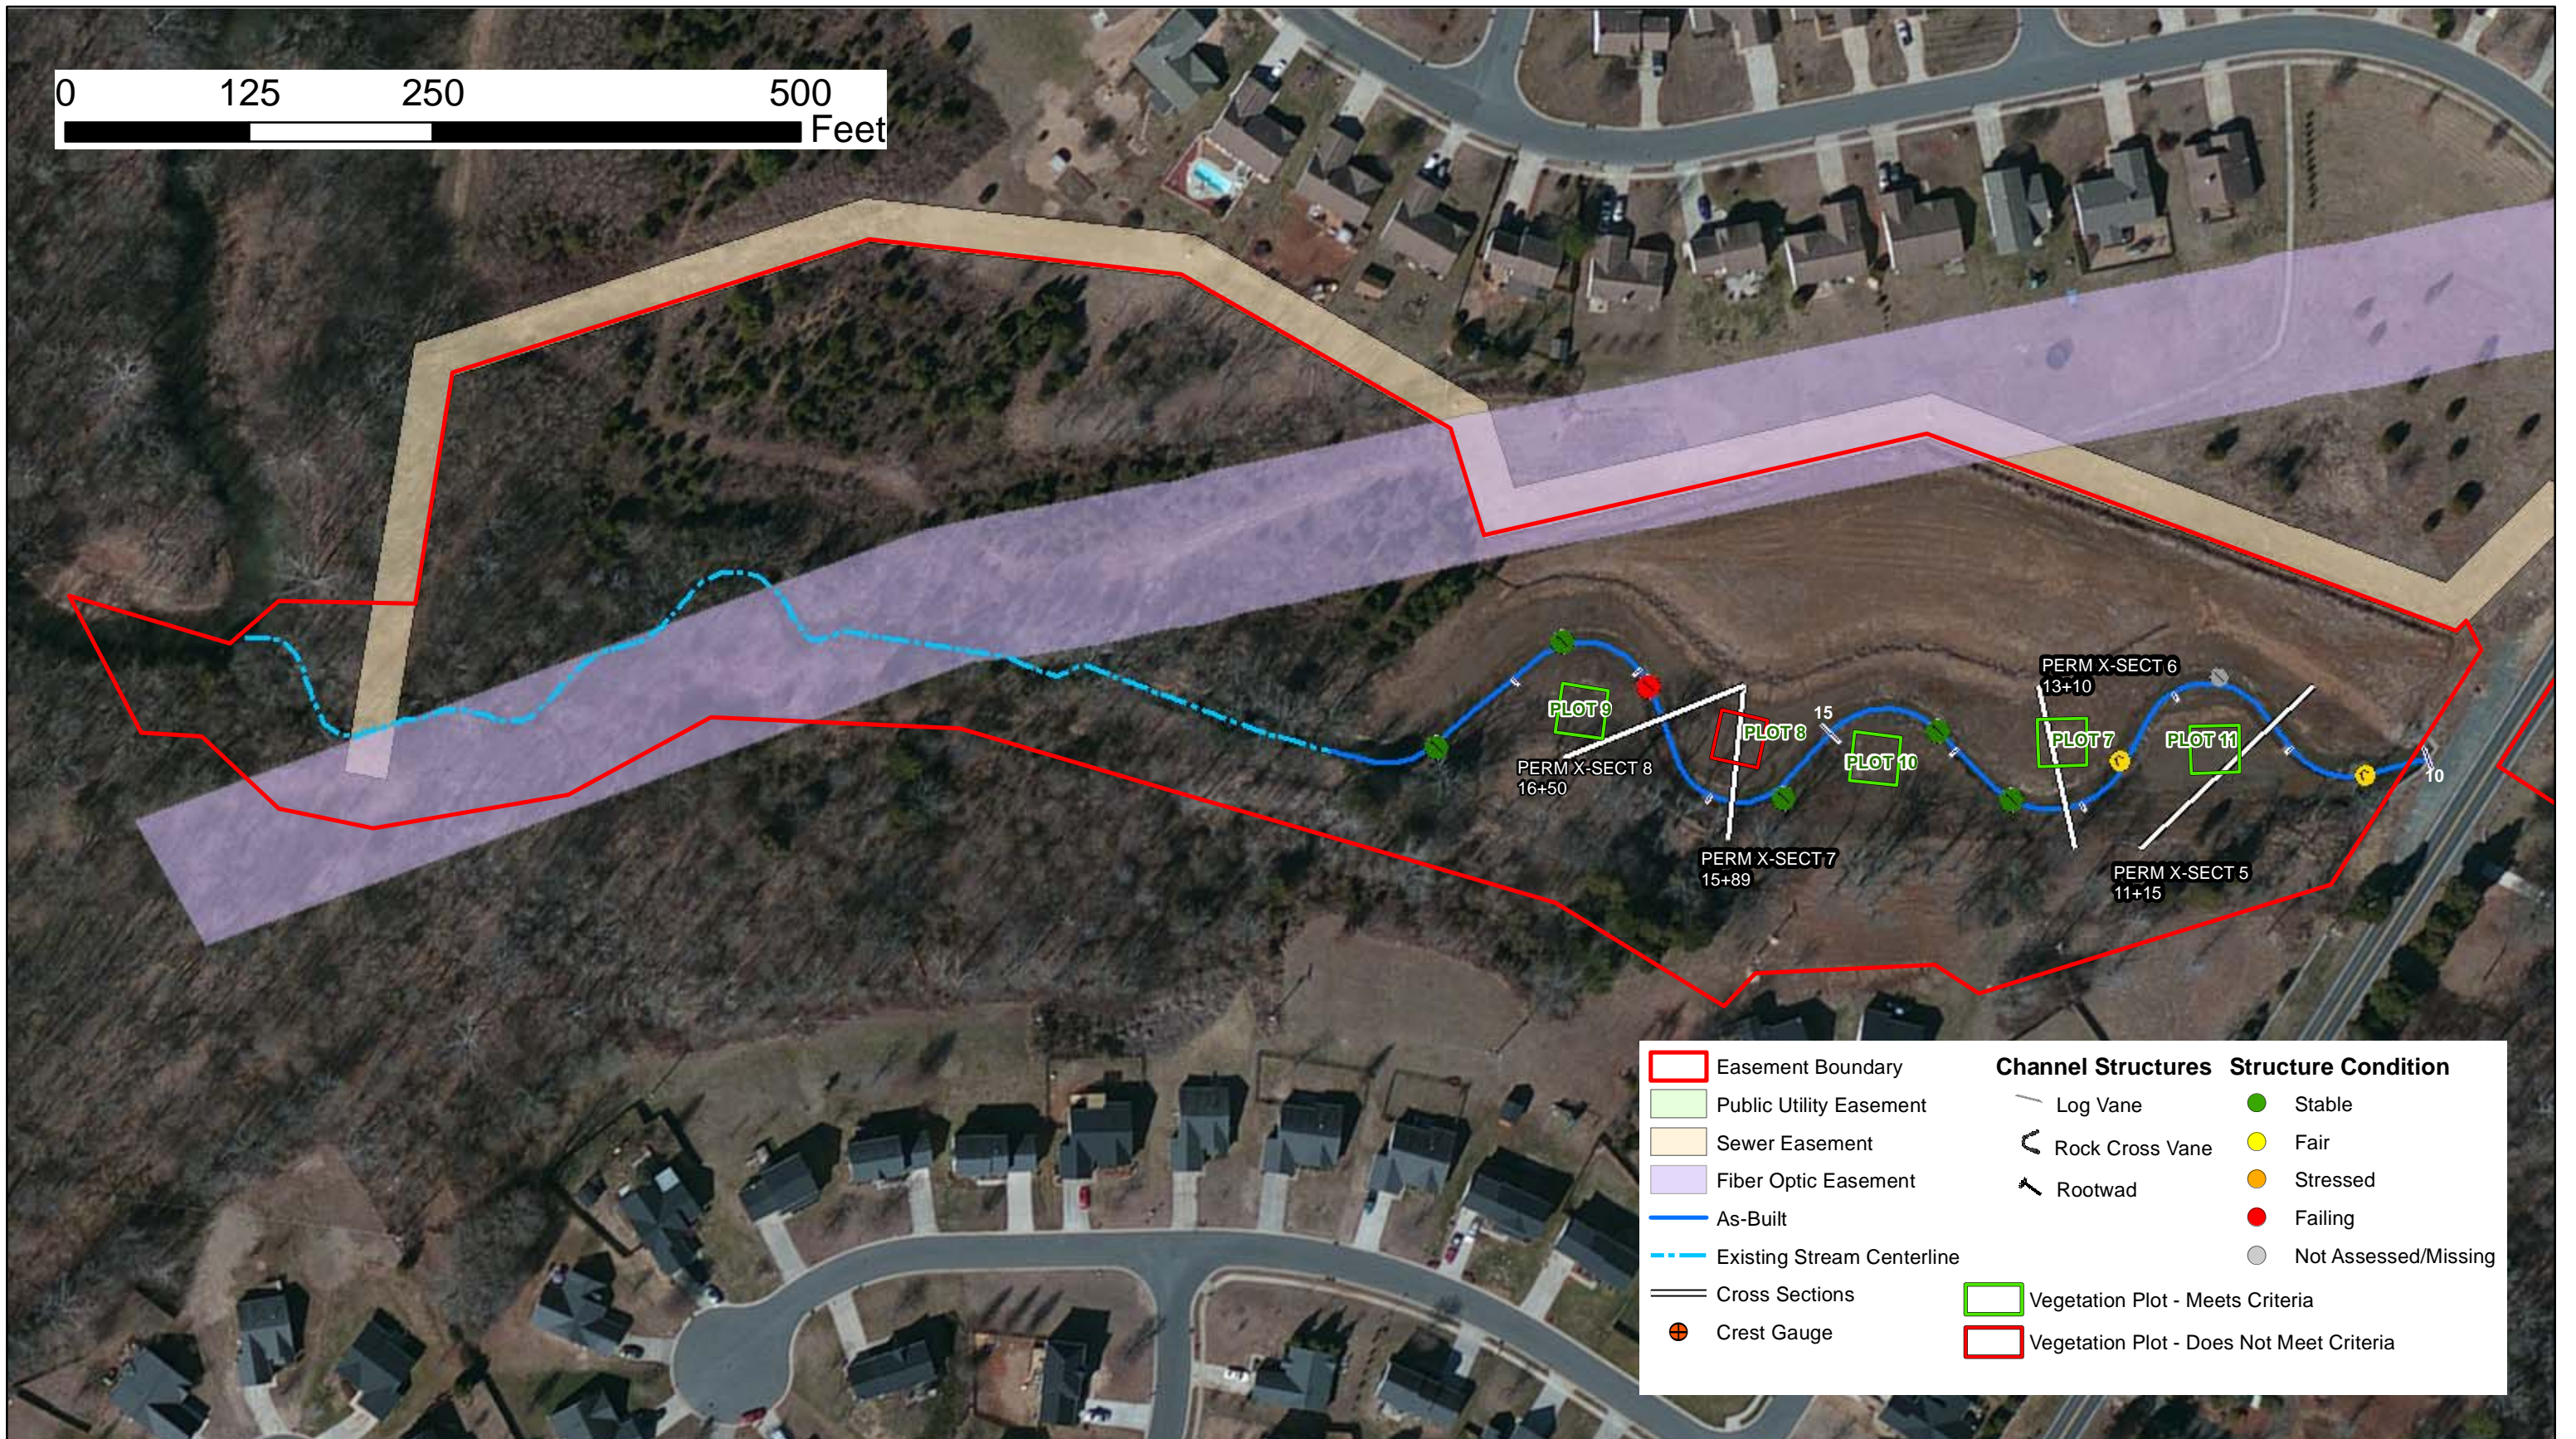
Cattails (*Typha latifolia*) continue to dominate the bed and banks throughout both reaches. These locations are noted on the CCPV and represent approximately 265 linear feet of the reach or 11 % of the total reach. The cattails are likely to continue to grow and take over additional stream footage without

One notable area of aggradation was observed on the lower reach at Sta. 10+68 which could be the result of the cattail growth near that location. Three areas of bar formation were noted at Sta. 25+29 – 25+62 and Sta. 26+50 – 26+67 on the upper reach and Sta. 11+35 on the lower reach. One area of bank erosion was noted between Sta. 22+12 and 23+00 on the upper reach which could have resulted from effects of the beaver dam. The terrace rill at approximately Sta. 18+00 on the left bank of the upper reach was noted in the Monitoring Year 1 report, but appears to have stabilized. This area will continue to be monitored for erosion. Two headcuts were noted at Sta. 20+00 on the upper reach and Sta. 17+75 on the lower reach. Both headcuts are outside of the stream channel and seem to be due to overland flow. A debris jam was noted at Sta. 15+60 on the lower reach. One beaver dam was noted at Sta. 22+12 on the upper reach and was removed in September 2014. Other than the previously mentioned bank erosion, this area did not appear to be negatively impacting channel morphology. A second beaver dam was noted at Sta. 14+43 on the lower reach and was removed in October 2014. The channel morphology upstream of this area shows evidence of minor impact in channel morphology. All problem areas are noted on the Current Conditions Plan View (CCPV) sheets in Appendix B.

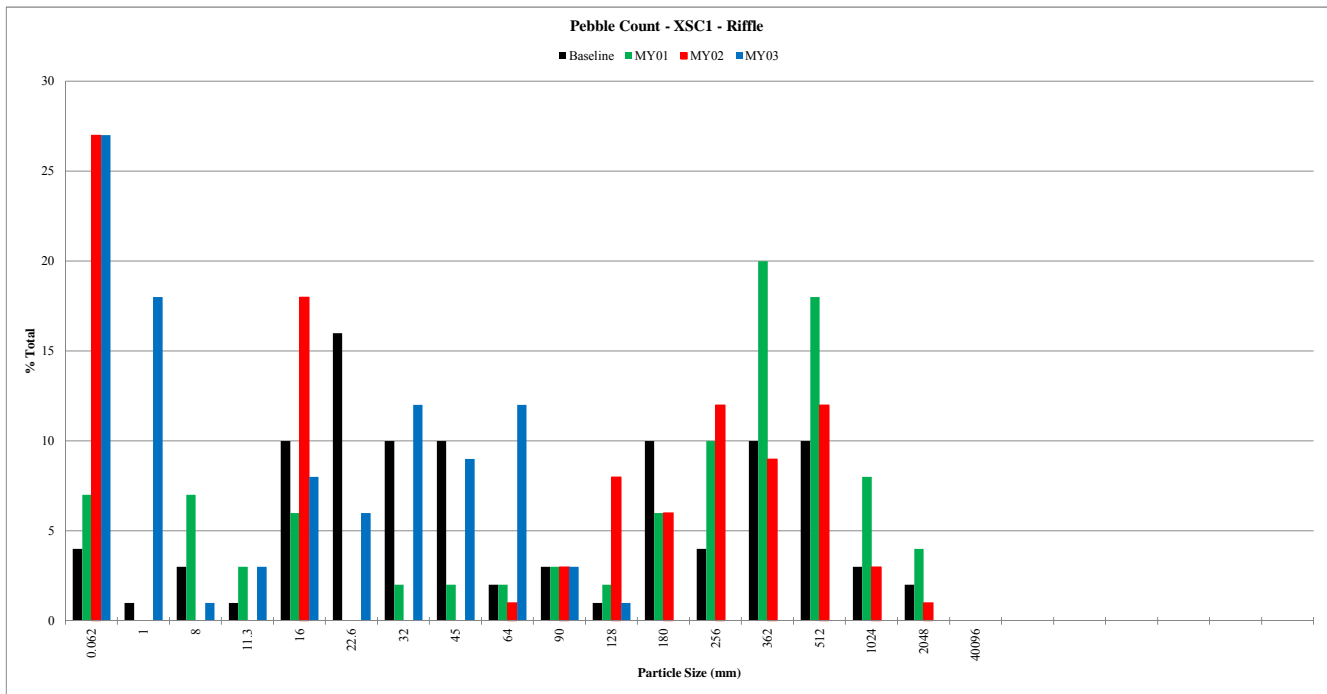
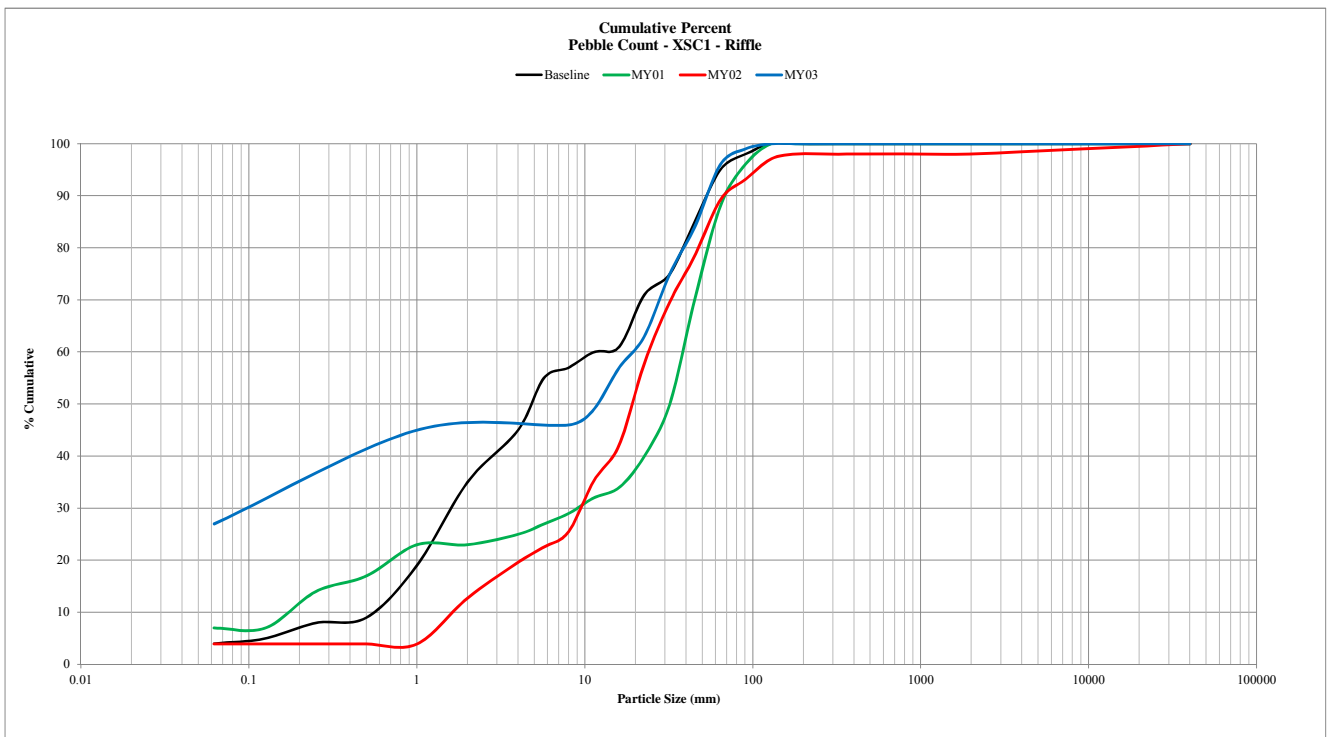
Coddle Creek Tributary - Indian Run - UR - XS1 Riffle Pebble Count

Location: STA 18+40

Summary Data	
D50	11.3
D84	45
D95	60

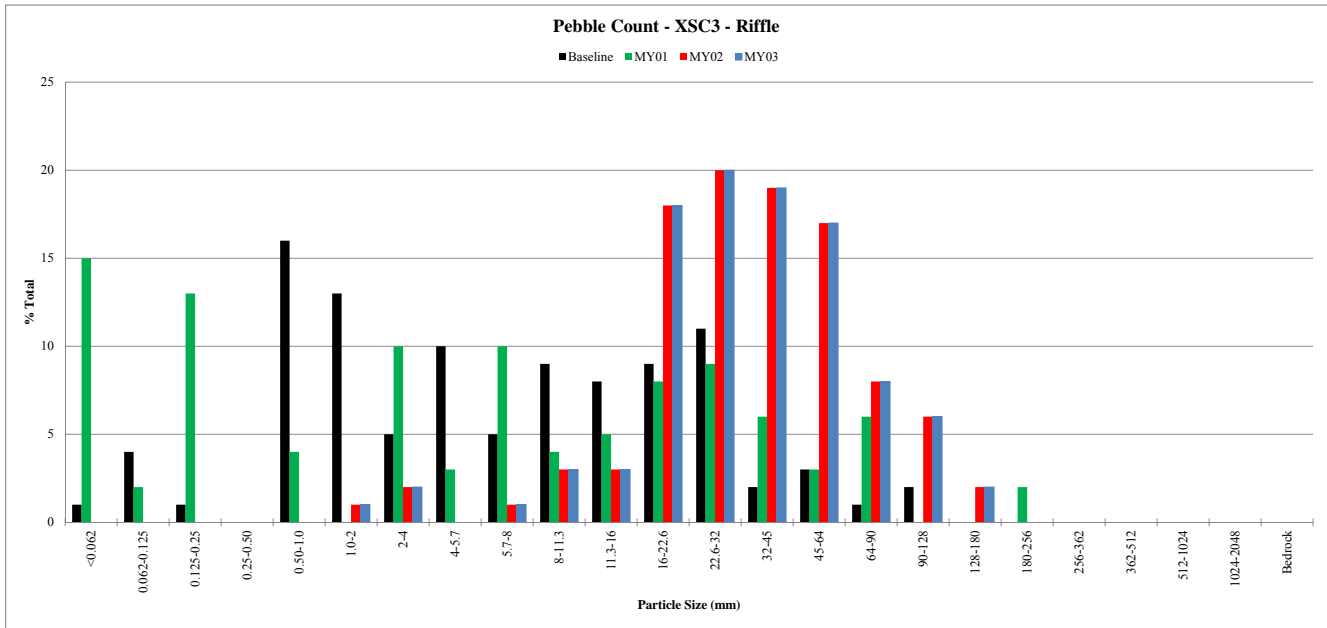
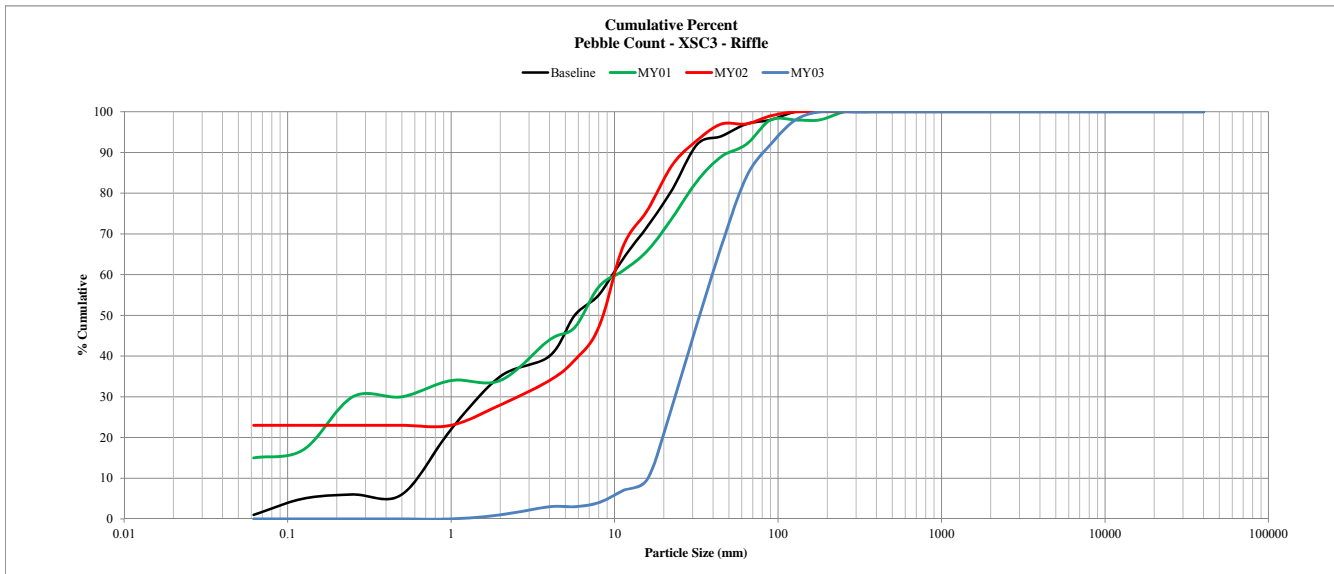
Coddle Creek Tributary - Indian Run -UR - XS3 Riffle Pebble Count

Location: STA 25+40

Summary Data	
D50	33
D84	64
D95	95

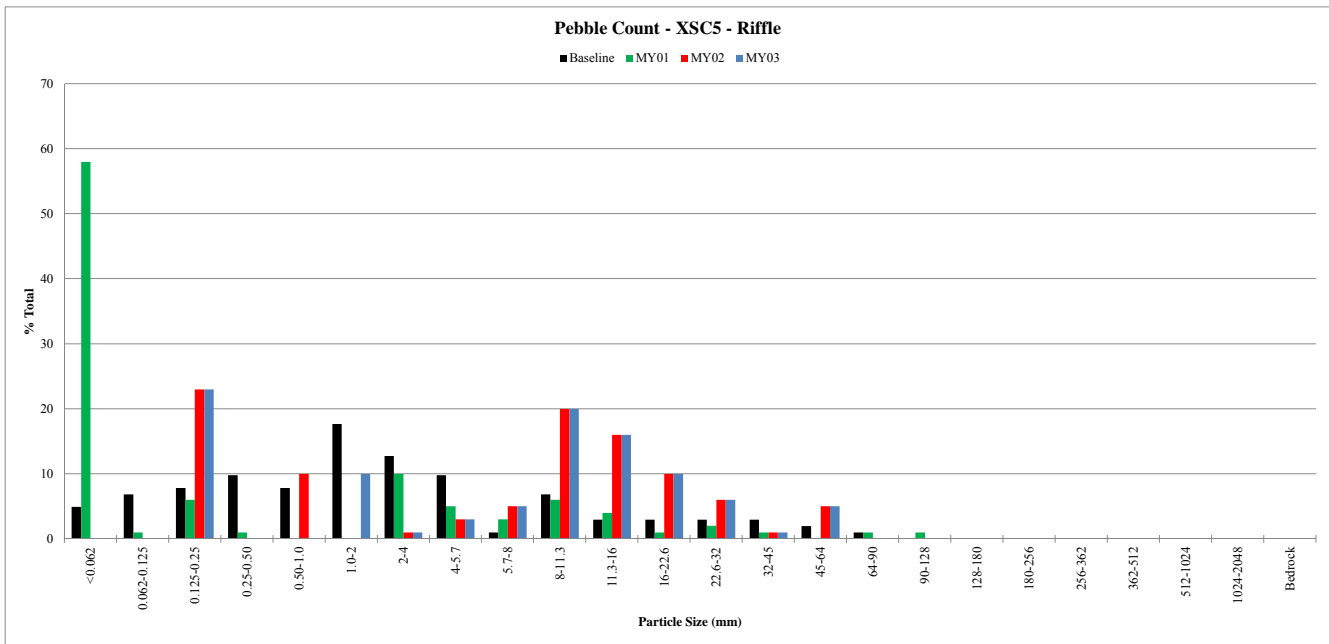
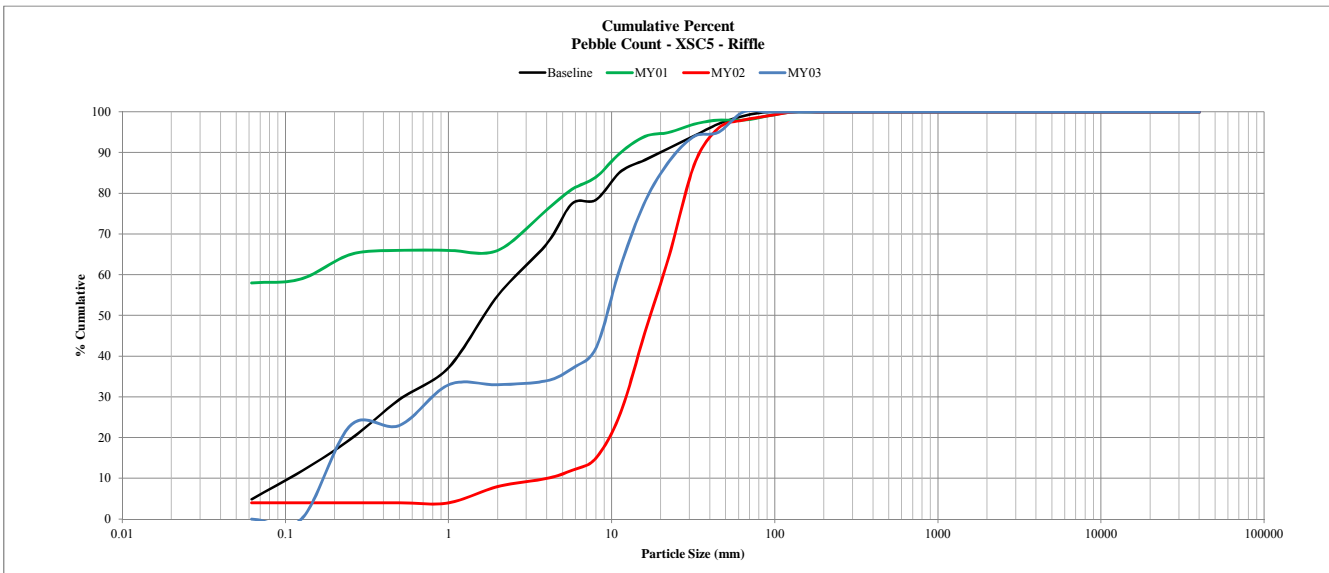
Coddle Creek Tributary - Indian Run - LR - XS5 Riffle Pebble Count

Location: STA 11+15

Summary Data	
D50	9
D84	20
D95	32

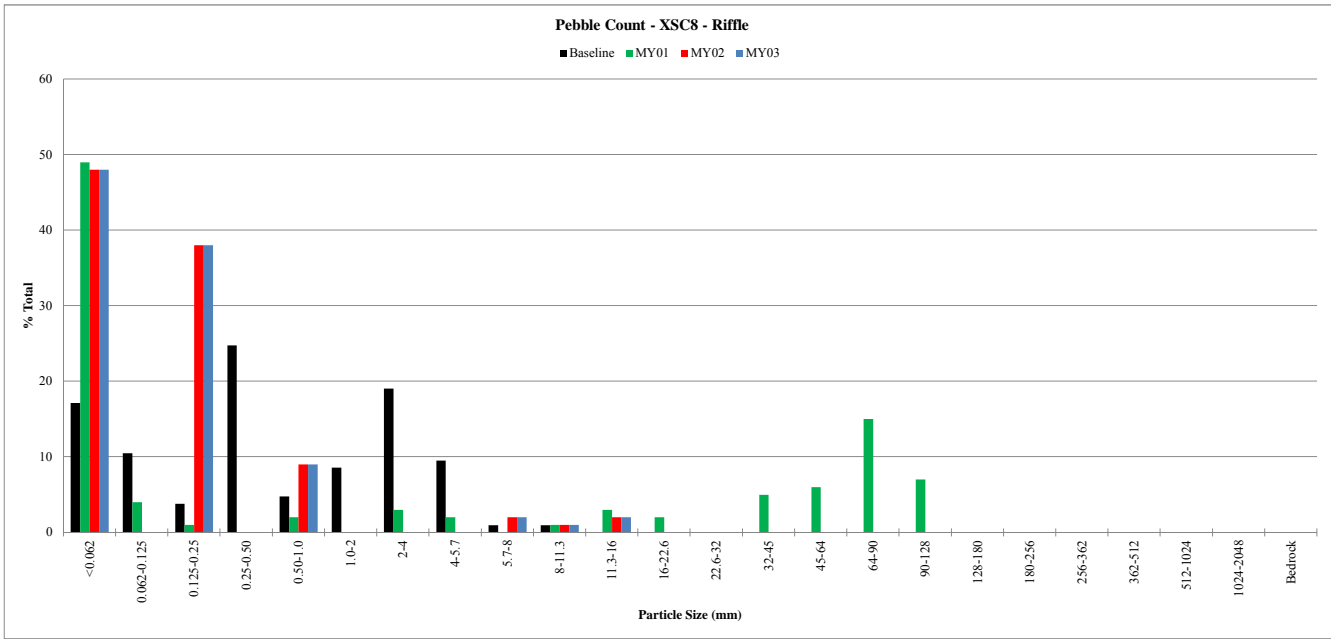
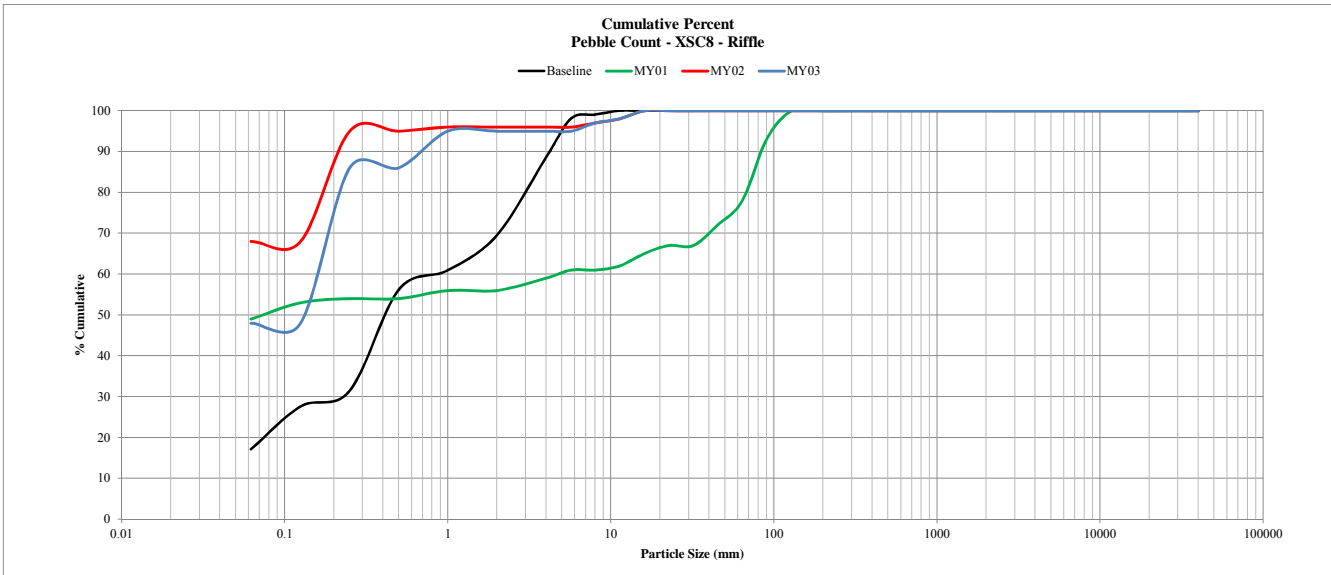
Coddle Creek Tributary - Indian Run - LR - XS8 Riffle Pebble Count

*The pins for XS8 were not located in the field. The location of the cross section for MY3 is approximate and was set during MY2.

Location: STA 16+50

Summary Data	
D50	0.125
D84	0.25
D95	5.7
