**Coddle Creek Tributary
(Indian Run) Stream Restoration
EEP Project # 94
DENR Contract # 5360**

**Annual Monitoring Report Year 3 of 5
Cabarrus County, North Carolina**

**Construction Completed: March 27, 2011
Data Collected: September 2014
Report Submission: December 2014**

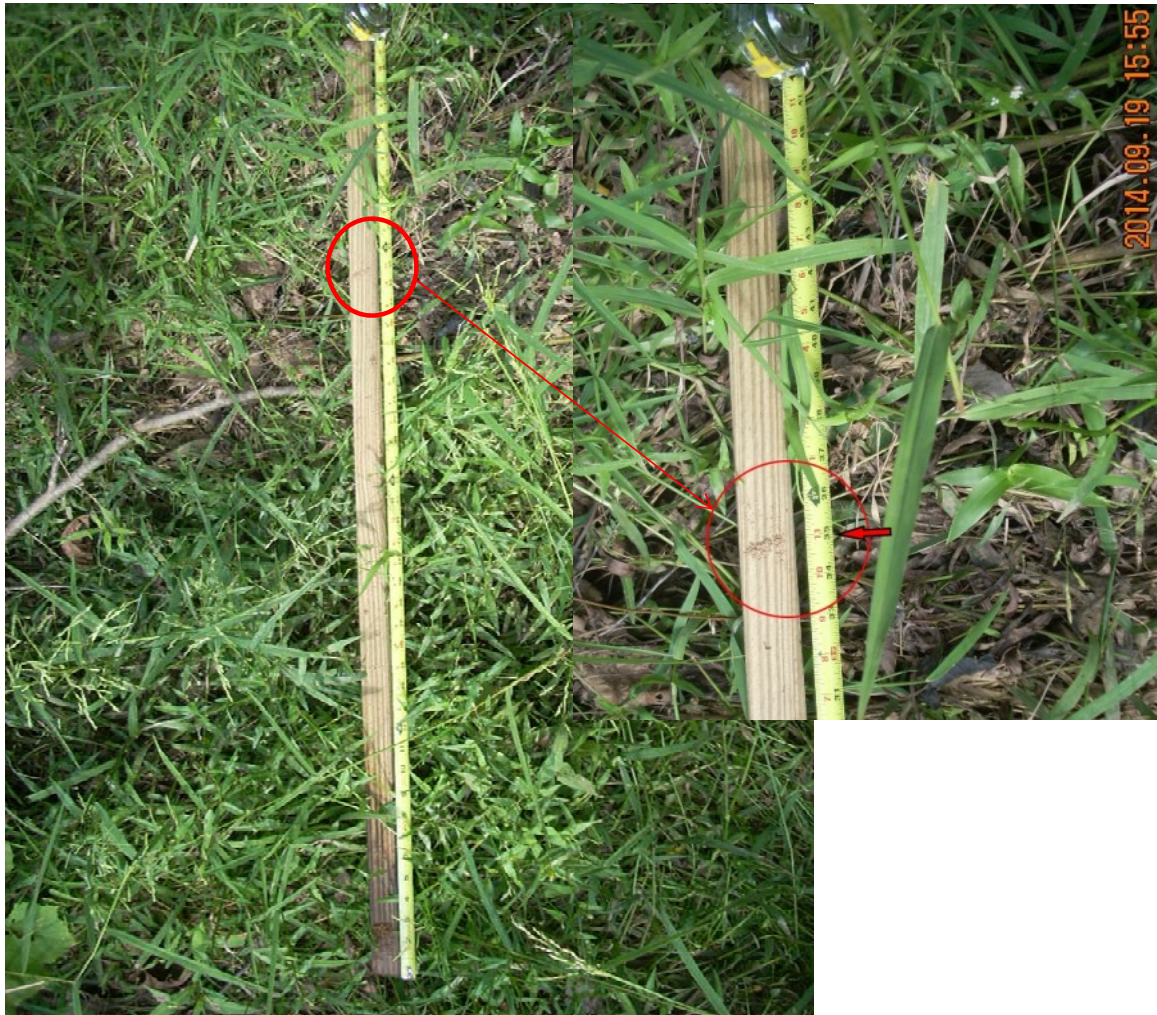
Table 12. Verification of Bankfull Events			
Coddle Creek Tributary (Indian Run)/ 94 Segment/Reach: 2270 feet			
Date of Data Collection	Date of Occurrence	Method	Photo
5/30/2012	Between 5/11/2011 - 5/30/2012	Visual observation of wrack lines; stream gauge	Photo in MY1 Report
11/4/2013	Between 5/30/2012 - 11/04/2013	Visual observation of wrack lines; stream gauge	Photo in MY2 Report
11/4/2013	Between 11/04/2013 - 9/19/2014	Visual observation of wrack lines; stream gauge reading at 35" above bankfull	Photo below
