**Collins Creek Stream Restoration Site
Monitoring Report – MY01
Orange County, NC
Basin 03030002 - Contract # D05011**

KCI
ASSOCIATES OF
NORTH CAROLINA, PA

December 2008

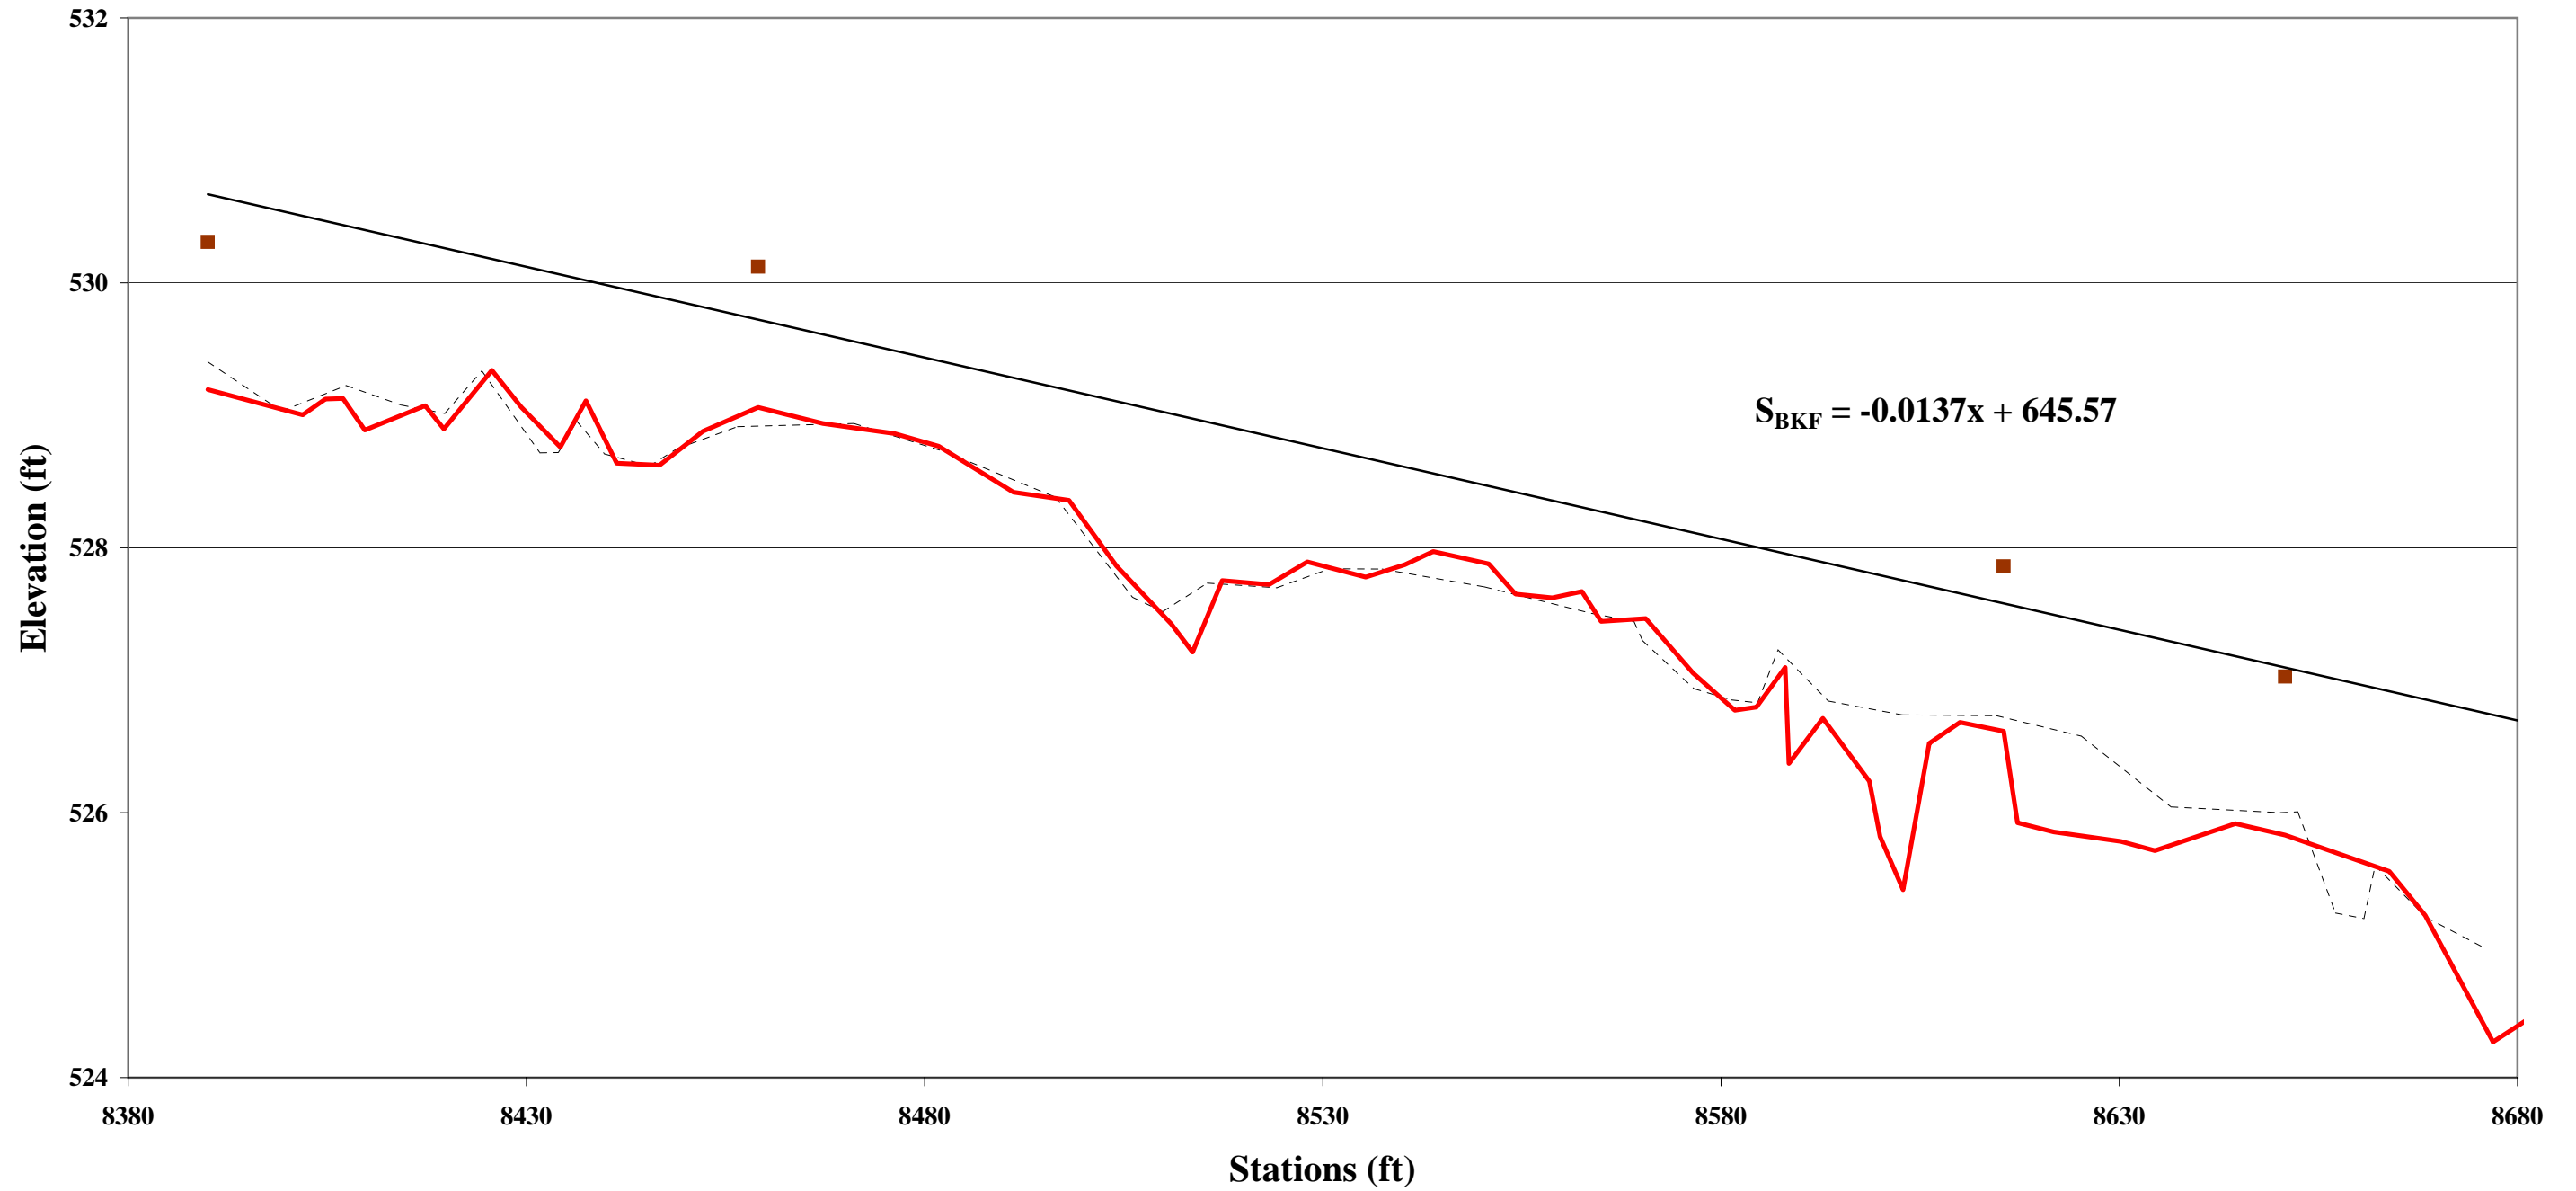
**Longitudinal Profile
Tributary 1A UTCC MY-01
Stations 83+80 - 86+80**

The stream assessment found the stream to be stable overall. Periods of high flow caused isolated bed degradation in T1A-1 and T1A-2. One of these areas is visible on the longitudinal profile of T1A. Overland flow has caused scour on the floodplain on the left side of T1B. It is expected that this issue will stabilize as vegetation becomes established on the floodplain. The rest of the project's stream banks, streambed, and floodplain have experienced little to no erosion throughout the project. The structures are performing well and as designed. The bed degradation will continue to be monitored to determine if corrective action are necessary.

*No WS due to no flow in channel during survey.
