**Collins Creek Stream Restoration Site
Monitoring Report – MY02
Orange County, NC
Basin 03030002 - Contract # D05011**

December 2009

**Design Engineer: Gary M. Mryncza, P.H., P.E.
Email: gary.mryncza@kci.com
KCI Project No: 12054130-01**

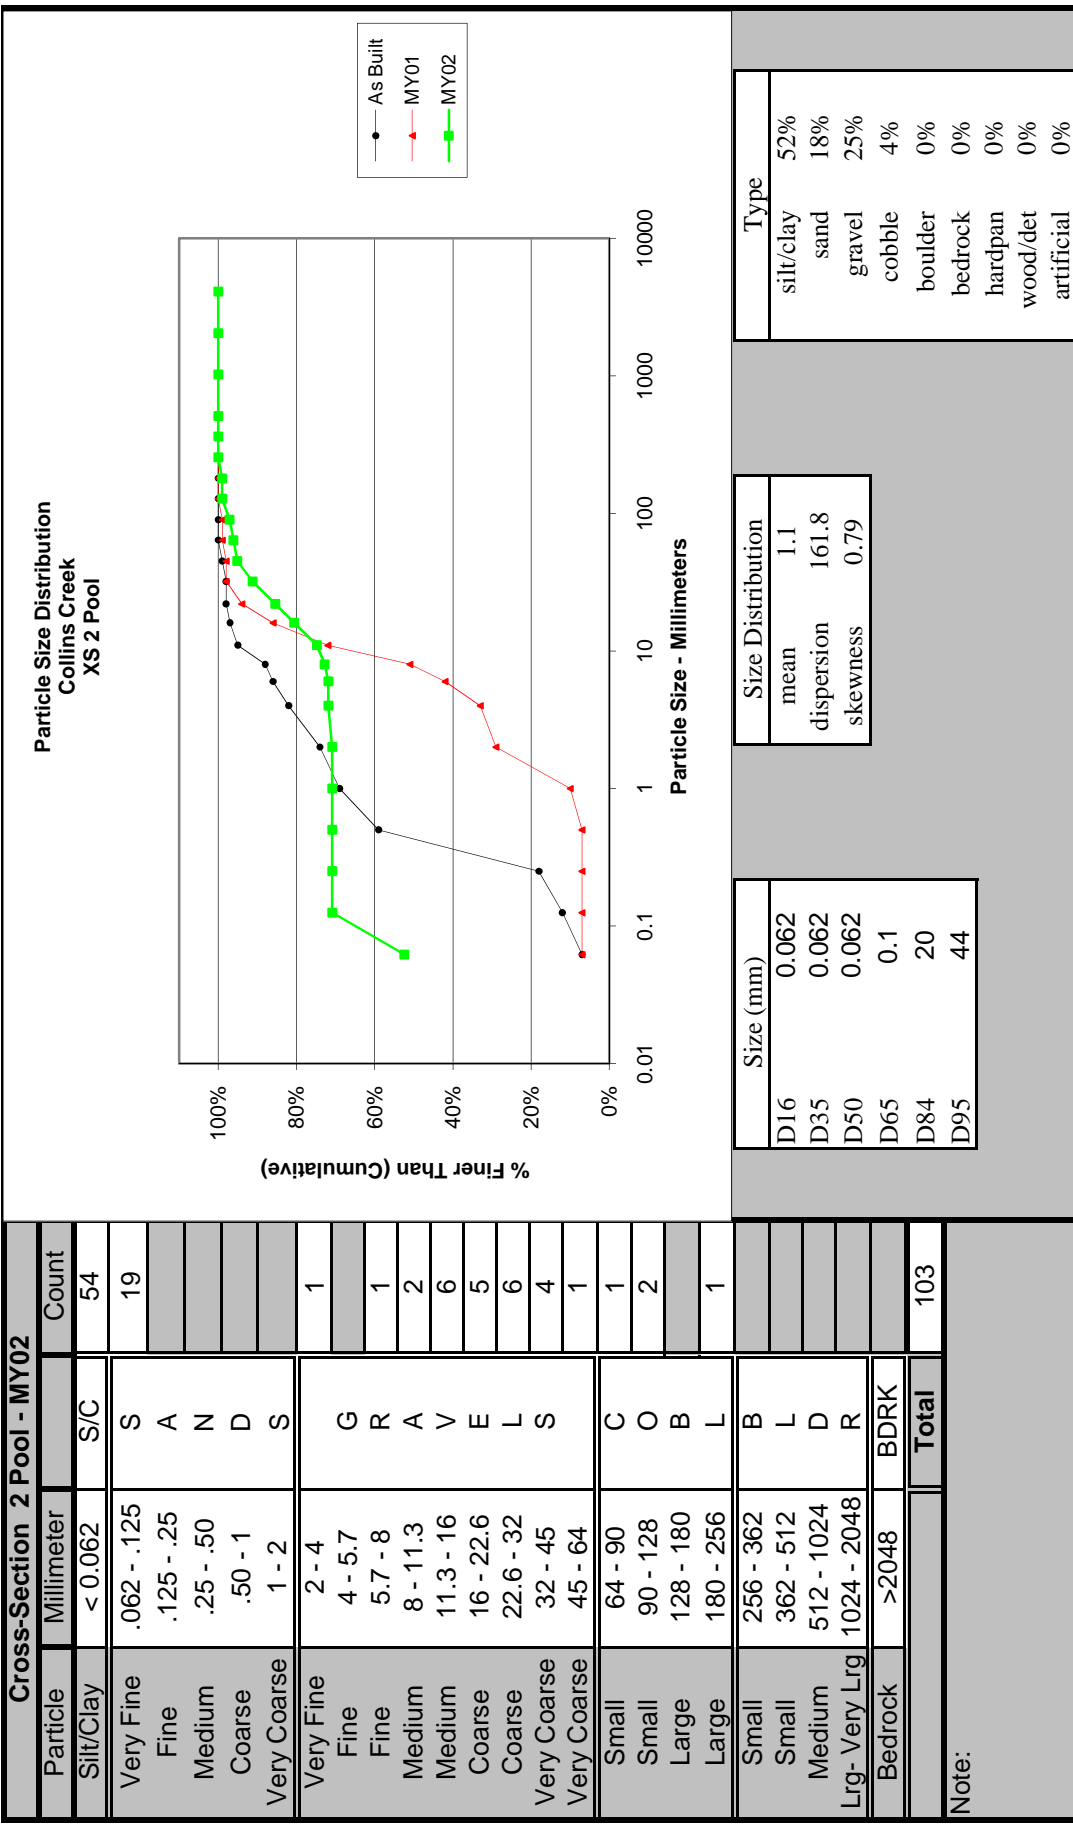
Note: Heavy vegetation in stream bed

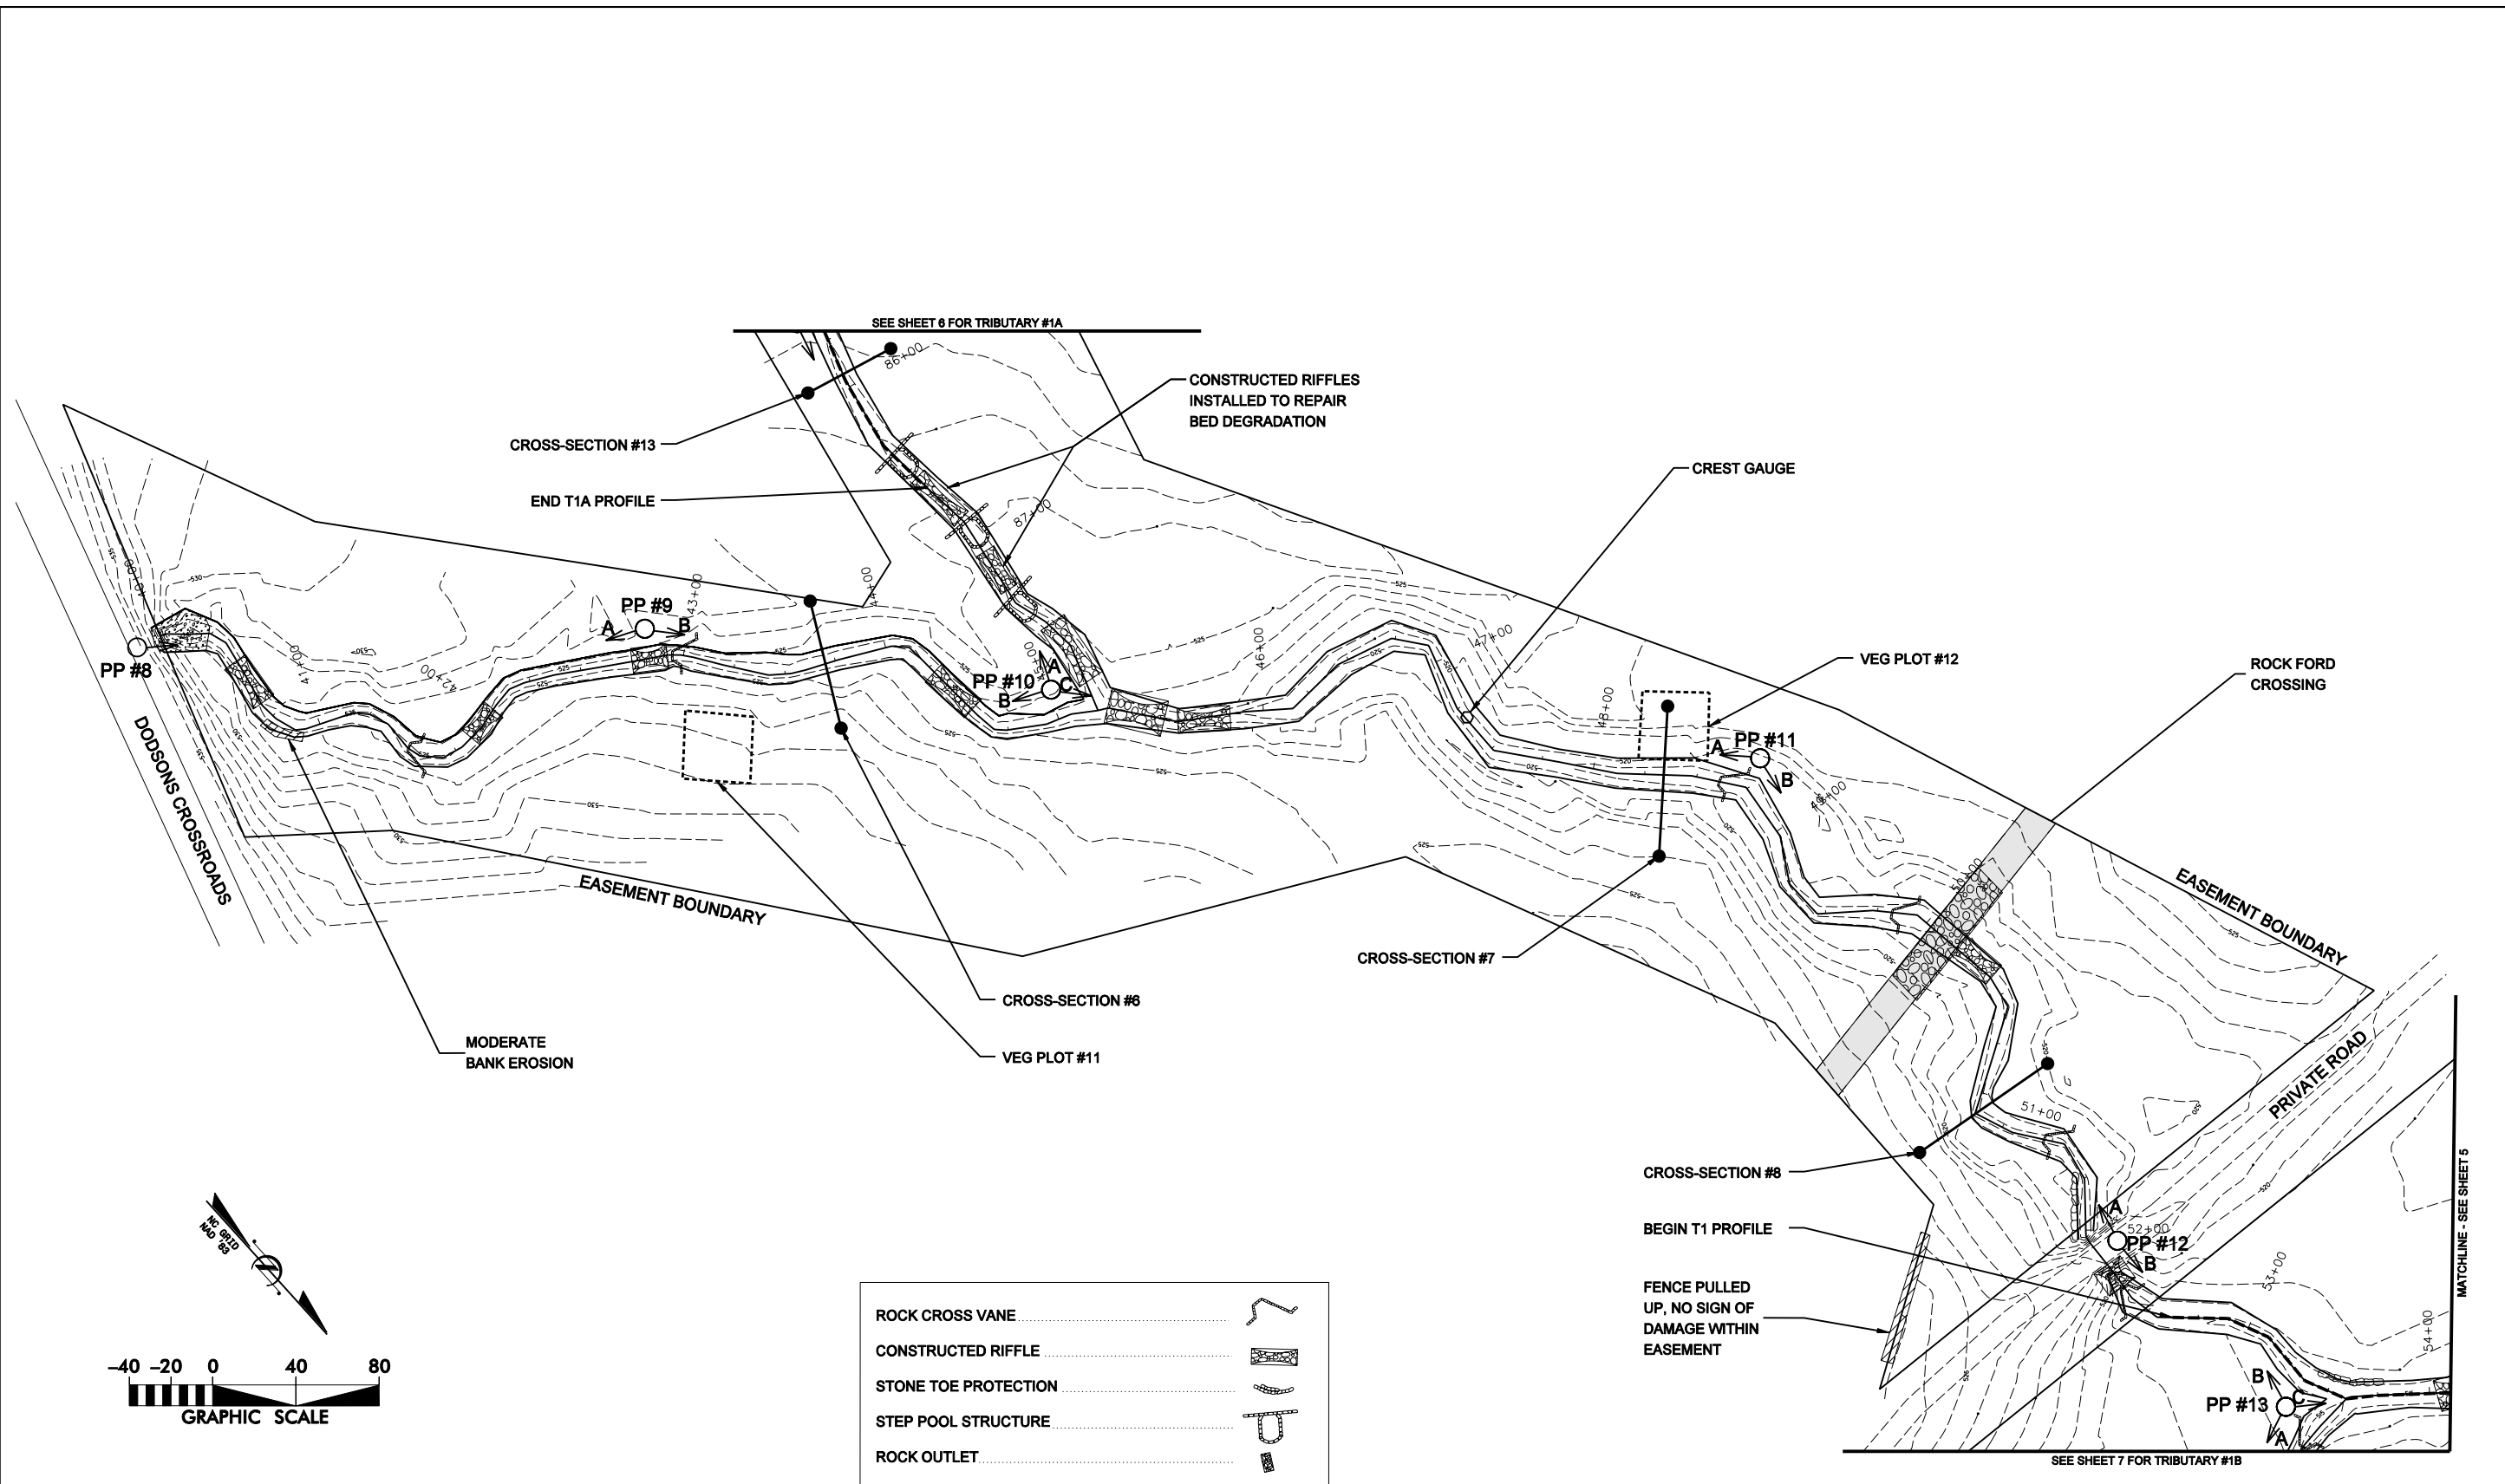
DATE: DECEMBER 2009
 SCALE: 1"=80'
 CURRENT
 CONDITION
 PLAN VIEW
 SHEET 3 OF 9

ROCK FORD CROSSING
 ROCK FORD CROSSING AND ADJACENT STREAM BANKS REGRADED AND STABILIZED WITH STONE TO REPAIR CATTLE DAMAGE.
