MONITORING YEAR 1 ANNUAL REPORT

COOL SPRINGS MITIGATION SITE

Harnett County, NC
Cape Fear River Basin
HUC 03030004

DMS Project No. 100166
NCDEQ Contract No. 0302-02
DMS RFP No. 16-20190302/Issued: December 20, 2019
USACE Action ID No. SAW-2020-01400
DWR Project No. 2020-1279

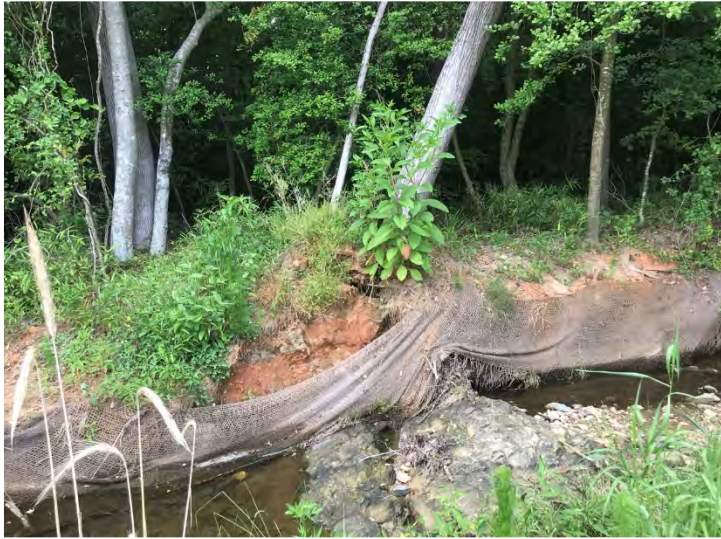
UT to Cedar Creek STA 127+74-128+44: Before – Partially Fallen Tree on Right Bank Causing Bank Erosion (4/7/2023)

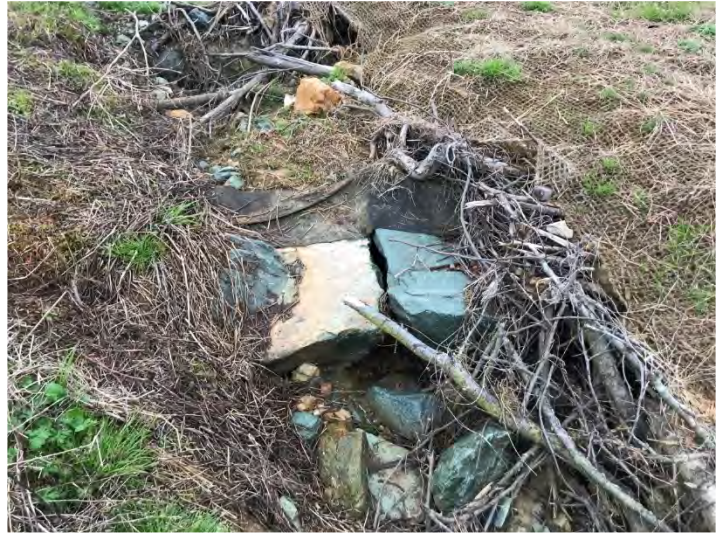
T2 STA 303+05-303+20: Before – Piping Rock Sill Causing Dislodged Brush Toe and Scouring of the Left Bank (4/7/2023)

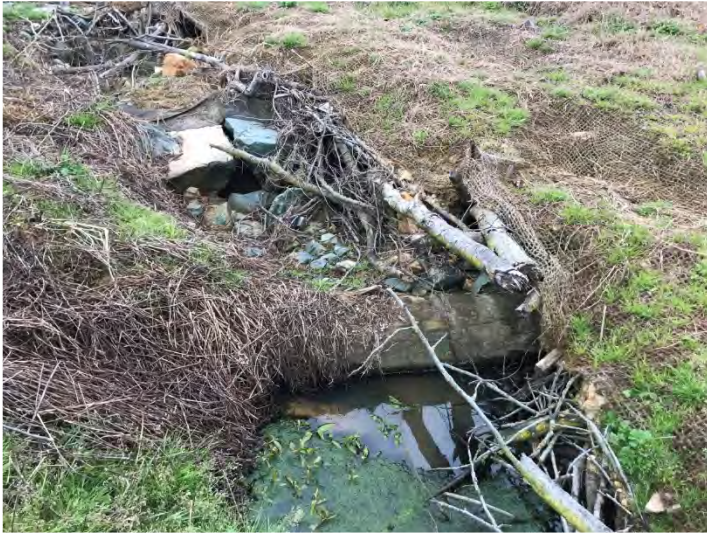
T2 STA 303+05-303+20: Before – Piping Log Sill Causing Dislodged Brush Toe and Scouring of the Left Bank (4/7/2023)

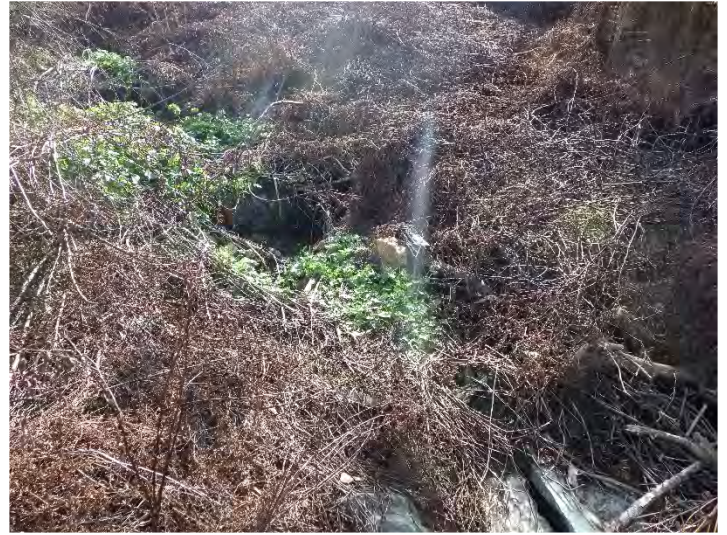
T2 STA 303+05-303+20: Before – Piping Log Sill Causing Dislodged Brush Toe and Scouring of the Left Bank (11/29/2023)

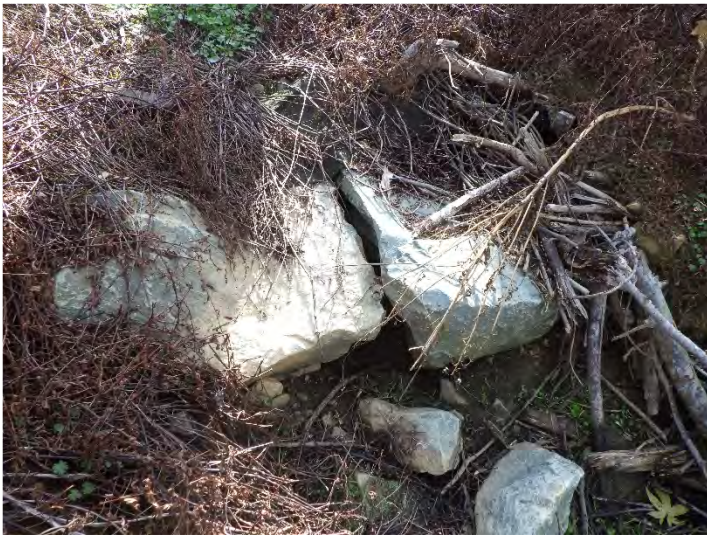
T2 STA 303+05-303+20: Before – Piping Rock Sill Causing Dislodged Brush Toe and Scouring of the Left Bank (11/29/2023)

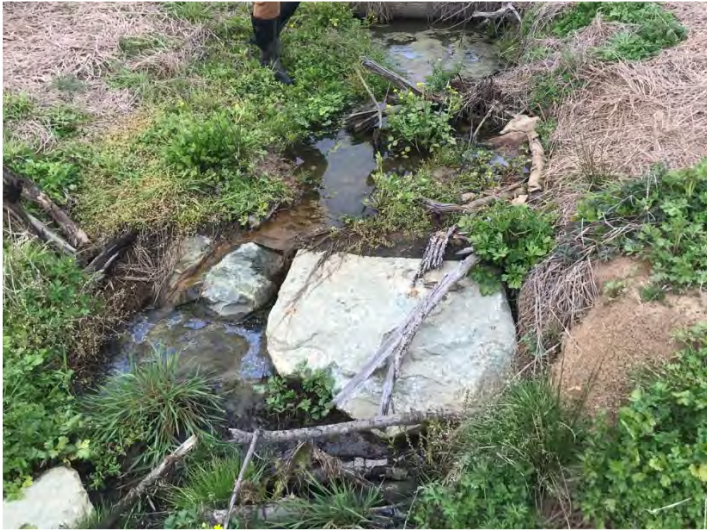
T8 STA 902+59: Before –Piping Rock Sill Causing Localized Scouring (4/7/2023)
