MONITORING YEAR 0 ANNUAL REPORT

COOL SPRINGS MITIGATION SITE

Harnett County, NC
Cape Fear River Basin
HUC 03030004

DMS Project No. 100166
NCDEQ Contract No. 0302-02
DMS RFP No. 16-20190302/Issued: December 20, 2019
USACE Action ID No. SAW-2020-01400
DWR Project No. 2020-1279

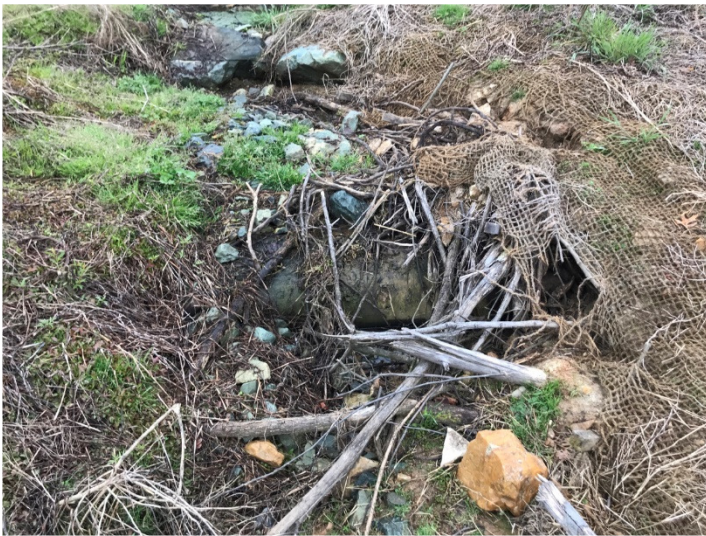
T2 STA 303+05-303+20: Before – Piping Log Sill Causing Dislodged Brush Toe and Scouring of the Left Bank (4/7/2023)

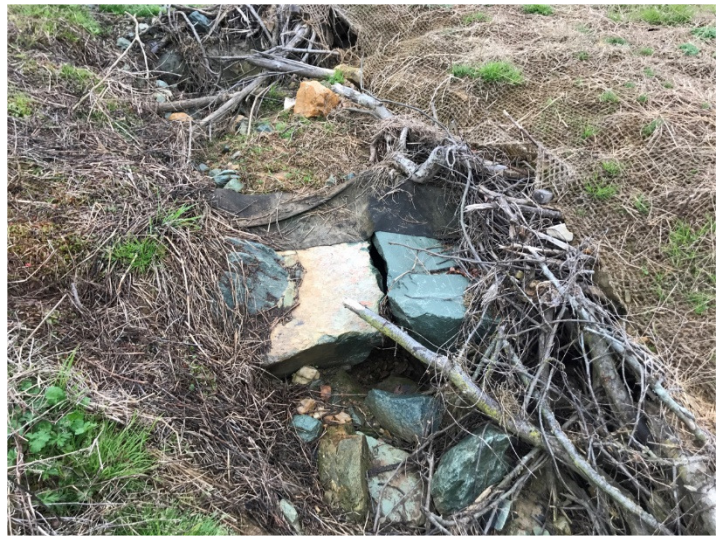
T2 STA 303+05-303+20: Before – Piping Rock Sill Causing Dislodged Brush Toe and Scouring of the Left Bank (4/7/2023)

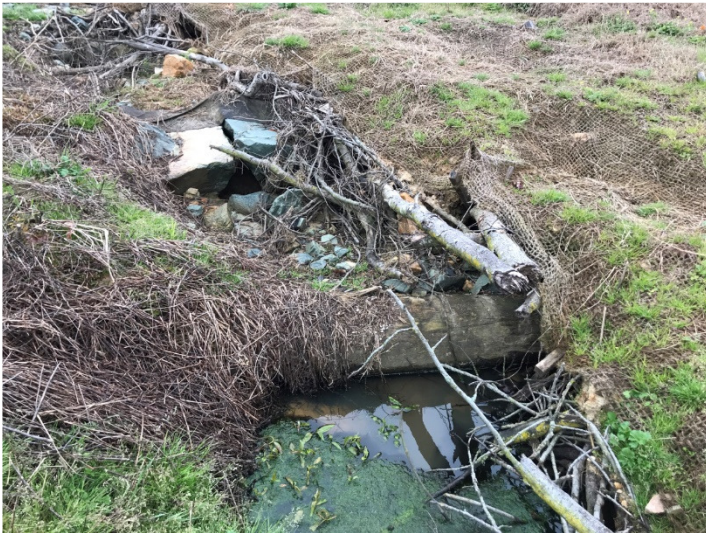
T2 STA 303+05-303+20: Before – Piping Log Sill Causing Dislodged Brush Toe and Scouring of the Left Bank (4/7/2023)
