**Coon Creek Riparian Buffer and Nutrient Offset Mitigation Project  
2018 Monitoring Report  
Monitoring Year 5 of 5**

**Granville County, North Carolina  
Tar-Pamlico River Basin  
USGS Hydrologic Unit 03020101**

**NCDMS Project No. 95807  
NCDMS Contract No. 5153**

2018 Monitoring Report – Year 5 of 5

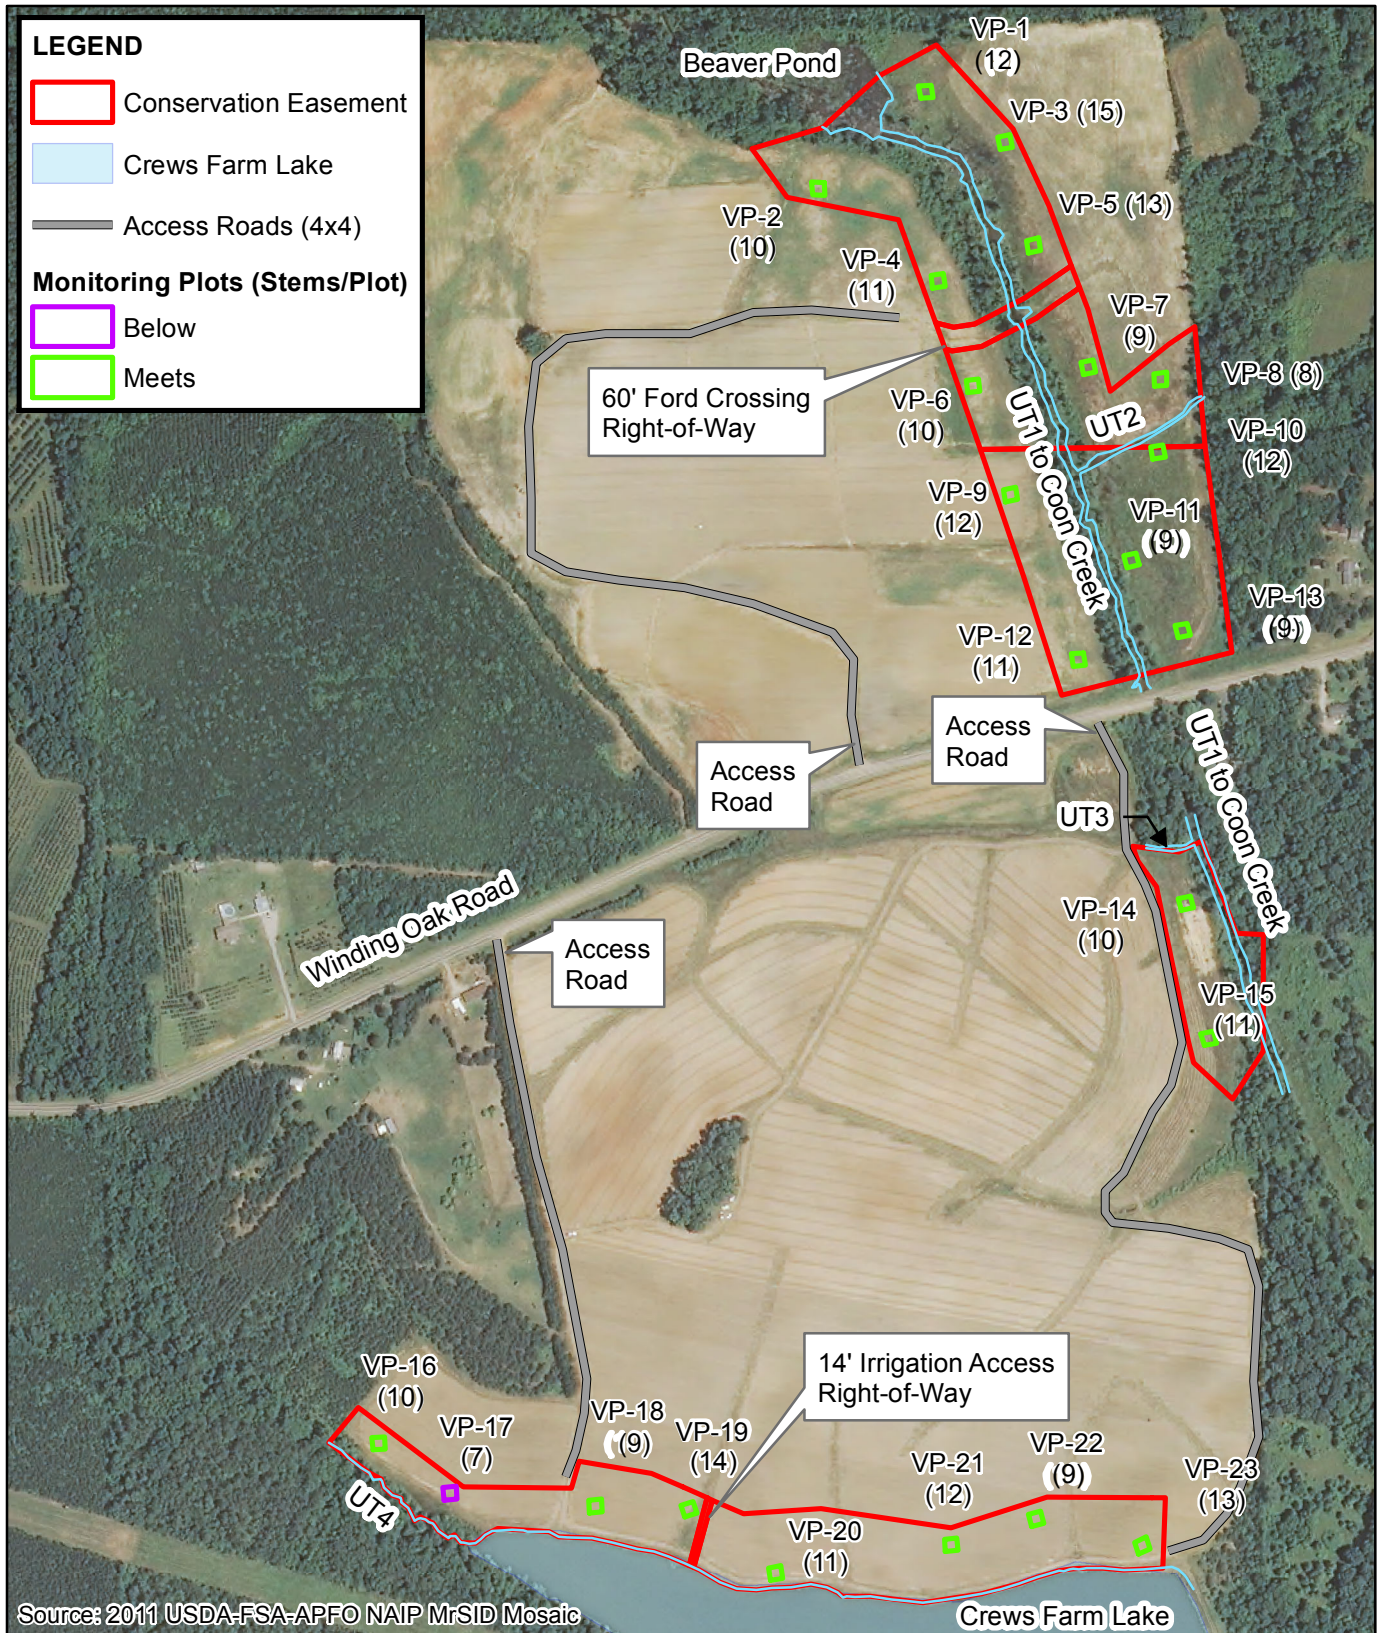
**FIGURE 3**

Vegetation plot data were collected on October 3 and 8, 2018. Of the 23 plots monitored, 22 plots met or exceeded the success criteria. Of these, one plot exceeded the success criteria by less than 10% (Figure 3 and Appendix B). Vegetation plot 17 did not meet success criteria for planted stems, but by only one stem, and volunteer hardwood stems in this plot elevate stem abundance above the 320 stems per acre minimum threshold (Appendix B). This is consistent with MY3 and MY4 results.
