COOR ISLAND MITIGATION SITE

Year 1 Monitoring Report (2023)
Wayne County, North Carolina
Neuse River Basin - 03020201

DMS Project ID No. 100183
Full Delivery Contract No. 0402-03
DWR Project No. 2021 0021 v3
RFP No. 16-20200402

**FINAL
MY1 (2023) MONITORING REPORT**

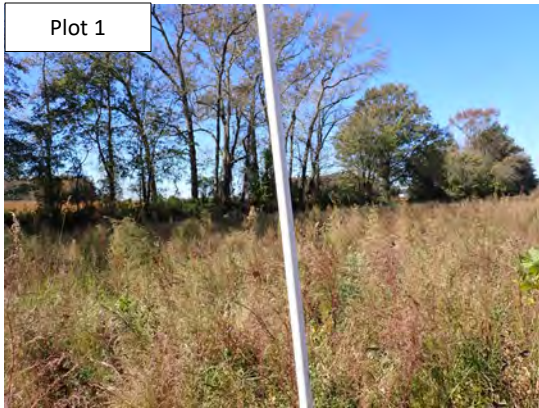
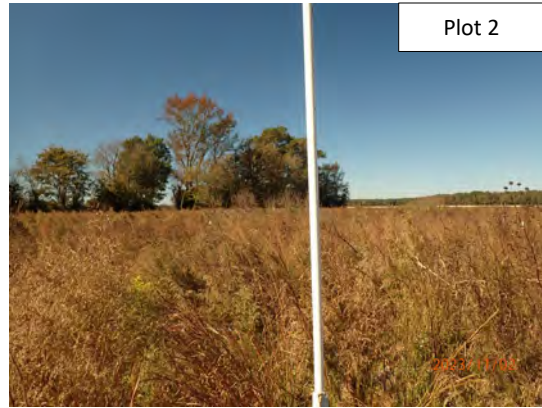
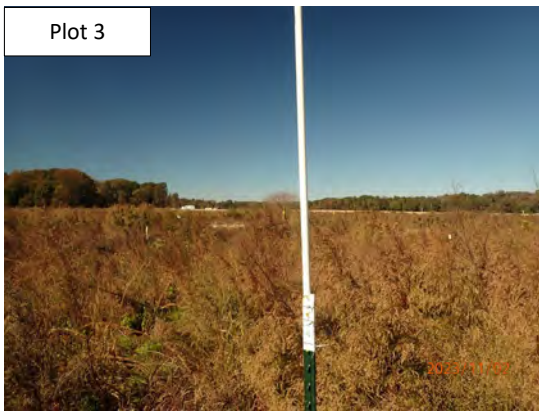
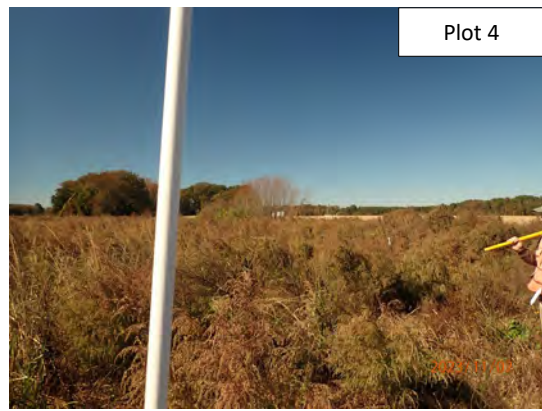
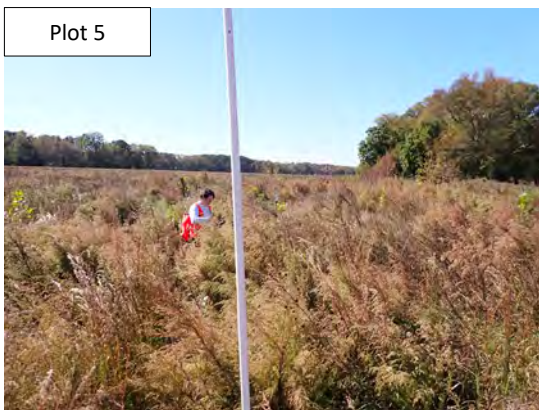
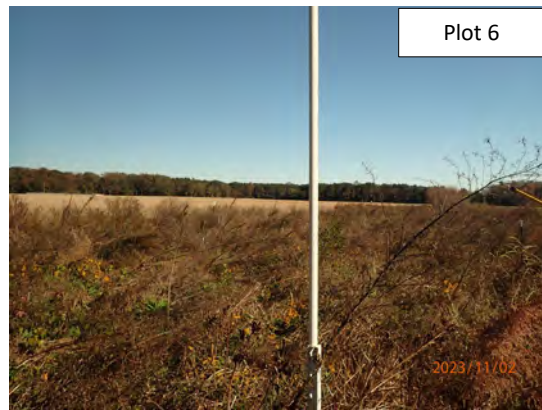
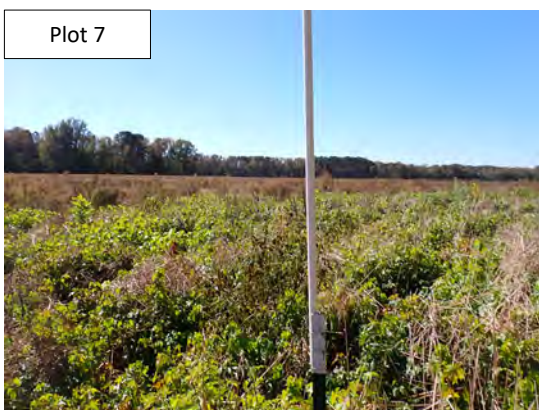
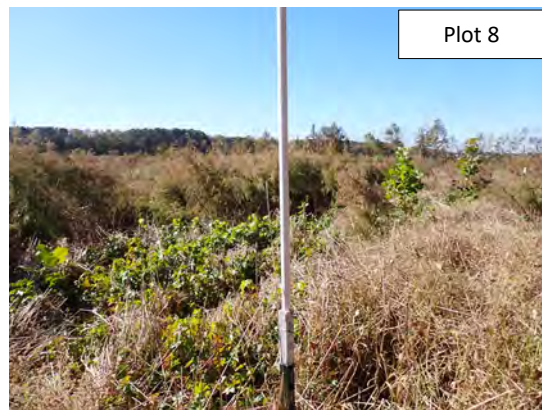
Coor Island
MY1 (2023) Vegetation Monitoring Photographs (November 2023)

Year 1 (2023) data was collected on November 1-2, 2023 by Axiom Environmental and derived an average planted stem density of 430 stems per acre. All individual plots met success criteria except plot 4. Plot 4 failed to meet the success criteria by less than 10% (1 stem) with an average of 243 stems/acre. Additionally, all 8 vegetation plots contained at least 4 native hardwood and native shrub species where no one species was greater than 50% of stems. Appendix B includes Year 1 (2023) vegetation plot photographs along with planted and total stem counts.
