County Line Creek Stream Restoration (High Vista) 2004 Annual Monitoring Report

March, 2005

2004 County Line Creek Monitoring Abstract

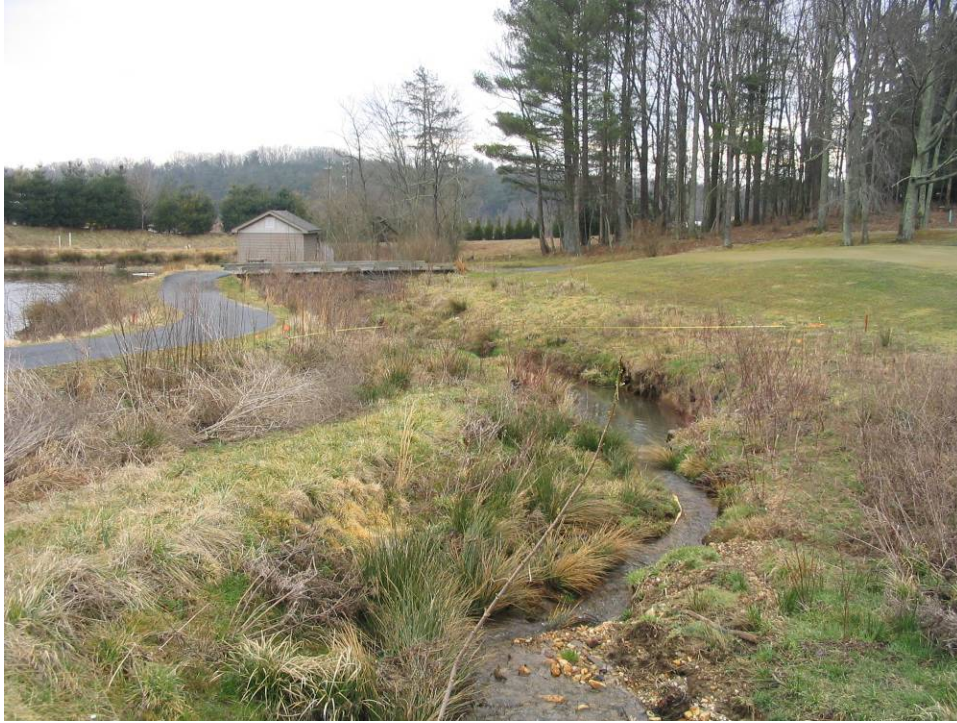
PS #5 Looking Downstream from STA 33+50 Rifle Cross Section #3

- At station 33+60 the rock cross vane has water piping under the invert rock with a head loss of 2 inches due to the piping. At this point the structure is not at risk of complete failure due to the boulder size used for the vane construction, the total number of vanes in the project, and the existing vegetation.

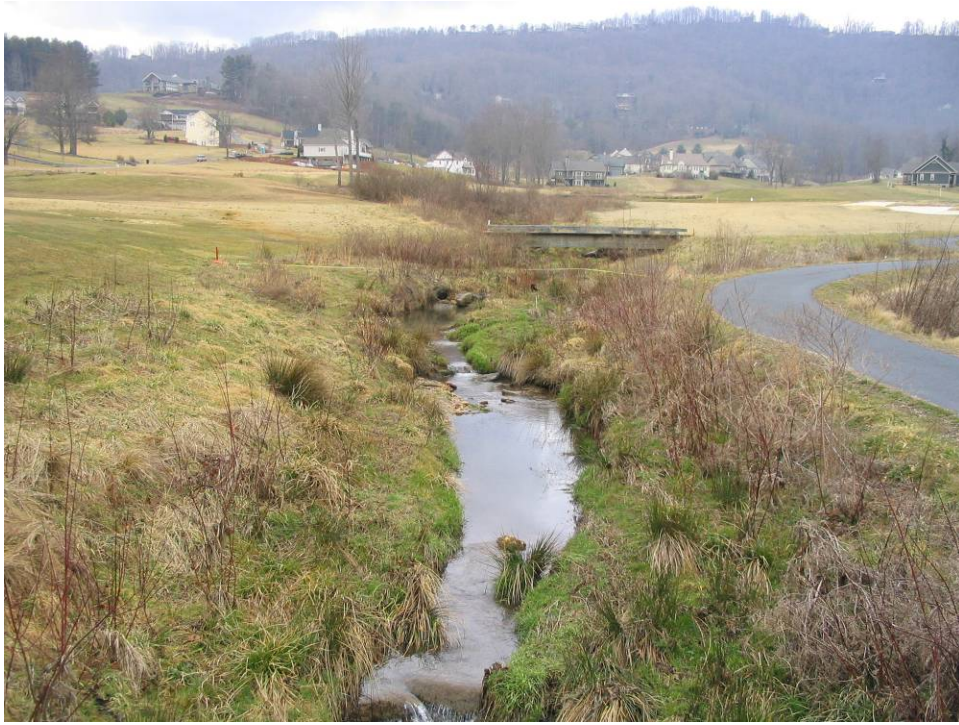
PS #11 Looking Upstream from STA 34+80

- At station 34+70 the rock cross vane has failed and needs to be repaired as soon as possible the reach near this failed rock vane has a severe head-cut of about one foot.

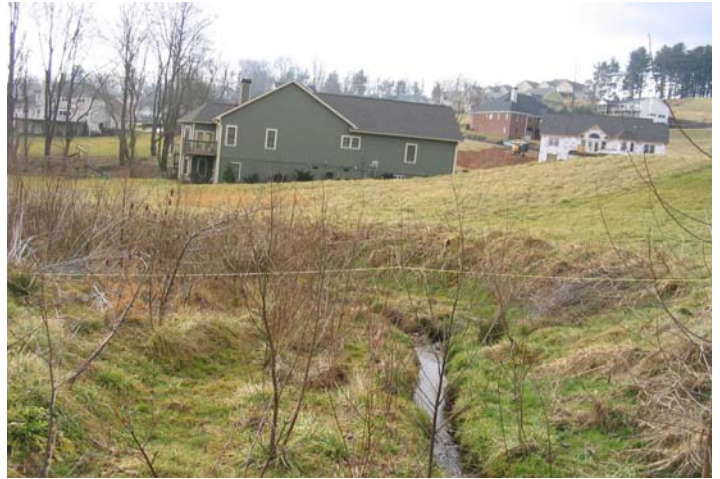
Photo of Cross-Section #1 - Looking Downstream @ STA 19+60

2004
Area	2.1
Width	3.7
Mean Depth	0.6
Max Depth	1.0
W/D	6.4

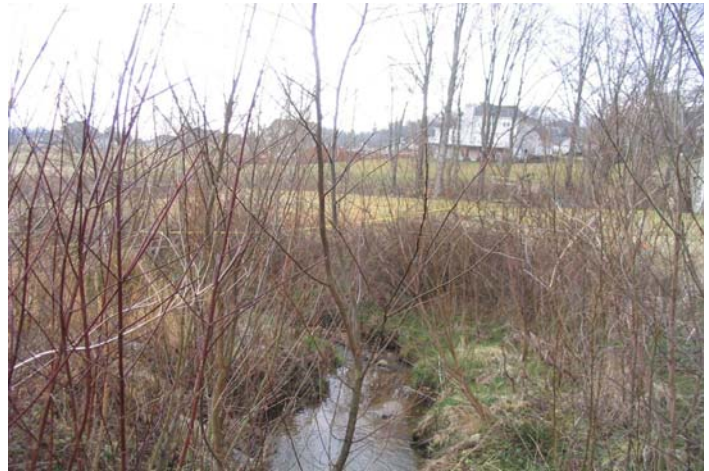
Photo of Cross-Section #2 - Looking Downstream @ STA 20+60

2004
Area	2.0
Width	6.0
Mean Depth	0.3
Max Depth	1.4
W/D	18.2

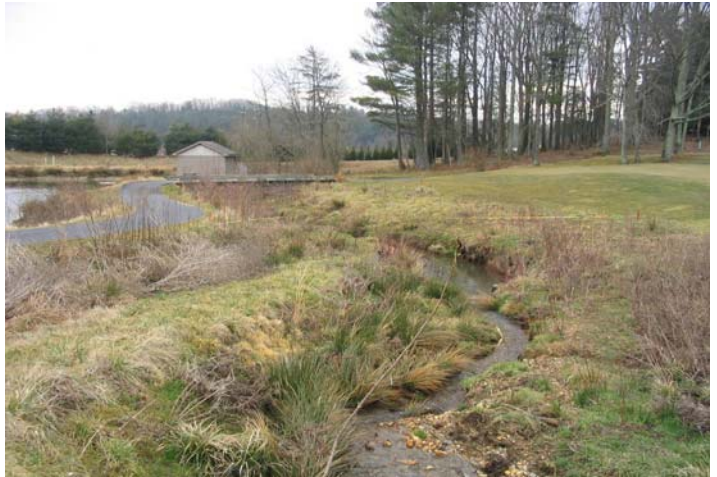
Photo of Cross-Section #3 - Looking Downstream @ STA 33+70

2004
Area	18.4
Width	18.0
Mean Depth	1.0
Max Depth	3.0
W/D	17.7

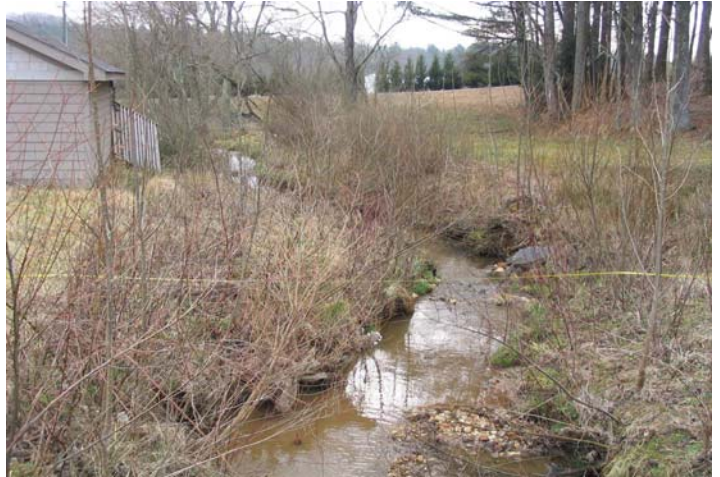
Photo of Cross-Section #4 - Looking Downstream @ STA 35+20

2004
Area	25.1
Width	11.4
Mean Depth	2.2
Max Depth	3.3
W/D	5.2
