Year 3 Monitoring Report

County Line Creek (High Vista) Stream Restoration

February 2006
S&EC Project No. 9445.D1
EEP Project No. 00044

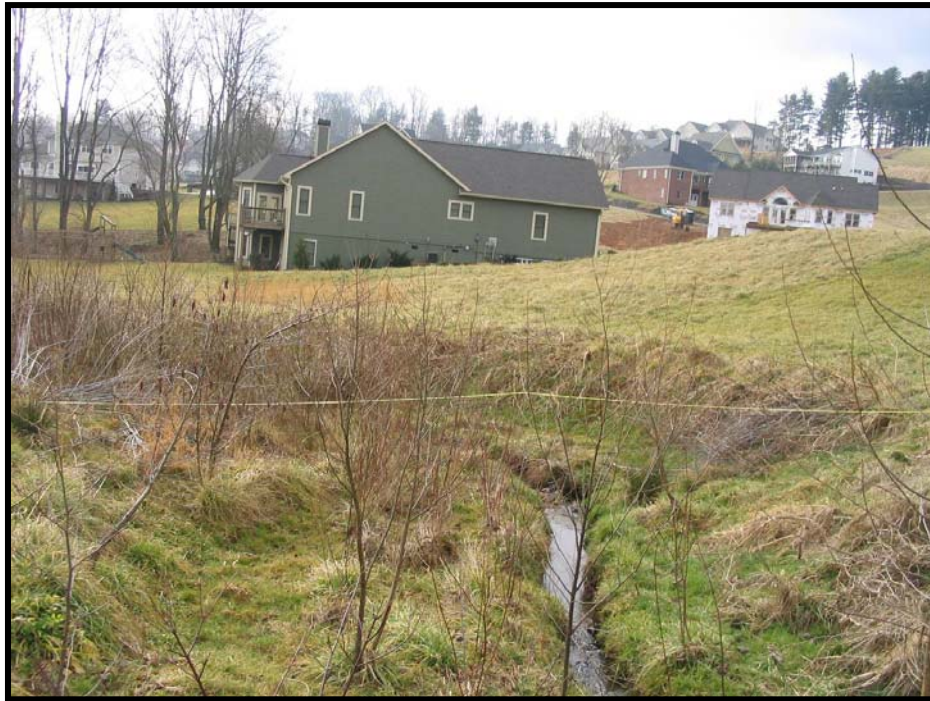
Cross-section 1—Year 2 (2004)

Floodprone Elevation	(ft)	2139.01
Bankfull Elevation	(ft)	2137.55
Floodprone Width	(ft)	32.29
Bankfull Width	(ft)	16.32
Entrenchm Ratio		1.98
Mean Depth	(ft)	0.59
Maximum Depth	(ft)	1.46
Width/Dept Ratio		27.7
Bankfull Area	(sq	9.62
Wetted Perimeter	(ft)	17.44
Hydraulic Radius	(ft)	0.55
Begin BKF	Station	18.86
End BKF	Station	35.18

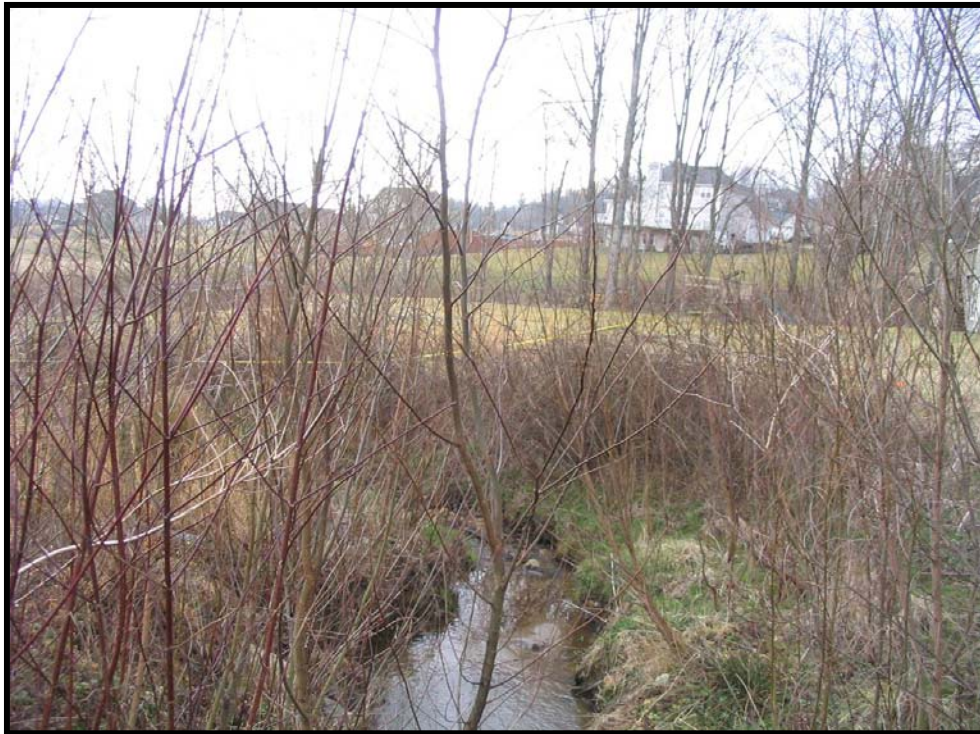
Cross-section 2—Year 2 (2004)

Floodprone Elevation	(ft)	2133.85
Bankfull Elevation	(ft)	2132.21
Floodprone Width	(ft)	25.46
Bankfull Width	(ft)	14.36
Entrenchm Ratio		1.77
Mean Depth	(ft)	0.82
Maximum Depth	(ft)	1.64
Width/Dept Ratio		17.44
Bankfull Area	(sq	11.83
Wetted Perimeter	(ft)	14.96
Hydraulic Radius	(ft)	0.79
Begin BKF	Station	19.78
End BKF	Station	34.15

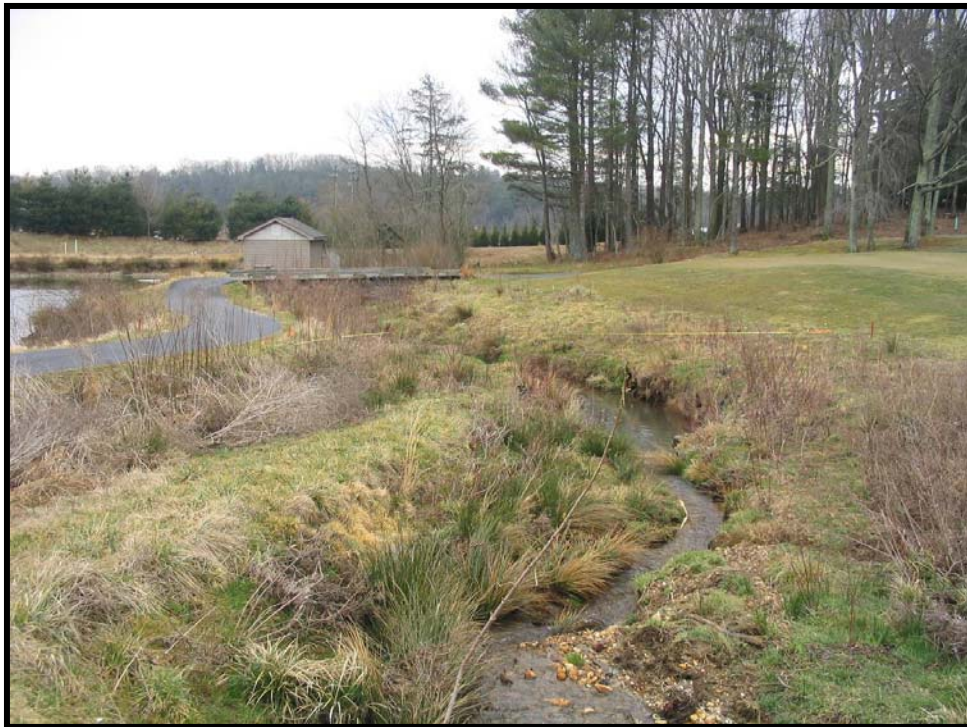
Cross-section 3—Year 2 (2004)

Cross	Sectional	Geometry
Floodprone Elevation	(ft)	2097.26
Bankfull Elevation	(ft)	2095.45
Floodprone Width	(ft)	23.7
Bankfull Width	(ft)	9.93
Entrenchm Ratio		2.39
Mean Depth	(ft)	0.96
Maximum Depth	(ft)	1.81
Width/Dept Ratio		10.3

Bankfull	Area	(sq	9.57
Wetted	Perimeter	(ft)	11.88
Hydraulic	Radius	(ft)	0.81
Begin	BKF	Station	9.95
End	BKF	Station	25.42

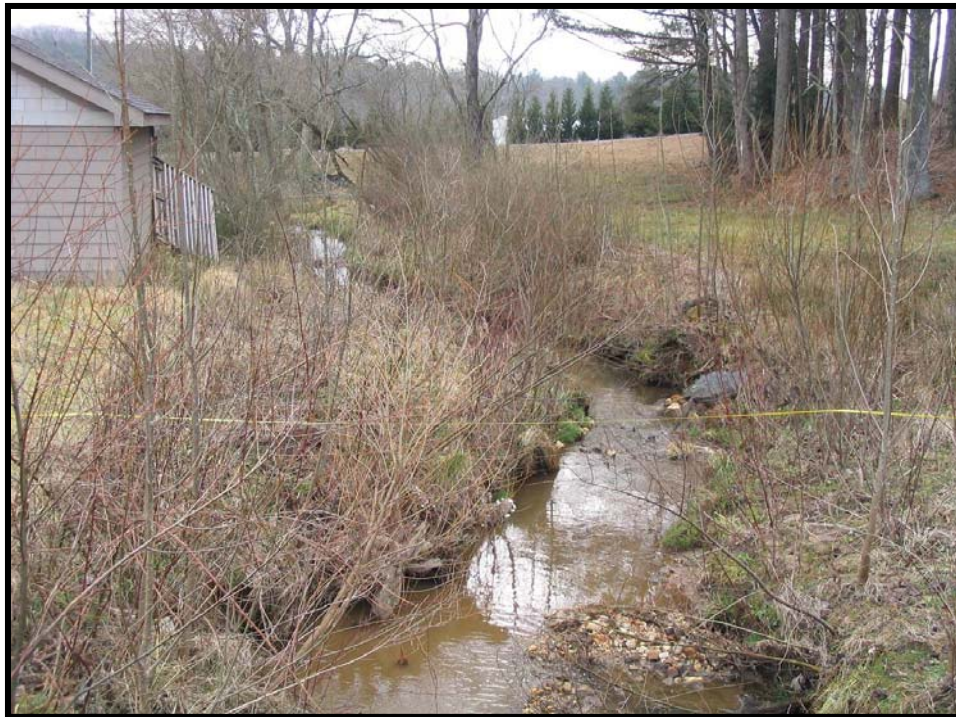
Cross-section 4—Year 2 (2004)

Floodprone Elevation	(ft)	2094
Bankfull Elevation	(ft)	2092.4
Floodprone Width	(ft)	17.92
Bankfull Width	(ft)	11.62
Entrenchm Ratio		1.54
Mean Depth	(ft)	0.97
Maximum Depth	(ft)	1.6
Width/Dept Ratio		11.99
Bankfull Area	(sq	11.26
Wetted Perimeter	(ft)	12.97
Hydraulic Radius	(ft)	0.87
Begin BKF	Station	7.35
End BKF	Station	18.97
