**Year 1 Monitoring Report**

**COWFORD PROJECT**

NCDMS Project #100095 (Contract #0007746)

**January 2023**

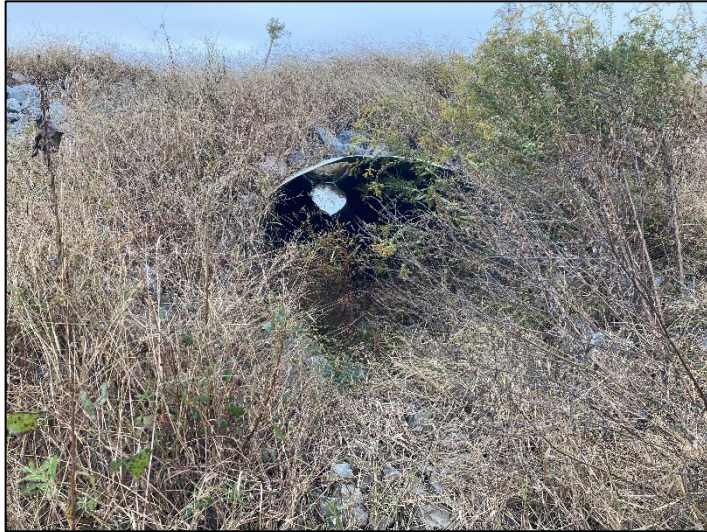
Photo Point 1: Culvert at the bottom of KJ1-B (11/3/2022)

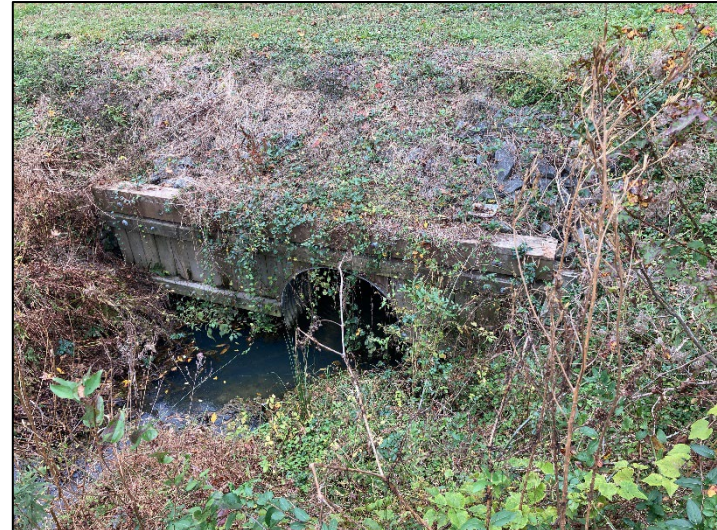
Photo Point 4: Culvert at Kinston Highway (11/3/2022)

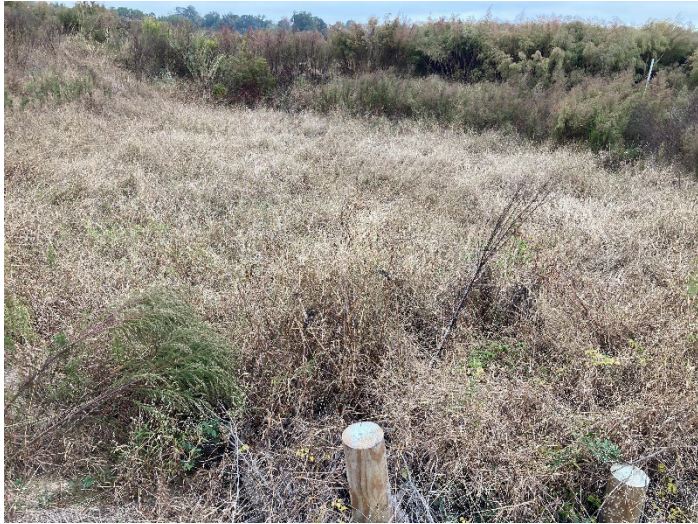
ESP & Treatment Pool (11/3/2022)
