Year 2 Monitoring Report

COWFORD PROJECT

NCDMS Project #100095 (Contract #0007746)
USACE Action ID: SAW-2019-00487
DWR Project #2019-0495

Onslow County, North Carolina
White Oak River Basin
HUC 03030001

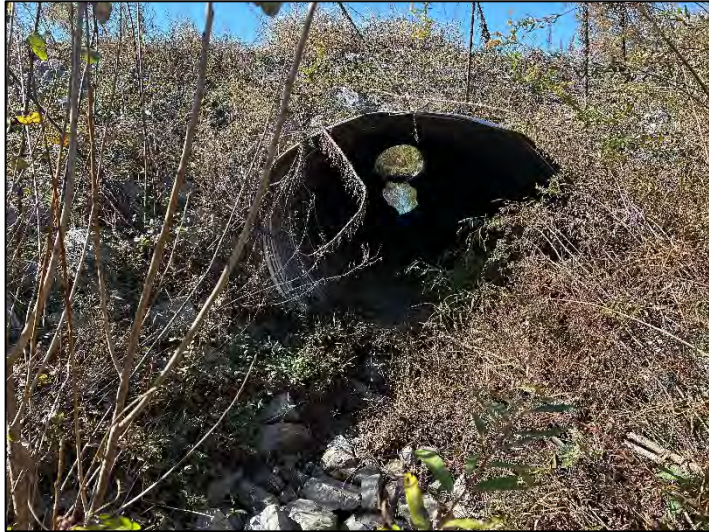
Photo Point 1: Culvert at the bottom of KJ1-B (11/2/2023)

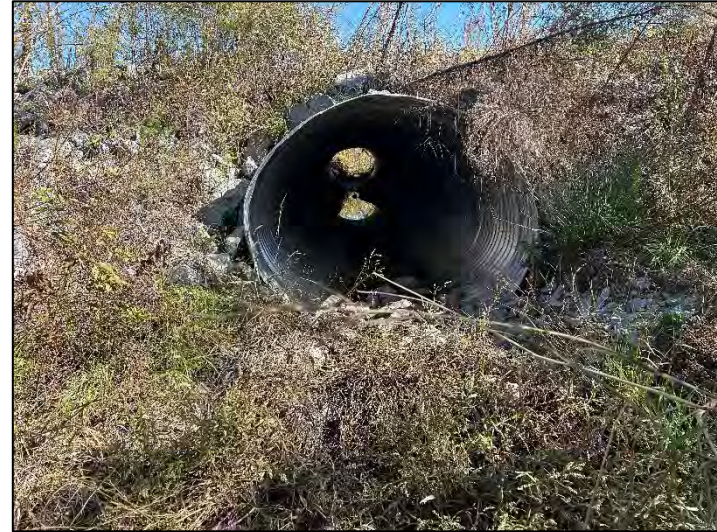
Photo Point 2: Culvert at the top of KJ1-C (11/2/2023)

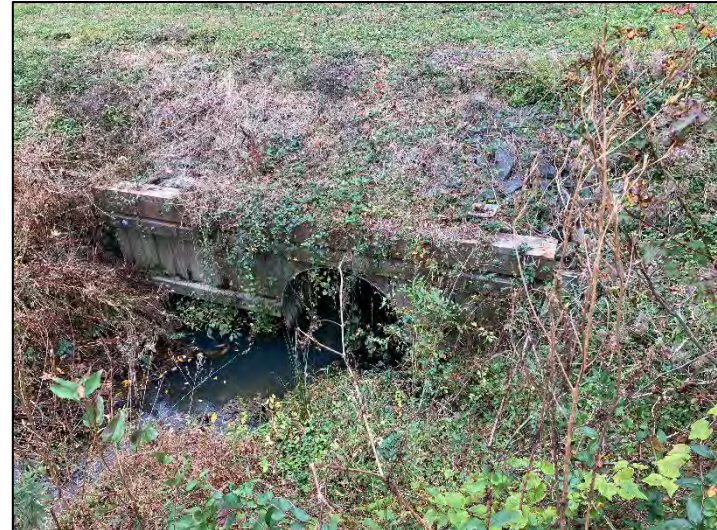
Photo Point 4: Culvert at Kinston Highway (11/3/2022)
