MY1 MONITORING REPORT

CRANE STREAM AND WETLAND MITIGATION SITE

Lee County, North Carolina
Cape Fear River Basin
Cataloging Unit 03030002

Data Collection: January 2023-November 2023
Submission: February 2024

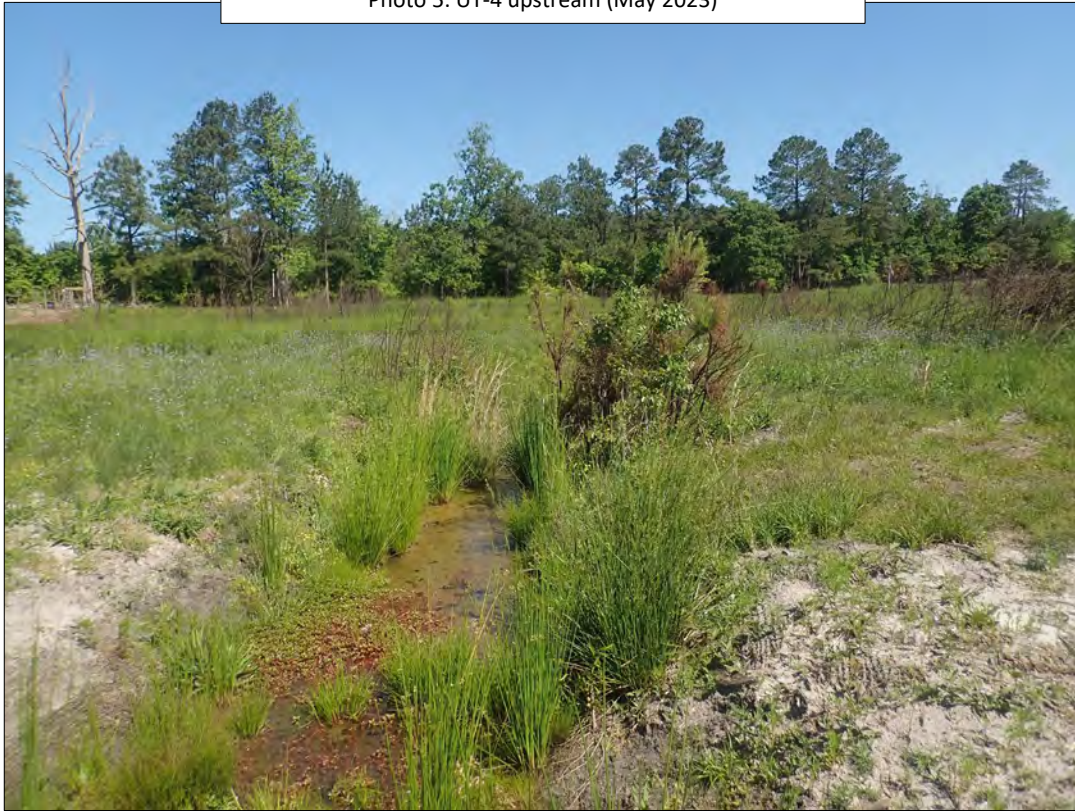
Photo 5: UT-4 upstream (May 2023)

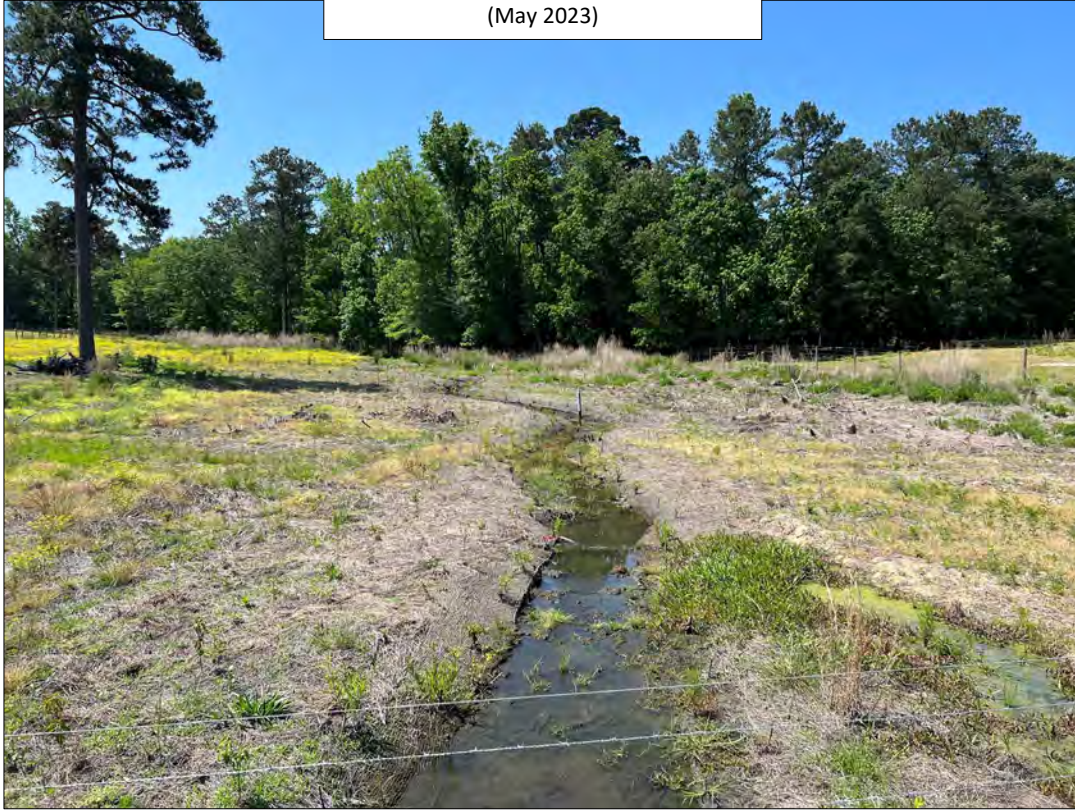
Photo 9: UT-1 from bridge; downstream
(May 2023)

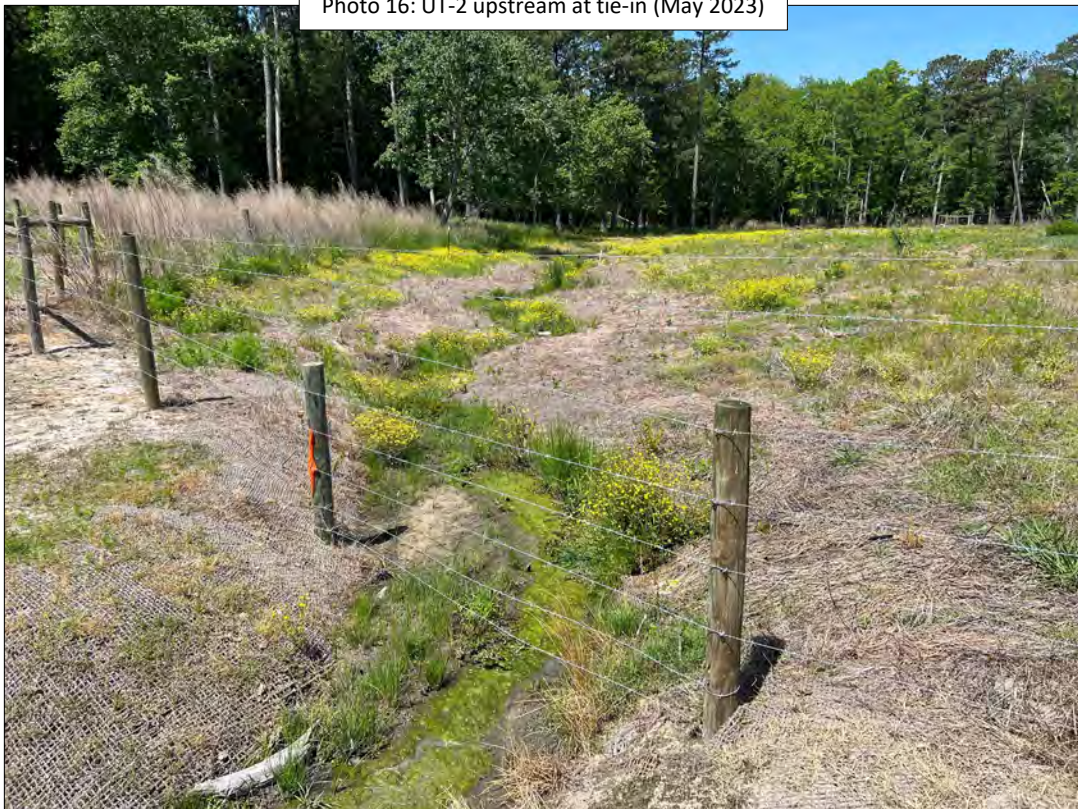
Photo 16: UT-2 upstream at tie-in (May 2023)

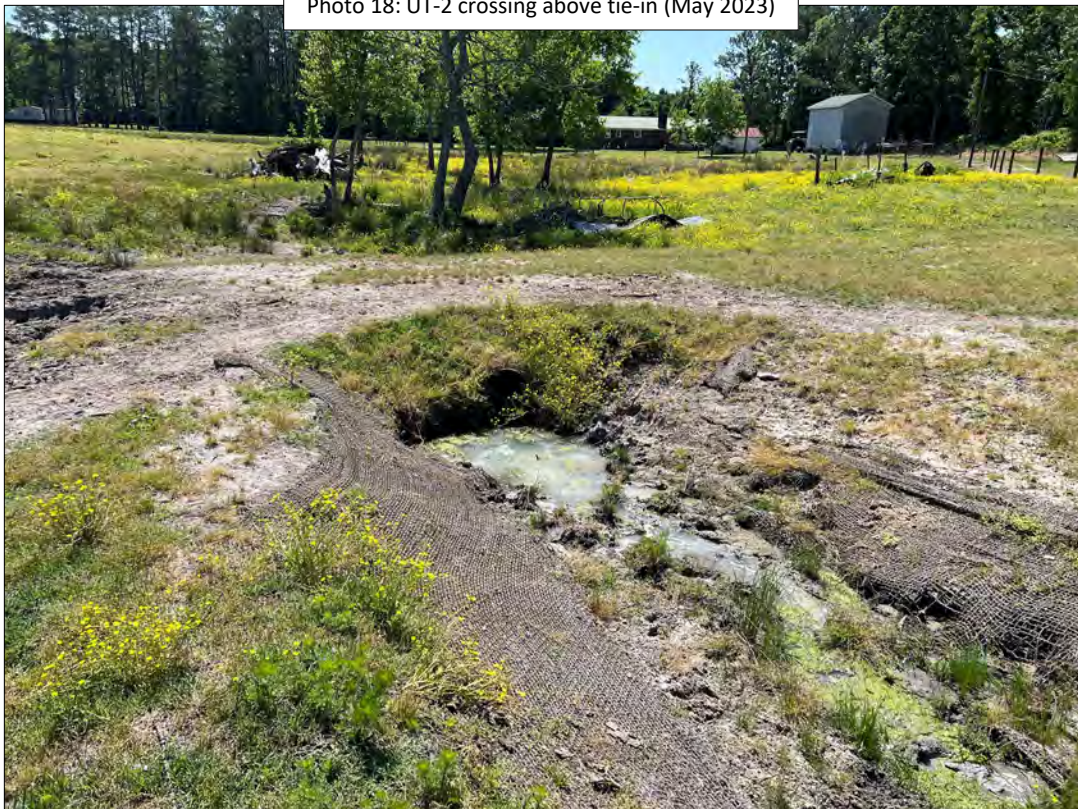
Photo 18: UT-2 crossing above tie-in (May 2023)

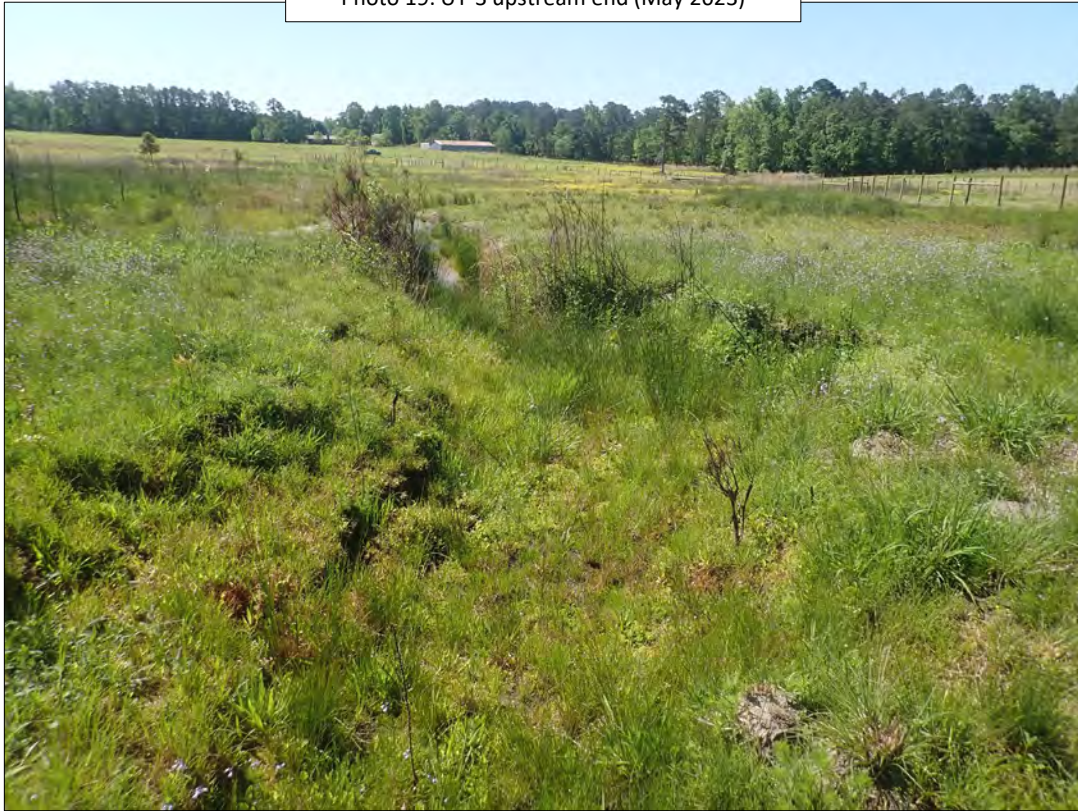
Photo 19: UT-3 upstream end (May 2023)
