MONITORING YEAR 1 ANNUAL REPORT

CROOKED CREEK #2 RESTORATION PROJECT

Union County, NC
NCDEQ Contract D09126S
DMS Project Number 94687

Data Collection Period: Aug. 2016 – Sept. 2016
Draft Submission Date: November 18, 2016
Final Submission Date: December 12, 2016

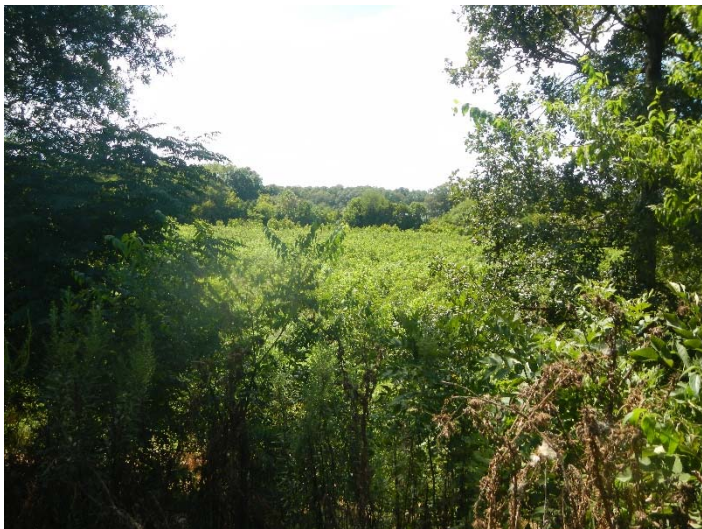
Photo Point 32 –Wetland AA facing W (08/18/2016)
