MONITORING YEAR 3 ANNUAL REPORT

CROOKED CREEK #2 RESTORATION PROJECT

Union County, NC

DMS Project Number 94687

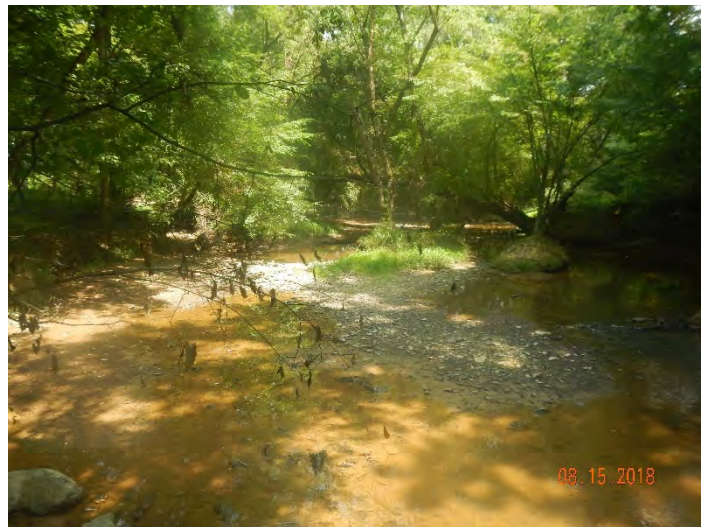
Photo Point 31 – UT2 looking upstream UT2 (8/15/2018)
