# **MONITORING YEAR 5 ANNUAL REPORT**

## **CROOKED CREEK #2 RESTORATION PROJECT**

DMS Project Number 94687

Data Collection Period: March – November 2020

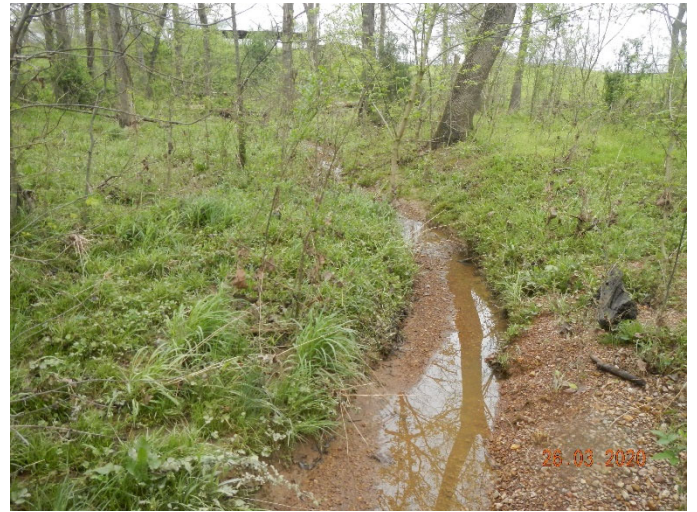
**Wrack Lines – UT2 (3/26/2020)**

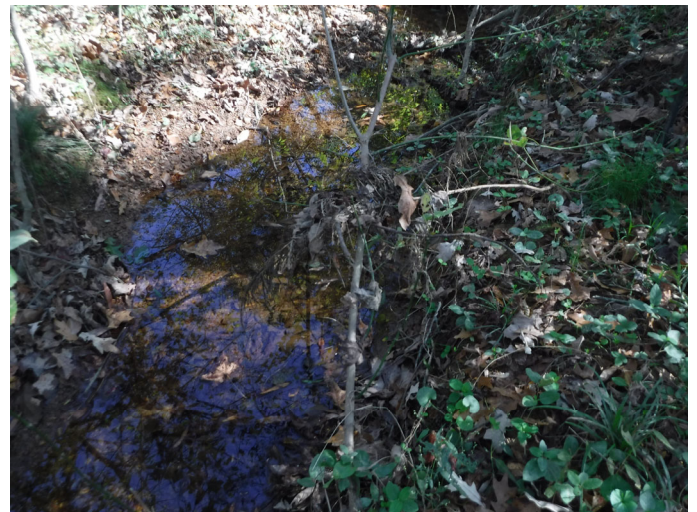
**Wrack Lines – UT2 (11/5/2020)**
