**MONITORING YEAR 1
ANNUAL REPORT**
Final

CROSS CREEK RANCH SITE

Montgomery County, NC
Yadkin River Basin
HUC 03040104

DMS Project No. 100138
NCDEQ Contract No. 7879-01
DMS RFP No. 16-007879 / Issued: May 6, 2019
USACE Action ID No. 2020-00051
DWR Project No. 2020-0016
Data Collection Dates: February 2022 – November 2022

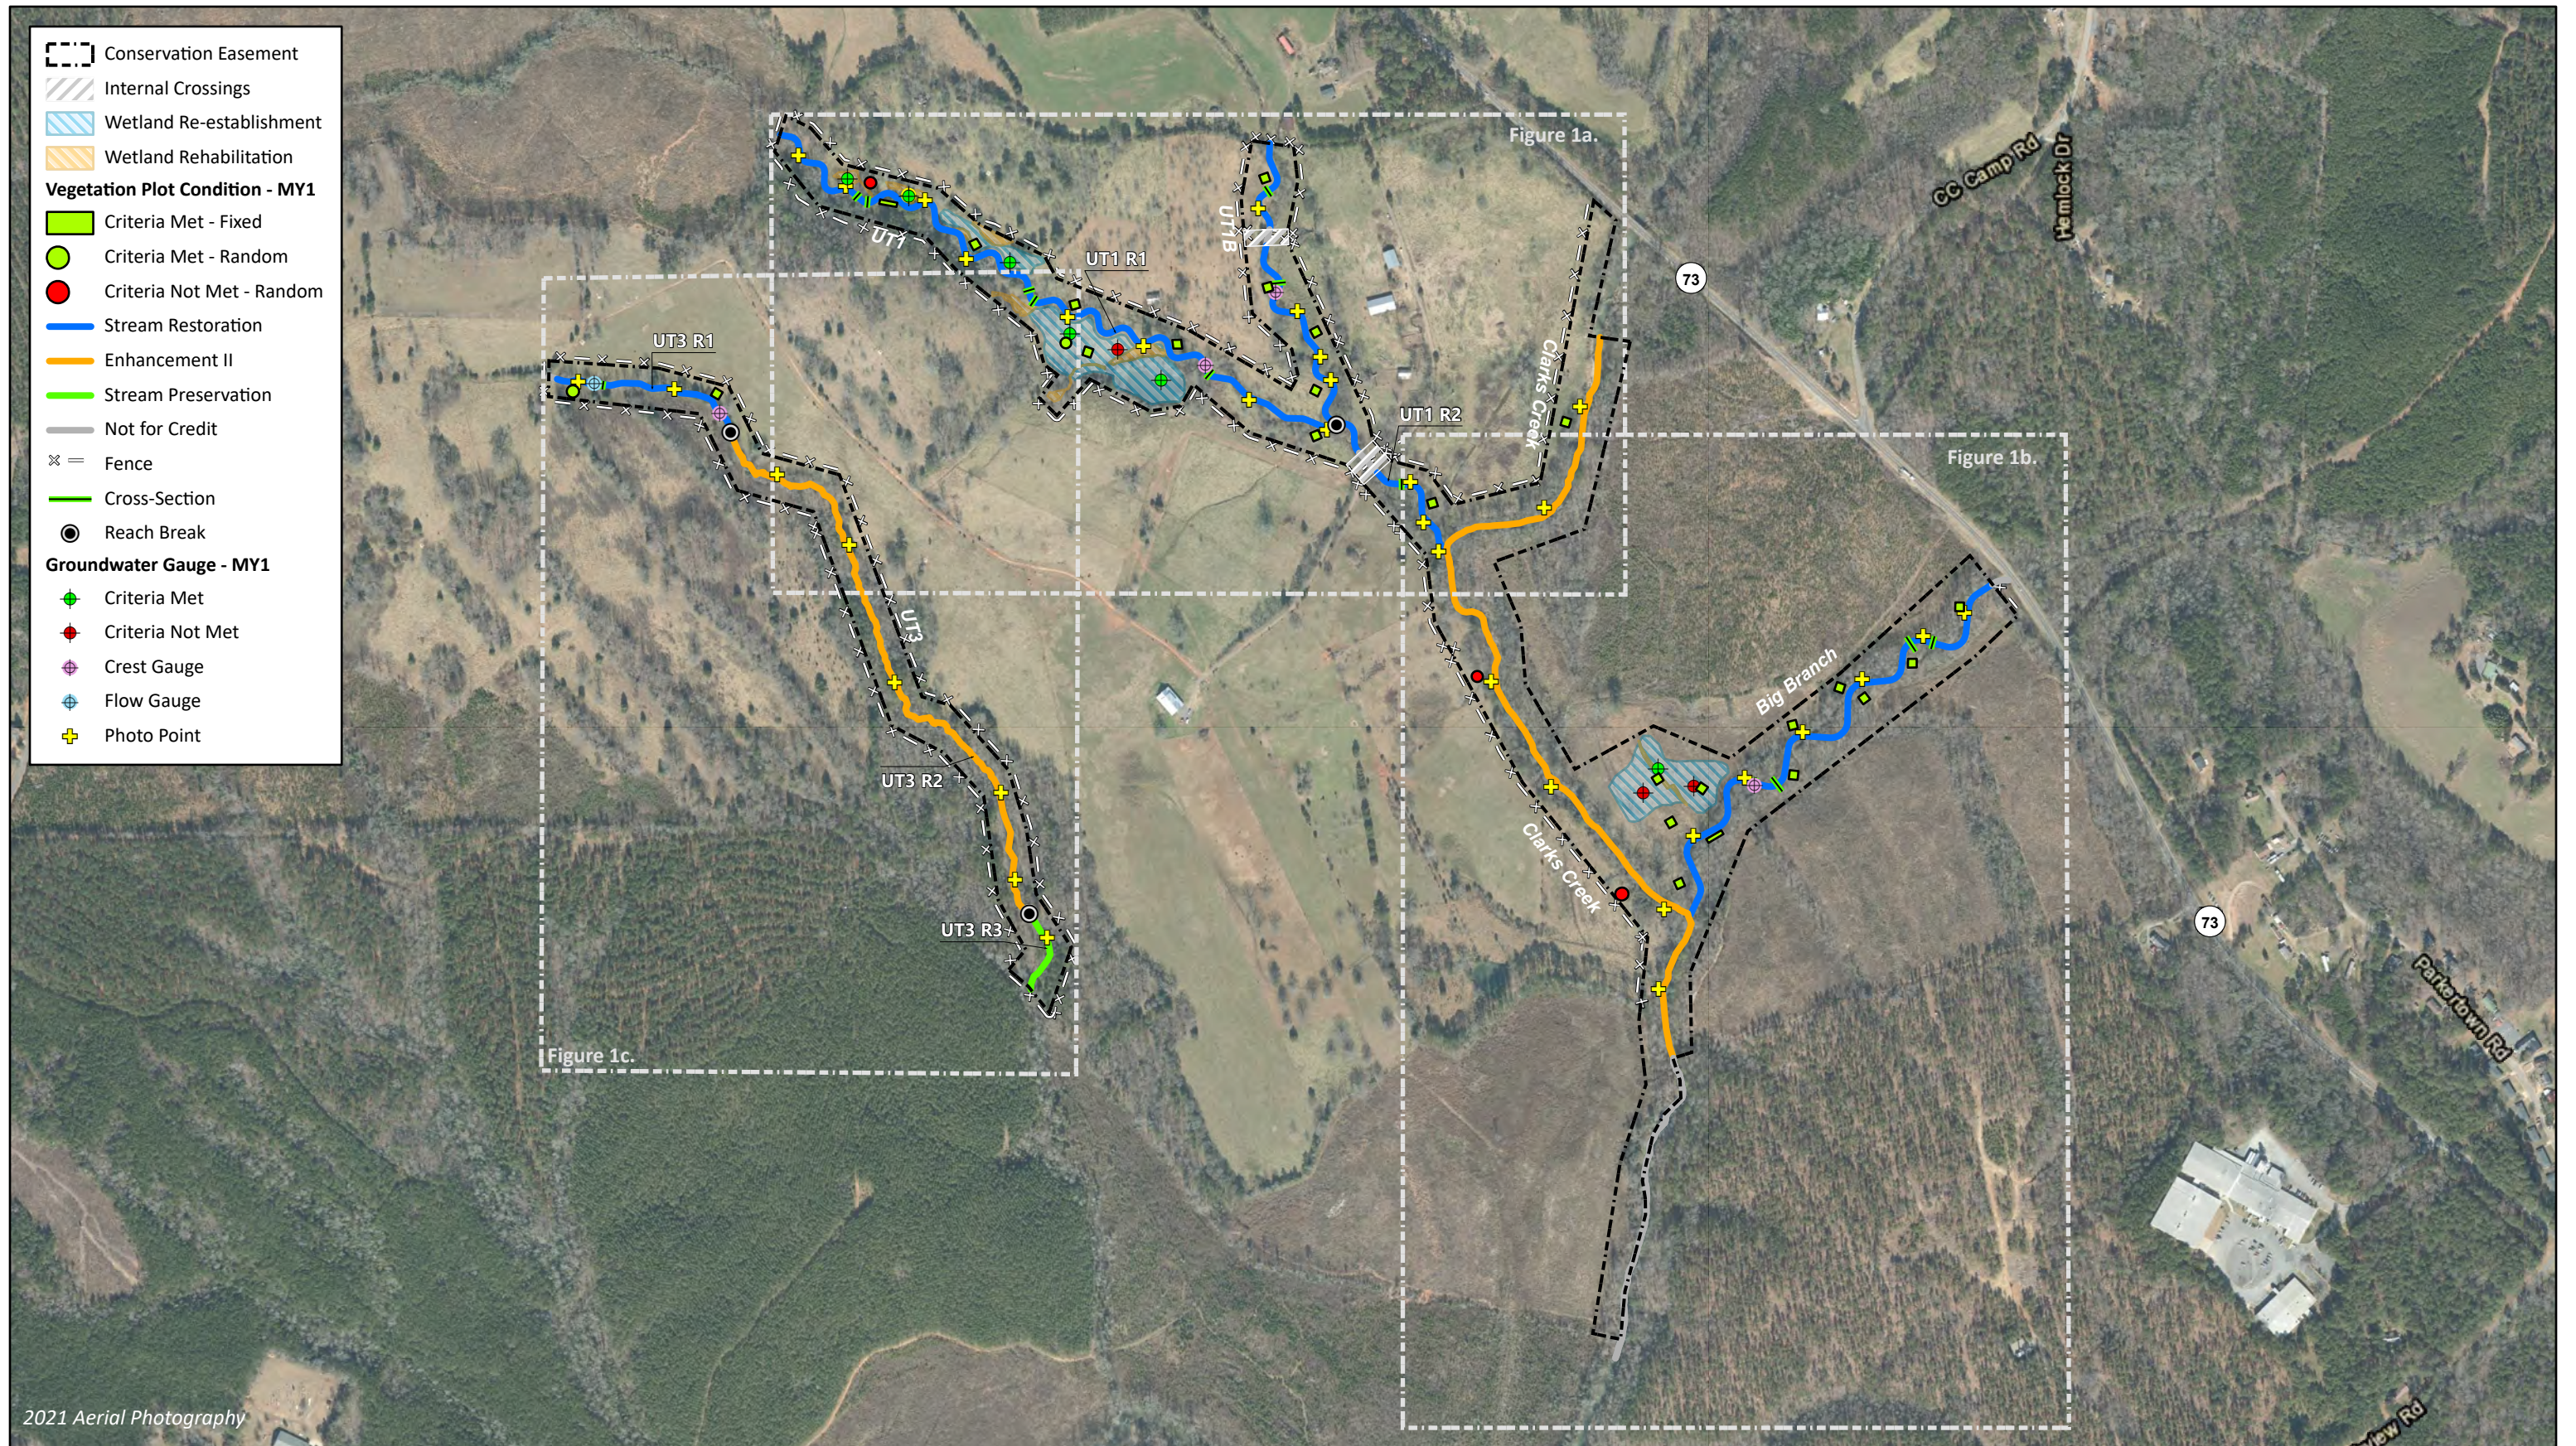
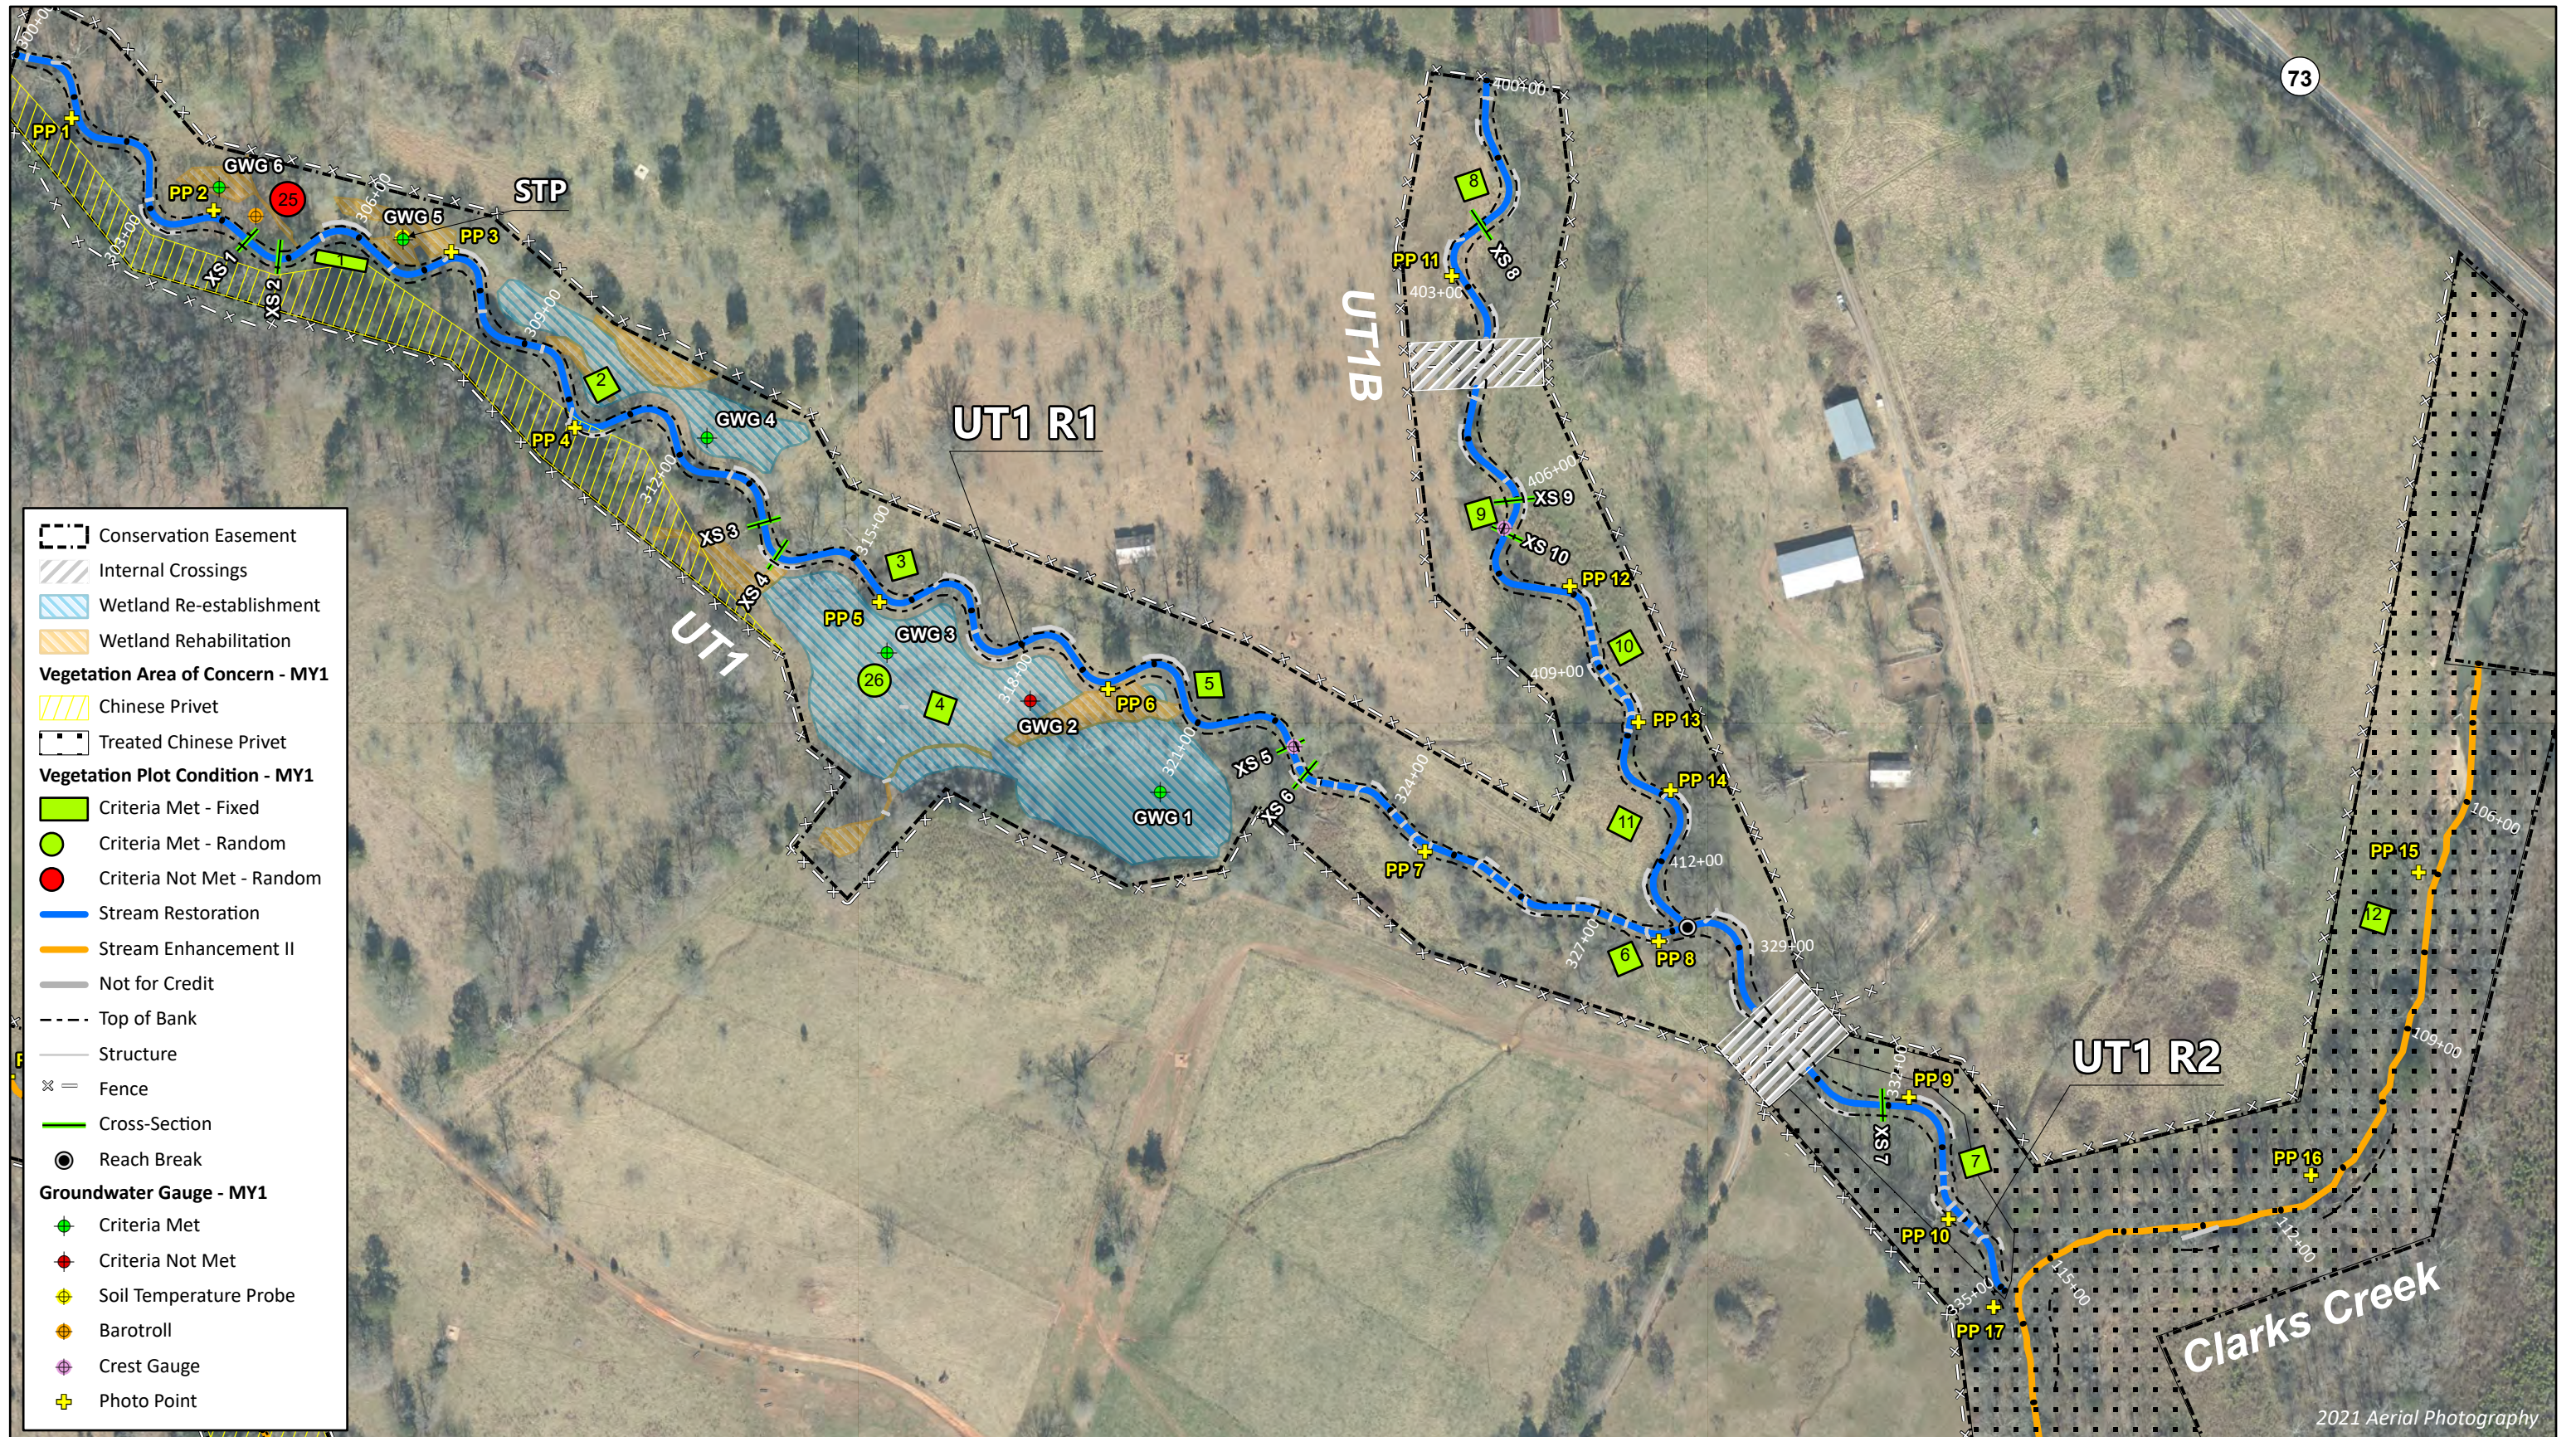
Figure 1. Current Condition Plan View
 Cross Creek Ranch Site
 DMS Project No. 100138
 Monitoring Year 1 - 2022

A visual assessment conducted on October 26, 2022, revealed that Chinese privet is present along portions of UT3 and UT1 (Figure 1a-b). A foliar chemical treatment will be applied to UT3 and UT1 during monitoring year 2 (MY2).

Dense Chinese privet (*Ligustrum sinense*) along Clarks Creek (Figure 1a-b) was removed mechanically in March 2022 on 19.57 acres. Initial removal was successful, with privet stem density greatly decreasing along Clarks Creek. Due to the nature of treating dense tracts of Chinese privet, addressing vegetation areas of concern will likely be a multi-year endeavor. Wildlands recognizes that multiple treatments are typically needed for effective invasive plant control. Previously treated areas will be re-treated with a foliar chemical treatment as necessary, and continue to be monitored in MY2. Refer to Appendix A for

the Vegetation Condition Assessment Table and Figures 1a-c for a mapped representation of previously removed Chinese privet on the Site, as well as areas to be treated in MY2.

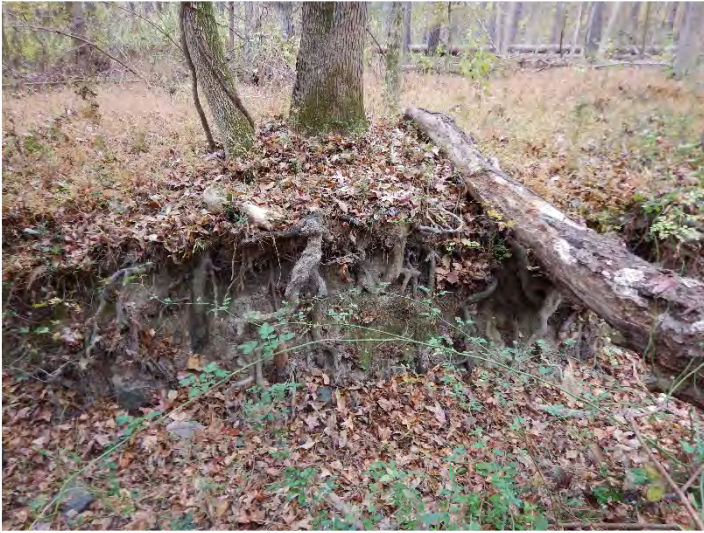
Photo Point 34 Bank Photos

PHOTO POINT 34 UT3 R2 – Right Bank (10/26/2022)
