**Cross Creek Stream Restoration
Year One Monitoring Report
Cumberland County, North Carolina**

NCEEP Project Number 105
SCO Number 01-05460-01
EEP Project Manager: Melonie Allen

December 2006

**CROSS CREEK STREAM RESTORATION
YEAR ONE MONITORING REPORT**

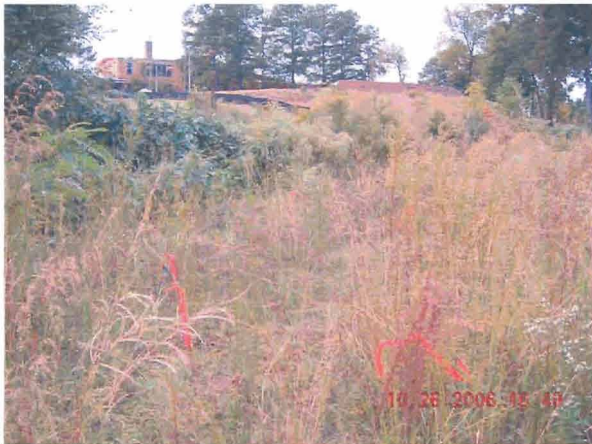
Vegetation Plot 103

VPA6. Invasive Species. Kudzu and Privet

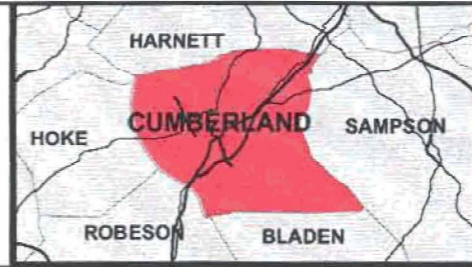
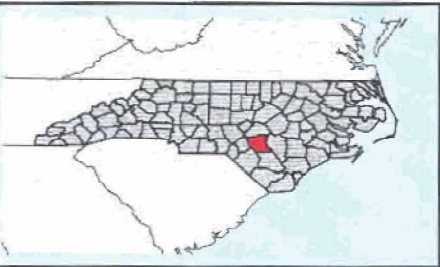
Appendix B-1
Stream Problem Areas
Plan View
 Cross Creek Stream Restoration Site
 Cumberland County, NC
 December 2006

During the initial Year 1 Monitoring, some bank scour was noted in a few locations and bar formation was noted on Little Cross Creek at station 11+00. The level spreader was also discovered functioning improperly and channelization erosion occurring immediately down-slope from the spreader. Specific problem areas are detailed in the following table.

Overall, the project is doing well with a few minor erosion areas and some areas of minimal vegetation. Repairs are recommended for the only major erosion area of the site, near Station 21+50. The other problem areas need to be watched and if the problems worsen over time, then solutions need to be discussed to assess the reason for the problem and potential options to fix the areas. Vegetative problem areas are described in Table VI and stream problem areas are described in Table IX.

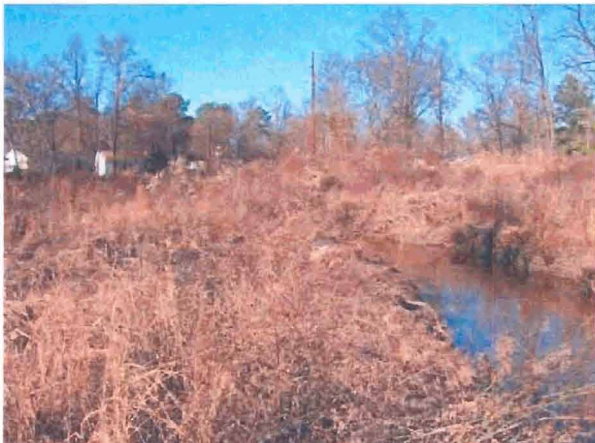
Cross-Section 5 (Station 15+30) Facing US

All of the cross sections appeared stable with little or no active bank erosion. Survey data collected during future monitoring periods may vary depending on actual rod placement and alignment; however, from this point forward this information should remain similar in overall appearance. It should be noted that there is an area of sever erosion occurring just downstream of XS-5 and may impact that cross section in the future.
