CROSS CREEK STREAM RESTORATION
MONITORING REPORT (YEAR 2 OF 5)

Cumberland County, North Carolina
NCEEP Project Number 105

Status of Plan: Final
Submission Date: March 2008

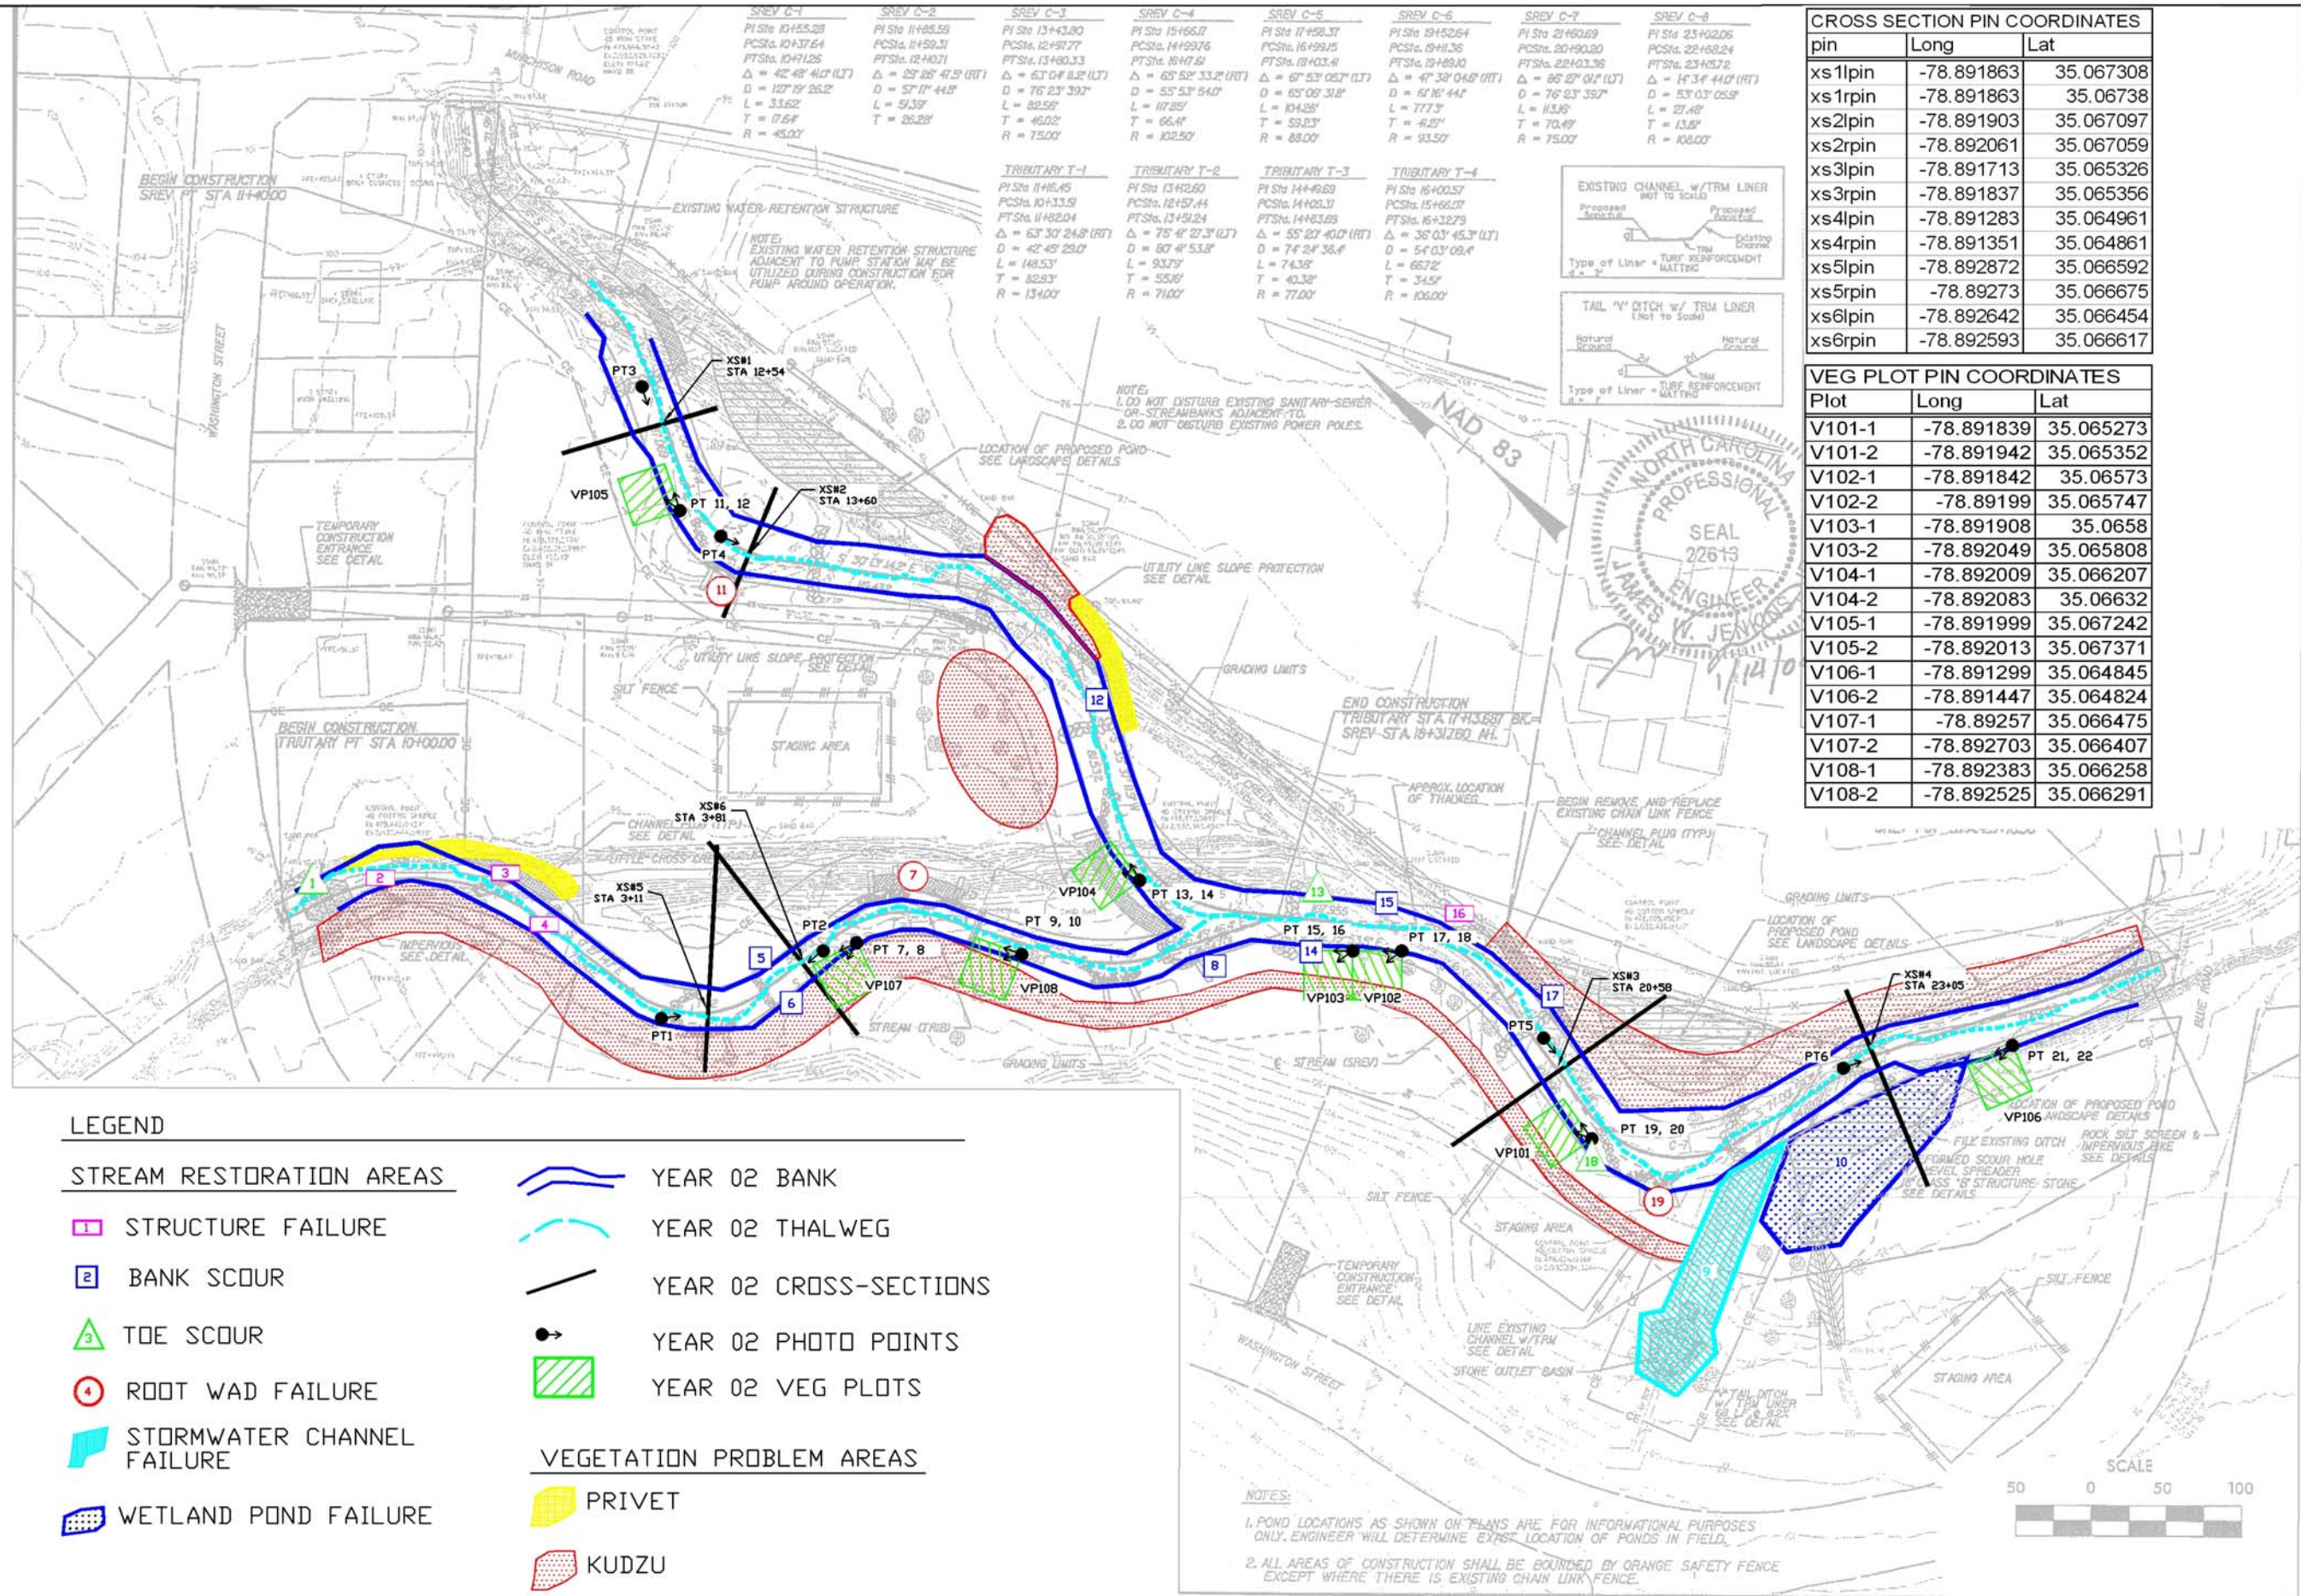
Appendix D. Current Condition Plan View

Please see the Integrated Current Condition Plan View in Appendix D for stream problem areas.

Exhibit Table B1. Stream Problem Areas Cross Creek Stream Restoration - EEP Project No. 105					
MAJOR PROBLEM AREAS					
Feature/Issue	Stream Reach	Station # / Range	Probable Cause	ID	Photo #
Stormwater Channel Failure	Cross Creek	~22+00	Channel is too small to handle flow	SP 9	1-3
Wetland Pond Failure	Cross Creek	~23+00	Failure of adjacent stormwater channel	SP 10	4-5
MINOR PROBLEM AREAS					
Feature/Issue	Stream Reach	Station # / Range	Probable Cause	ID	Photo #
Structure Failure	Little Cross Creek	10+50 - 11+80	improper design or installation	SP 2-4	6
	Cross Creek	19+25	improper design or installation	SP 16	
Rootwad Failure	Little Cross Creek	14+75	erosion around rootwad	SP 7	7
	Cross Creek	15+50	erosion around vane structure due to poor fill material at the former channel intersect	SP 11	
	Cross Creek	21+05	erosion around rootwad	SP 19	
Toe Scour	Little Cross Creek	10+20	scour from culvert outlet	SP 1	8
