# MONITORING YEAR 2 ANNUAL REPORT

## CROSS CREEK RANCH SITE

Montgomery County, NC

DMS Project No. 100138

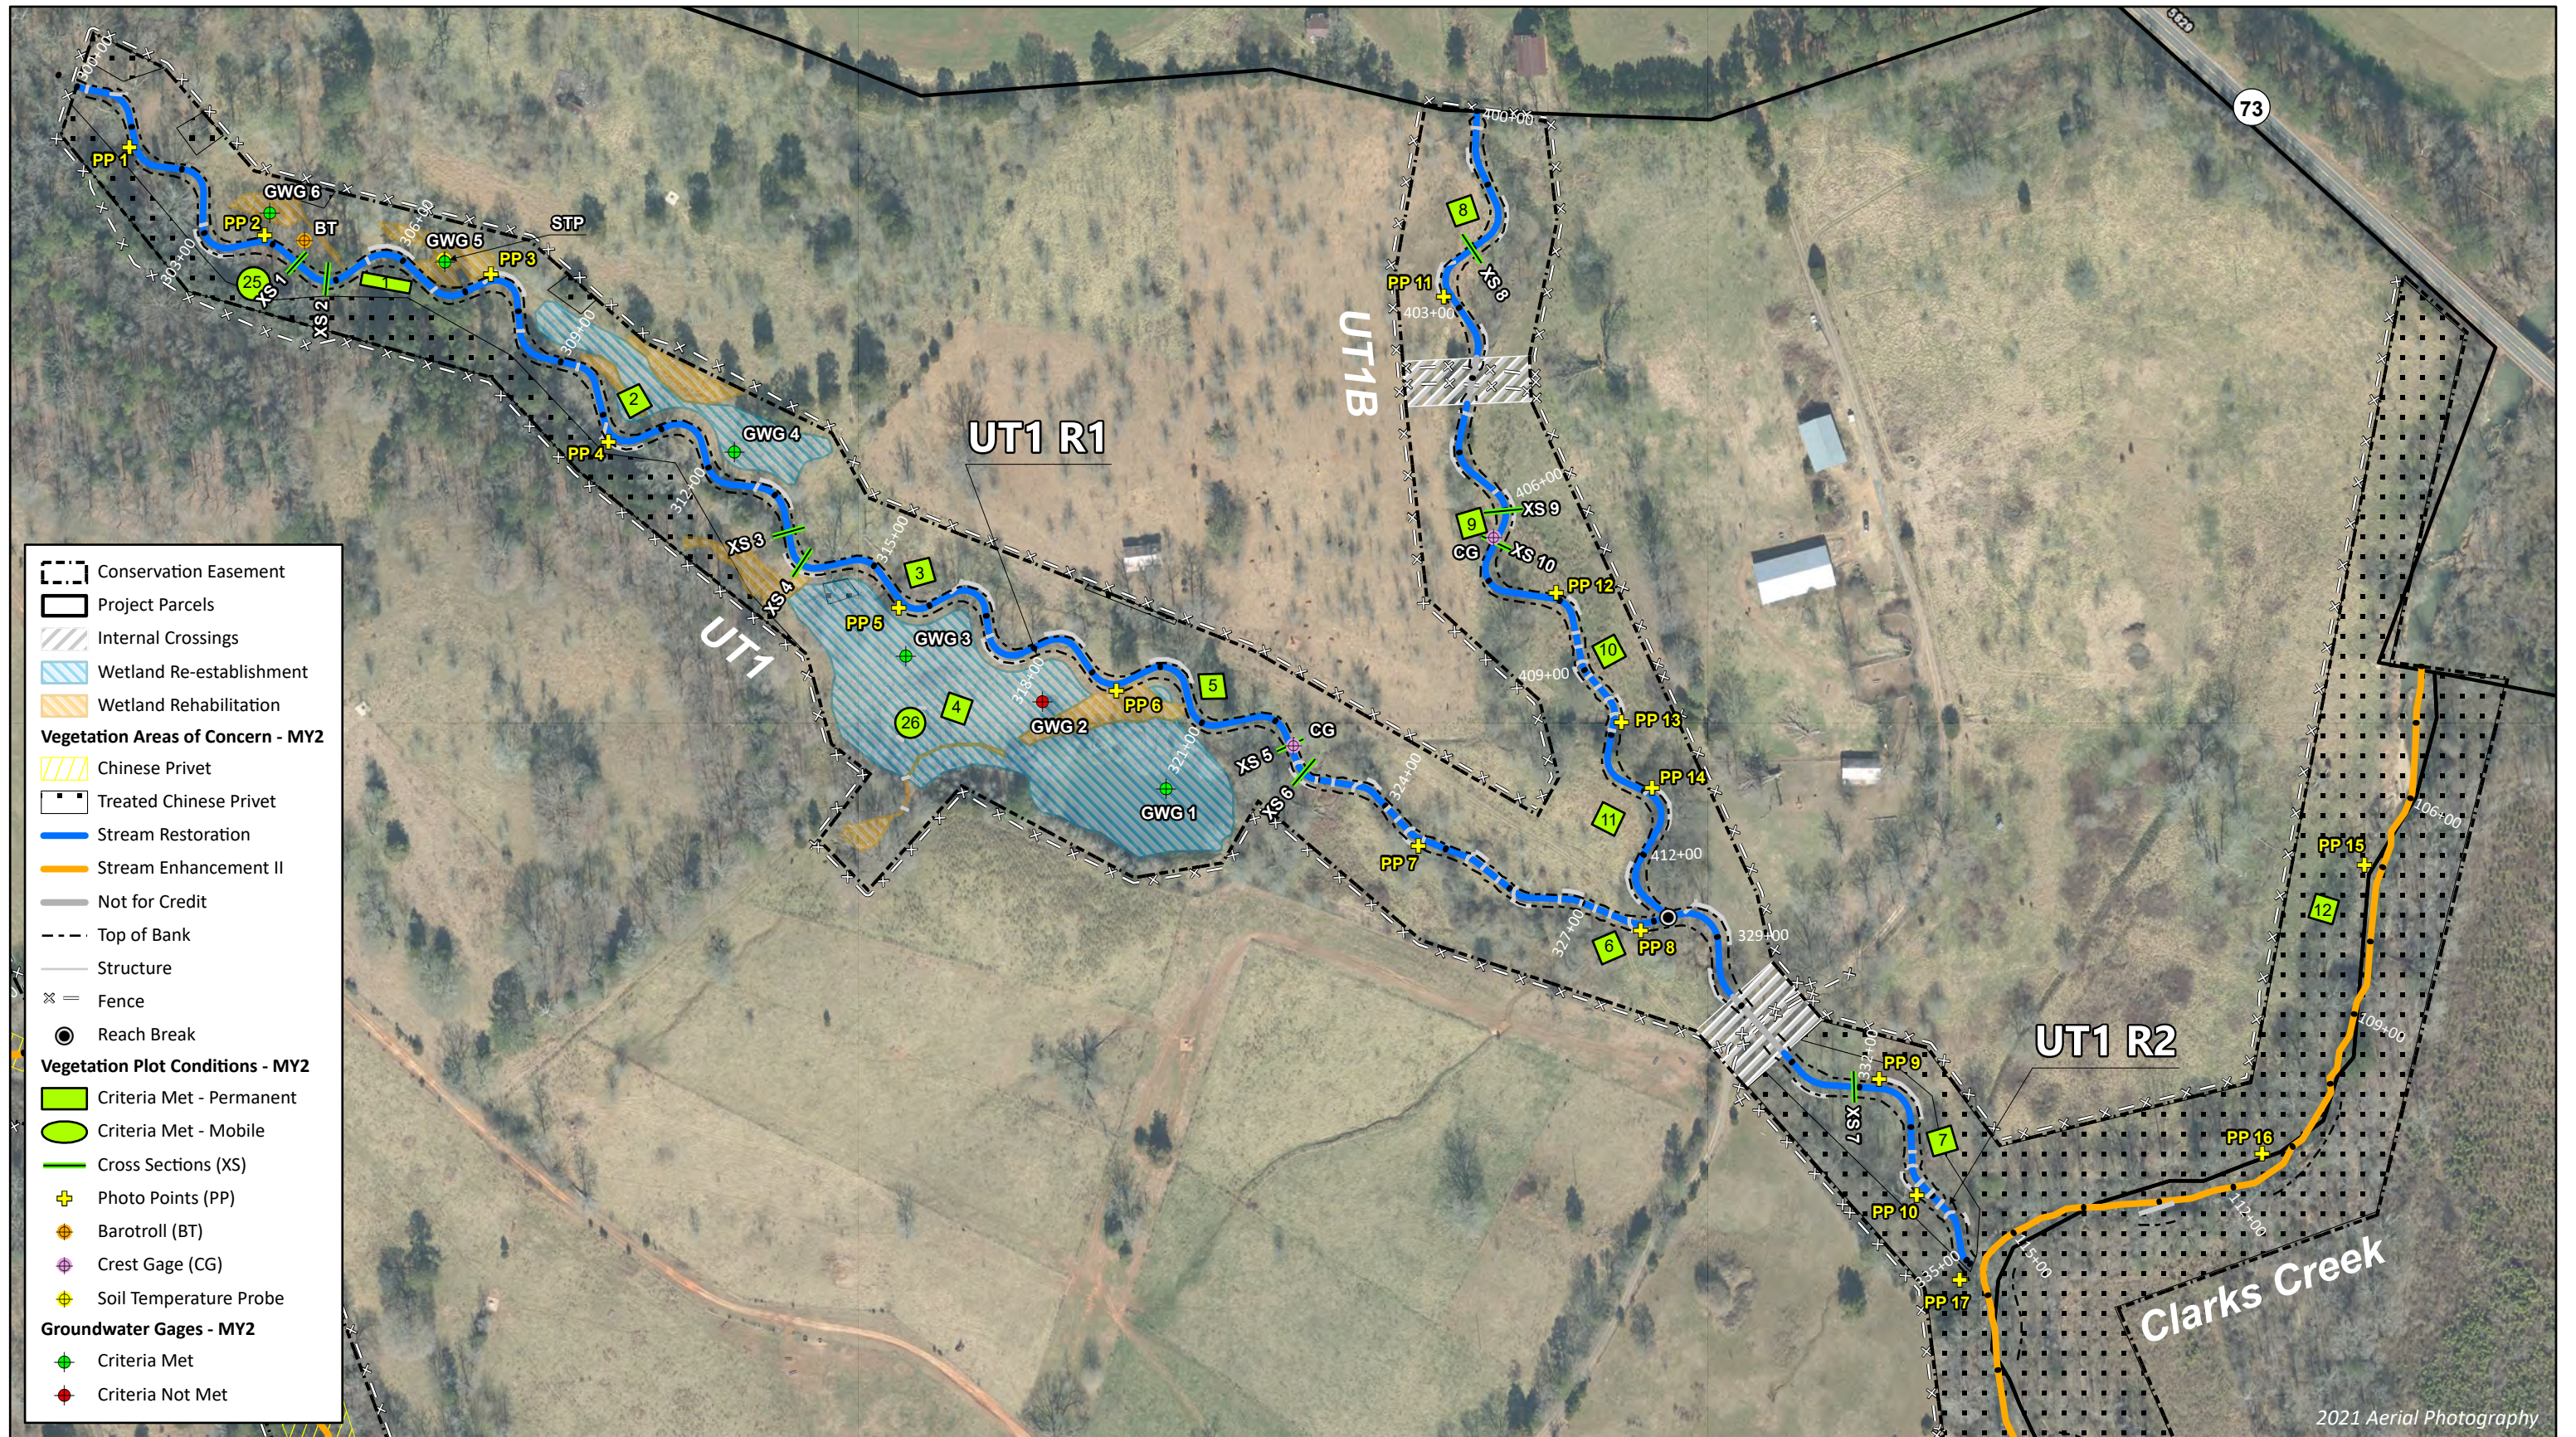
Figure 1a. Current Condition Plan View  
 Cross Creek Ranch Site  
 DMS Project No. 100138  
 Monitoring Year 2 - 2023  
 Montgomery County, NC

During construction, dense areas of Chinese privet (*Ligustrum sinense*) along Clarks Creek were mechanically removed; thereby, greatly decreasing the privet population along Clarks Creek. In February 2023, a foliar chemical treatment was applied to privet populations along UT1. This treatment was deemed successful when observed in the fall of 2023. These areas will be re-evaluated and re-treated, if necessary. In addition, previously untreated areas of dense Chinese privet along UT3 are scheduled for treatment in early 2024. Due to the nature of treating dense tracts of Chinese privet or any invasive species, Wildlands recognizes that multiple treatments are typically needed throughout the monitoring period for effective invasive plant control. Refer to the Vegetation Condition Assessment Table in Appendix A for information on additional vegetative areas of concern and to Figures 1a-c for the treated and untreated areas of Chinese privet.

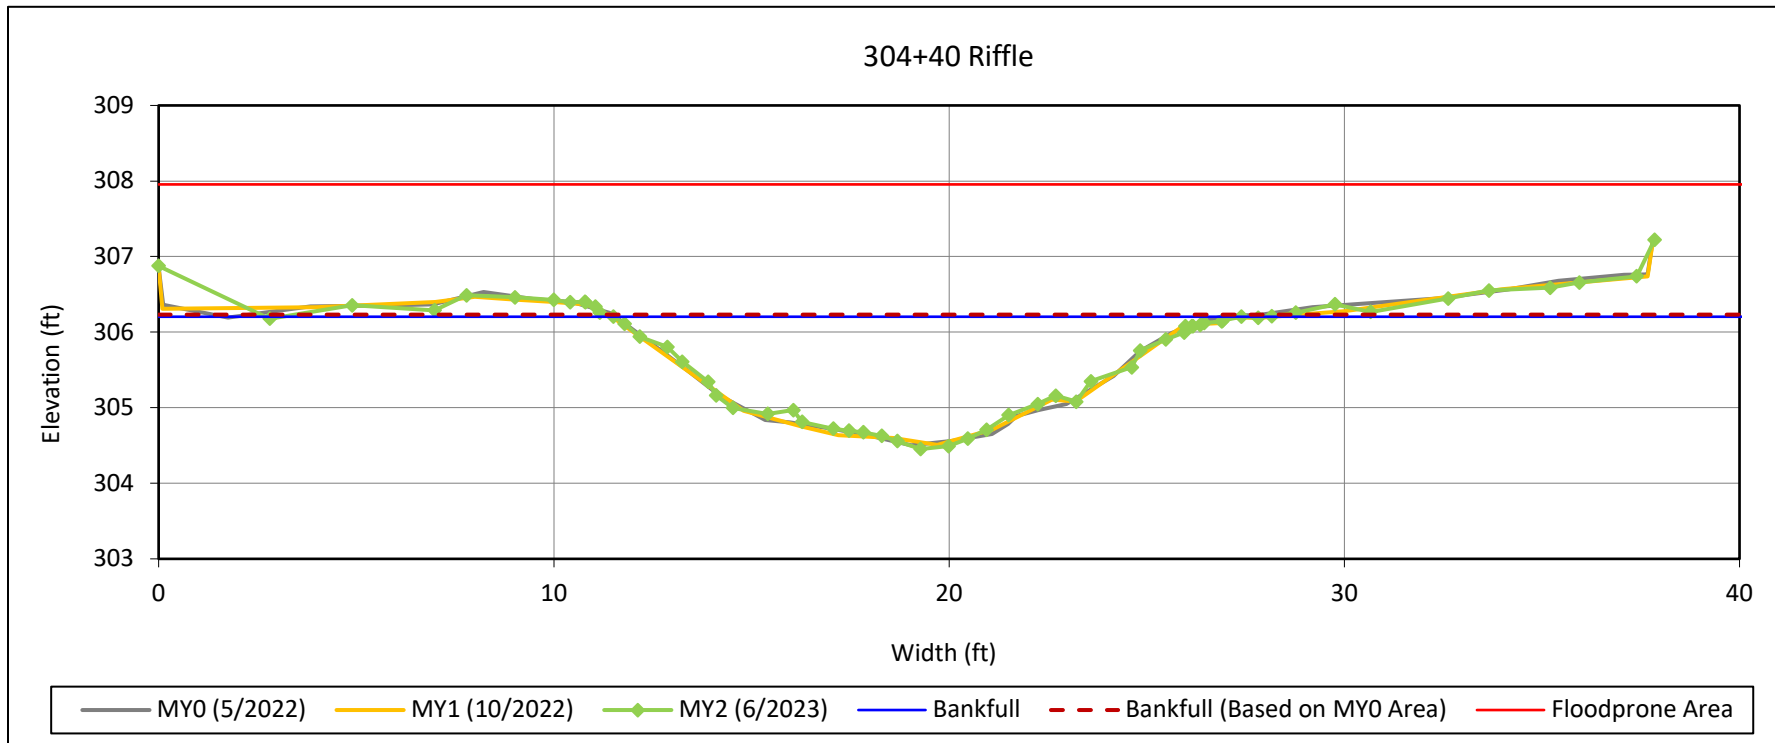
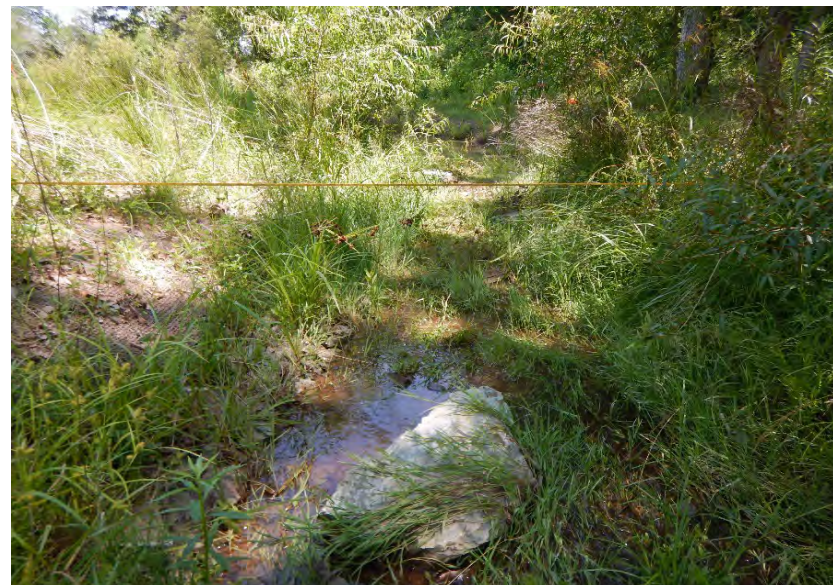
#### Cross-Section 1 - UT1 Reach 1

15.8	x-section area (ft.sq.)
15.9	width (ft)
1.0	mean depth (ft)
1.8	max depth (ft)
16.6	wetted perimeter (ft)
0.9	hydraulic radius (ft)
16.0	width-depth ratio
37.9	W flood prone area (ft)
2.4	entrenchment ratio
1.0	low bank height ratio

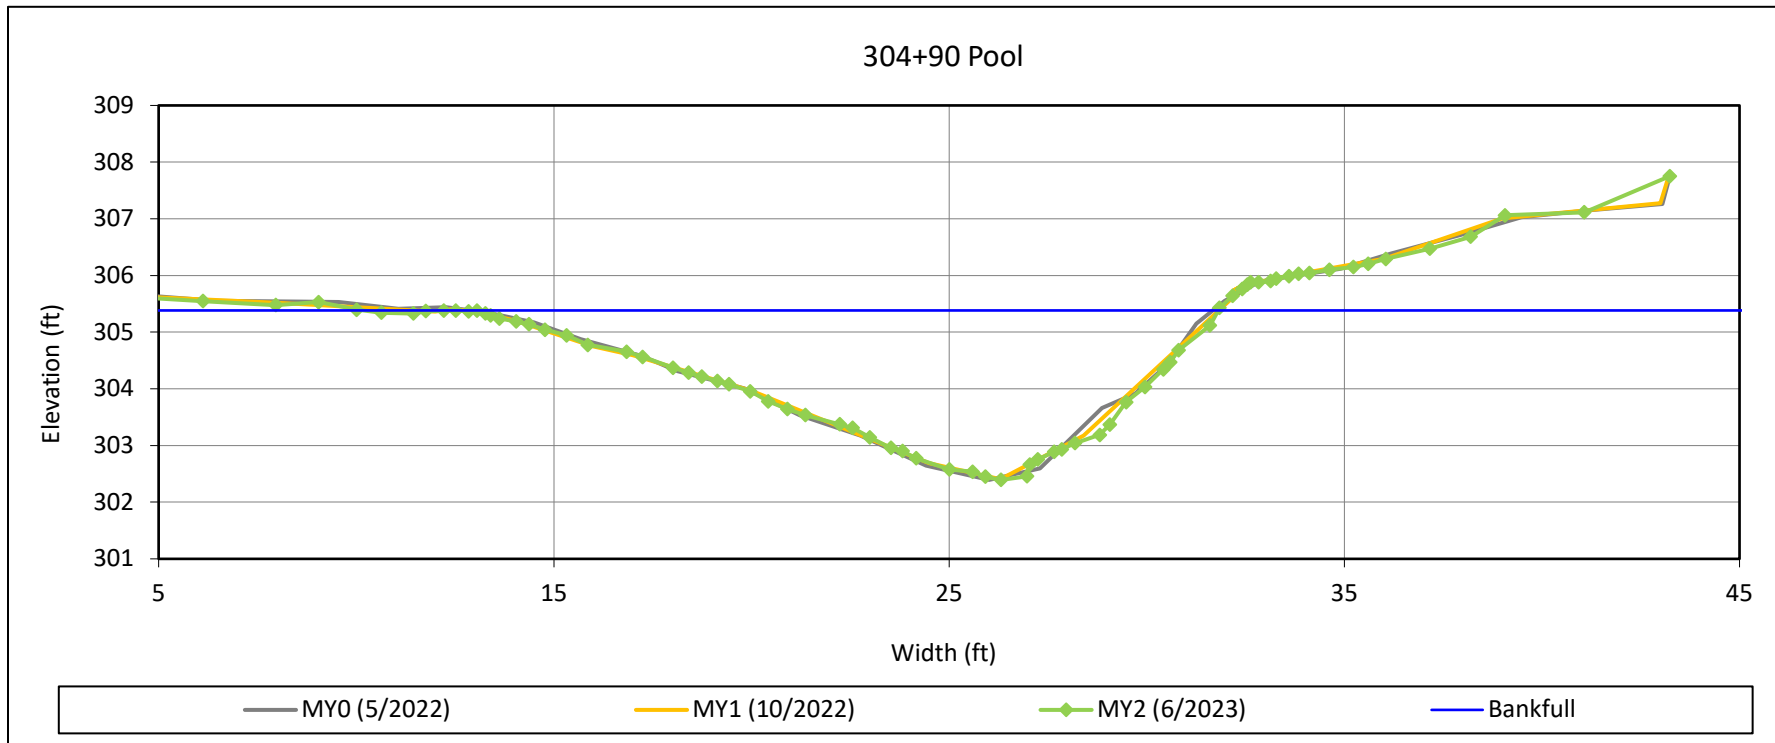
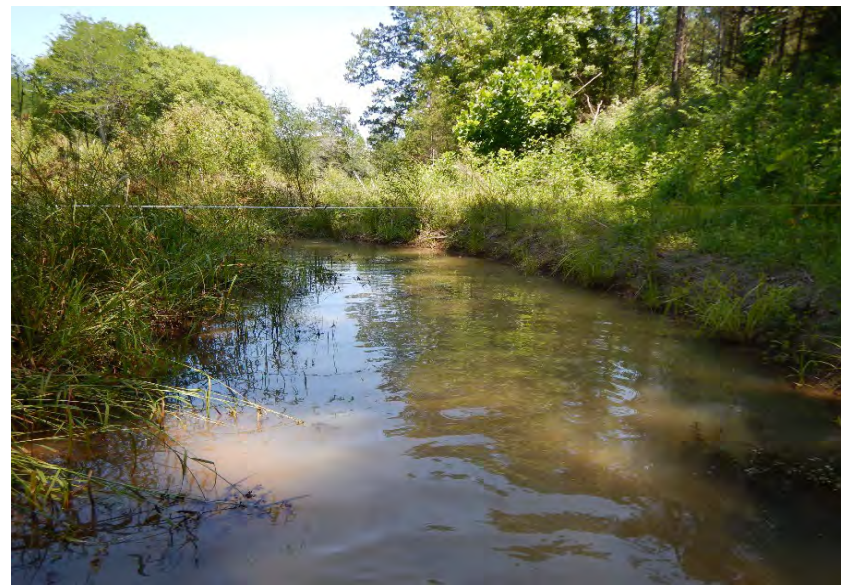
#### Cross-Section 2 - UT1 Reach 1

29.1	x-section area (ft.sq.)
18.7	width (ft)
1.6	mean depth (ft)
3.0	max depth (ft)
20.1	wetted perimeter (ft)
1.4	hydraulic radius (ft)
12.1	width-depth ratio

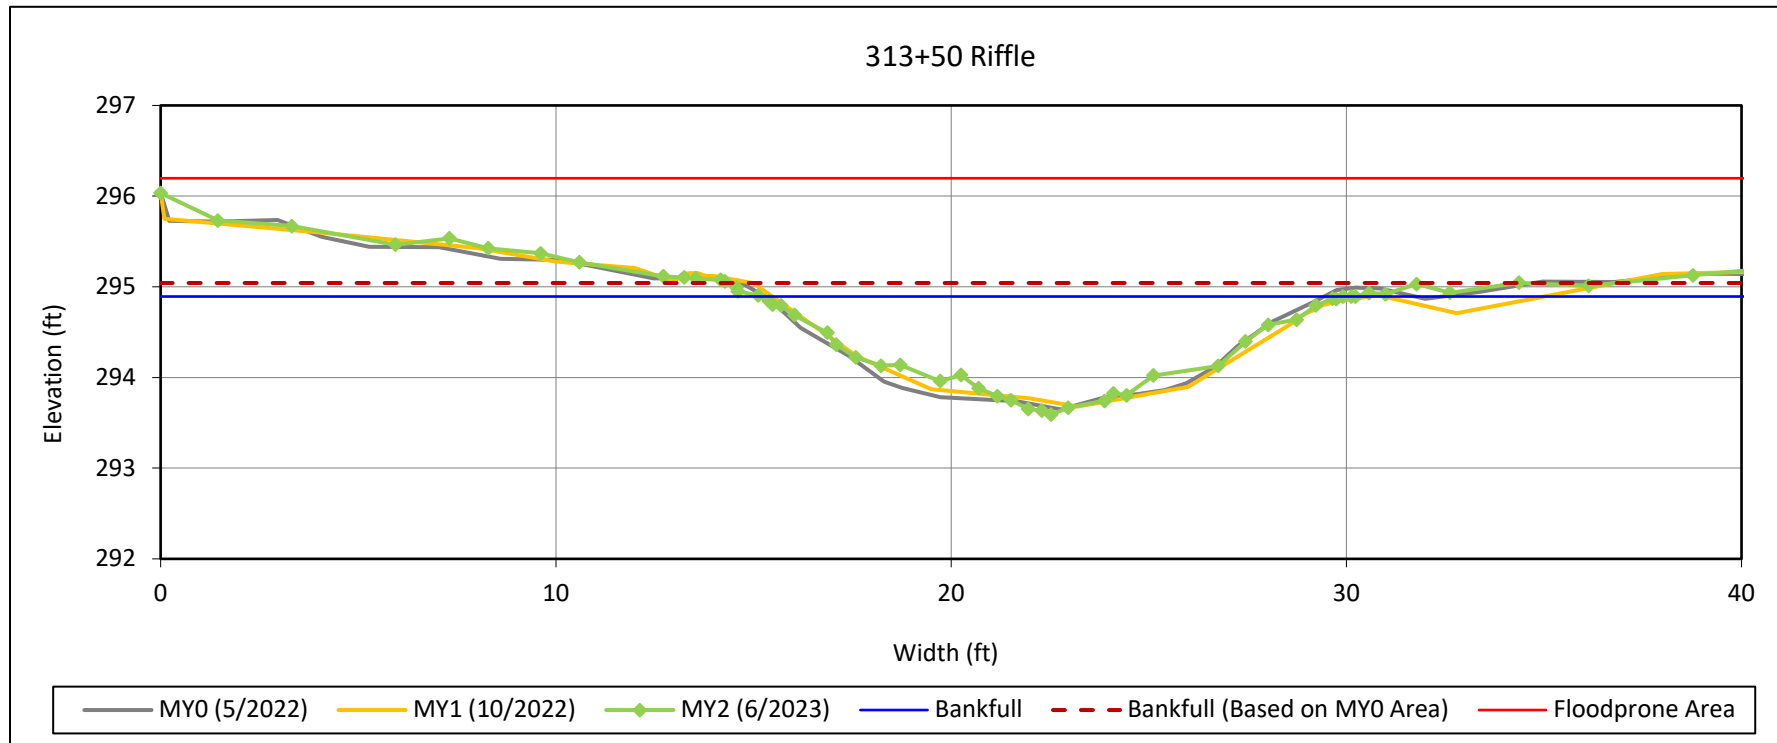
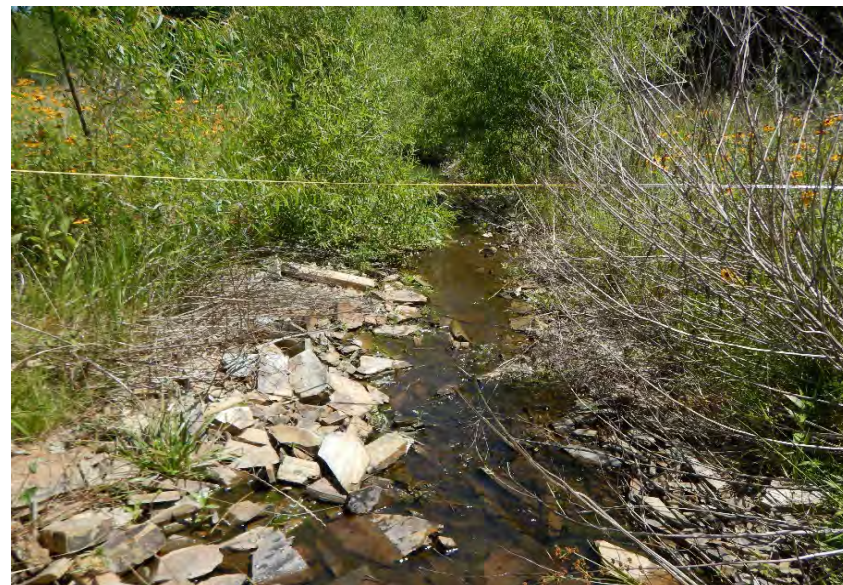
#### Cross-Section 3 - UT1 Reach 1

10.7	x-section area (ft.sq.)
14.8	width (ft)
0.7	mean depth (ft)
1.3	max depth (ft)
15.1	wetted perimeter (ft)
0.7	hydraulic radius (ft)
20.4	width-depth ratio
43.6	W flood prone area (ft)
3.0	entrenchment ratio
0.9	low bank height ratio

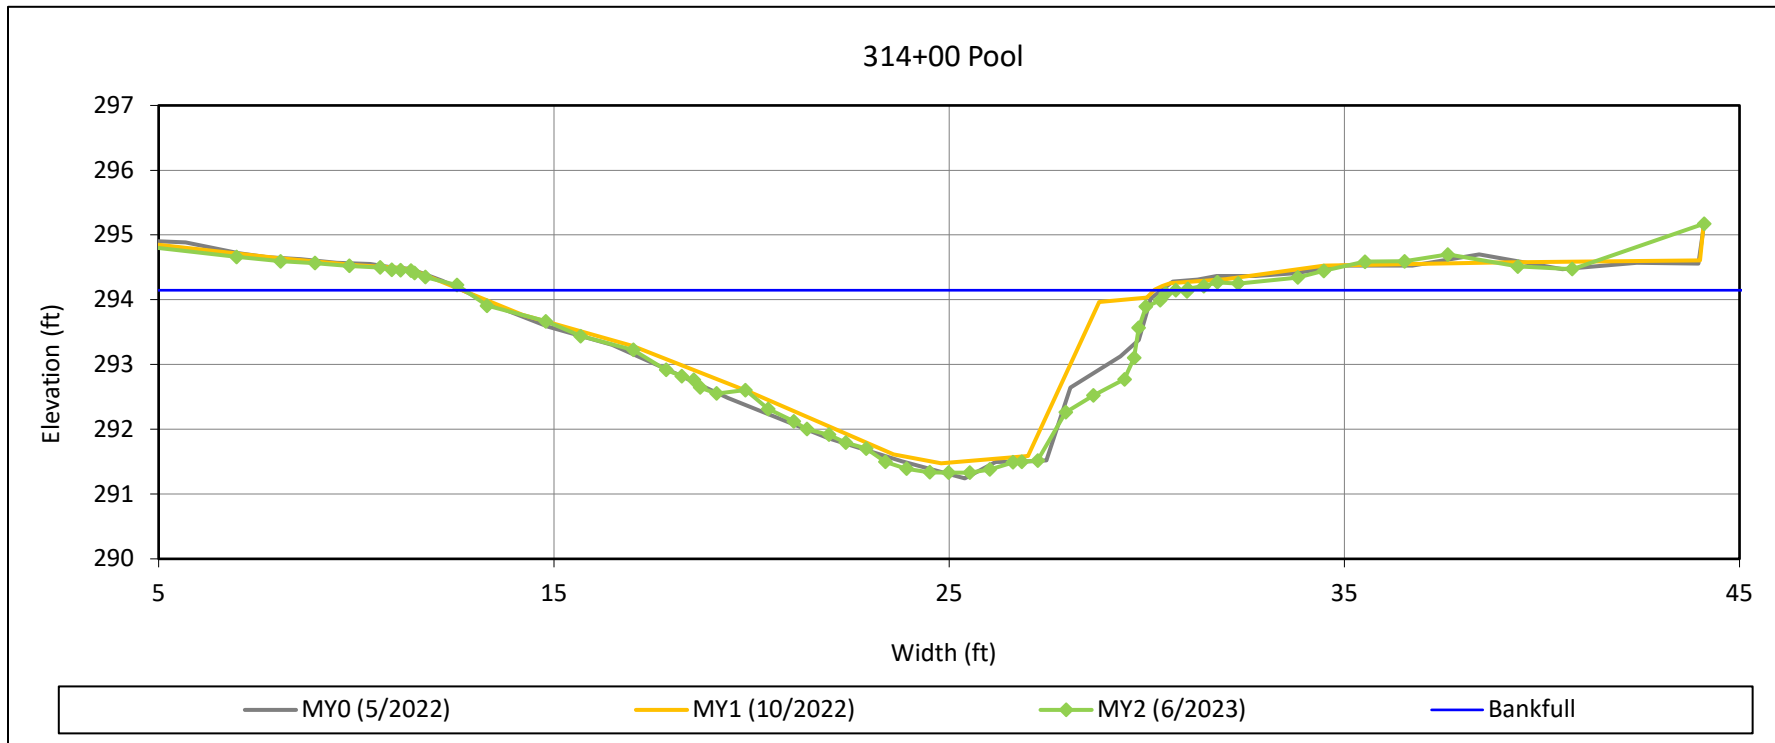
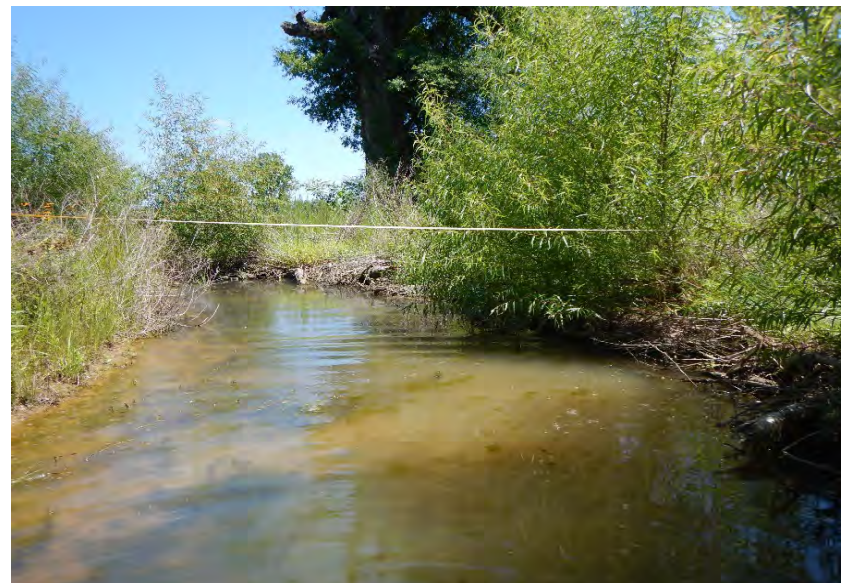
#### Cross-Section 4 - UT1 Reach 1

28.8	x-section area (ft.sq.)
18.0	width (ft)
1.6	mean depth (ft)
2.8	max depth (ft)
19.6	wetted perimeter (ft)
1.5	hydraulic radius (ft)
11.3	width-depth ratio

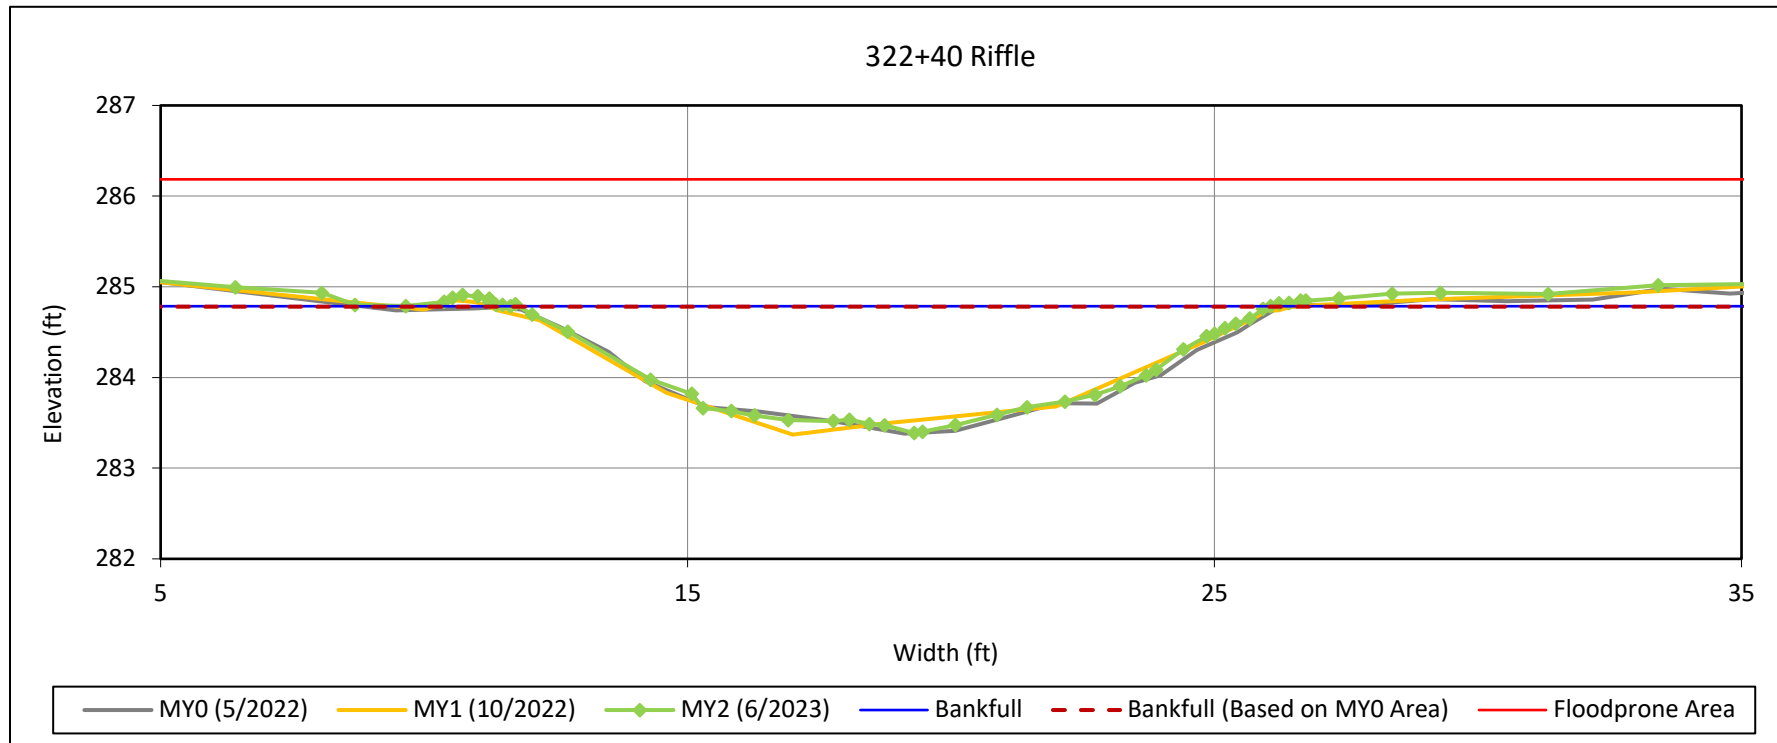
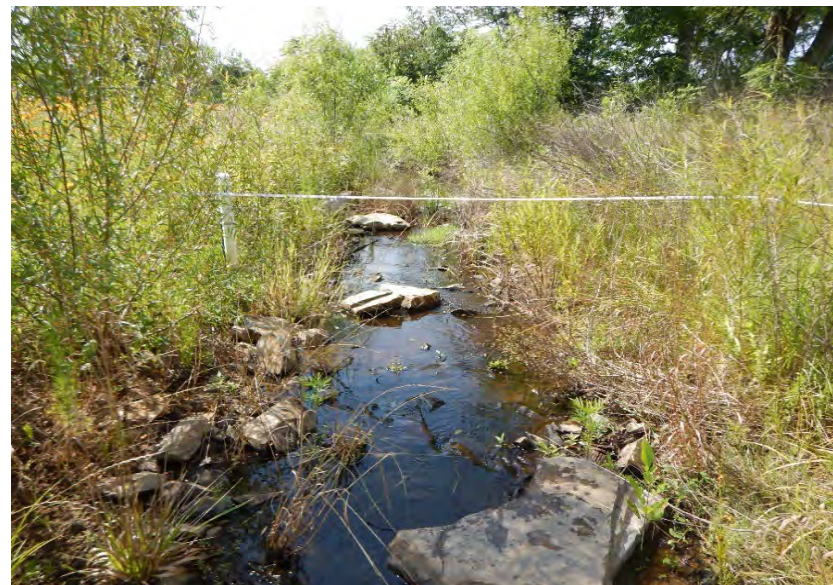
#### Cross-Section 5 - UT1 Reach 1

12.7	x-section area (ft.sq.)
14.3	width (ft)
0.9	mean depth (ft)
1.4	max depth (ft)
14.7	wetted perimeter (ft)
0.9	hydraulic radius (ft)
16.1	width-depth ratio
38.3	W flood prone area (ft)
2.7	entrenchment ratio
1.0	low bank height ratio

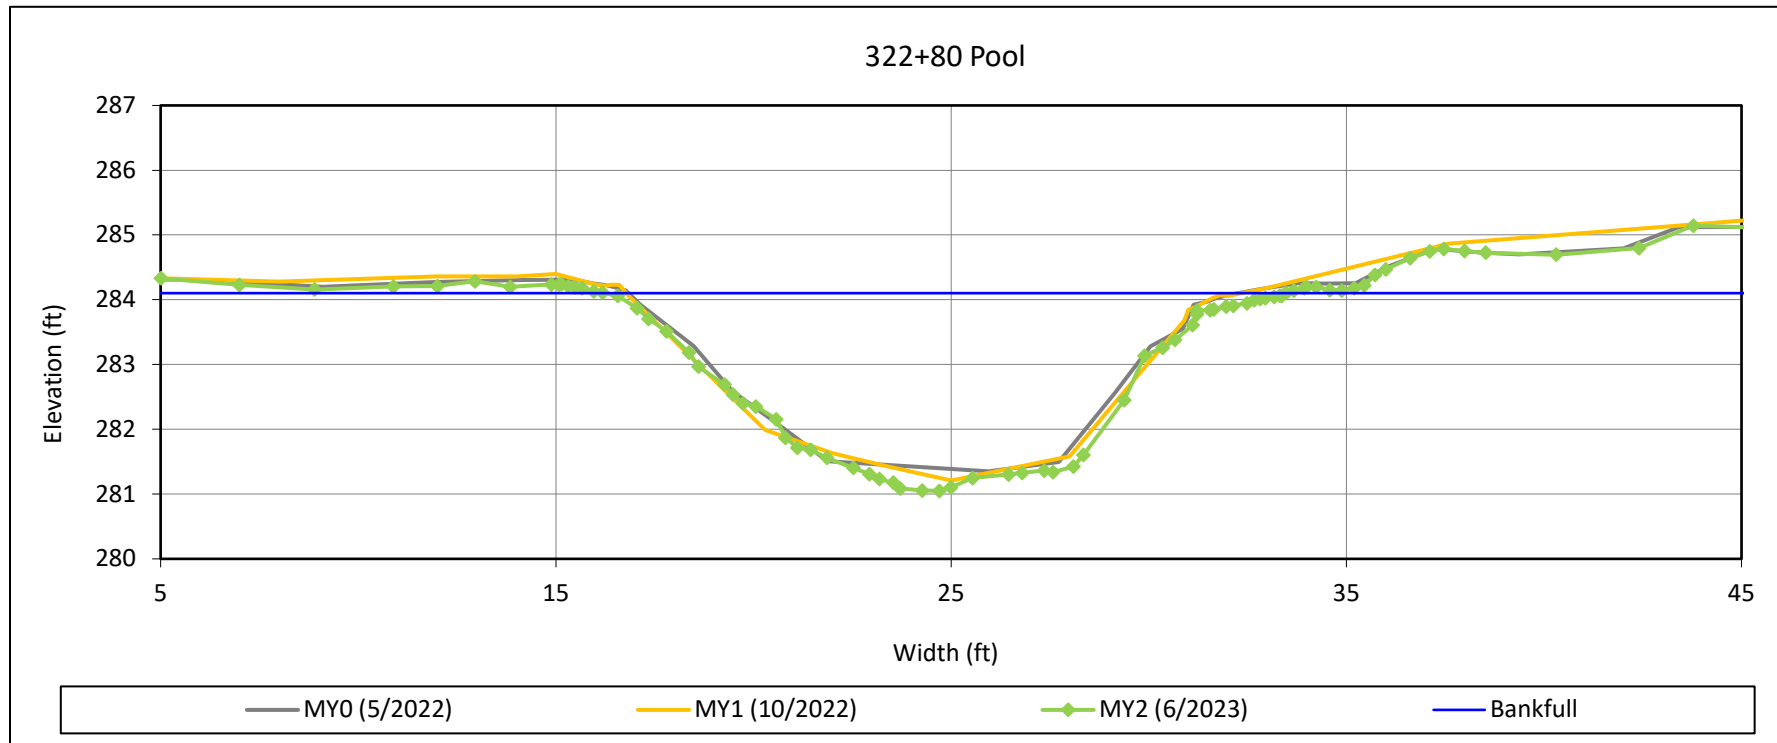
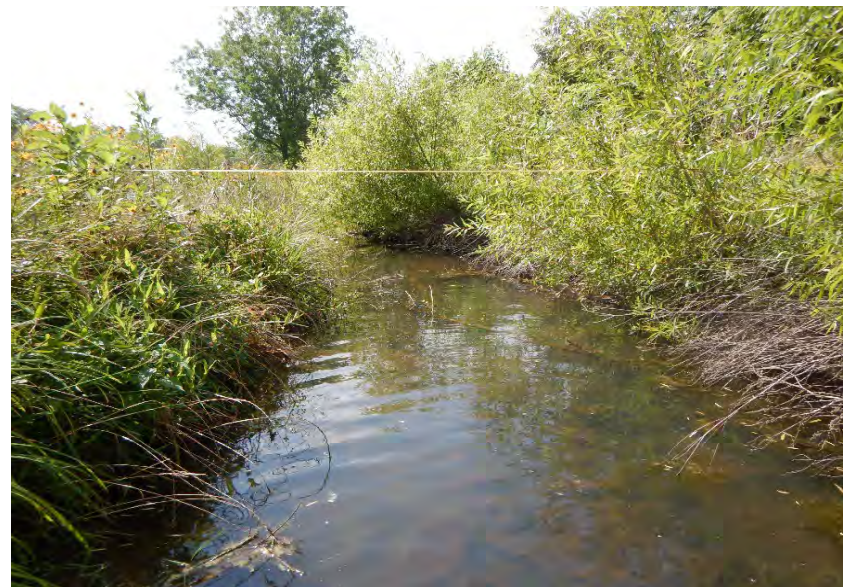
#### Cross-Section 6 - UT1 Reach 1

29.7	x-section area (ft.sq.)
17.2	width (ft)
1.7	mean depth (ft)
3.1	max depth (ft)
19.0	wetted perimeter (ft)
1.6	hydraulic radius (ft)
10.0	width-depth ratio

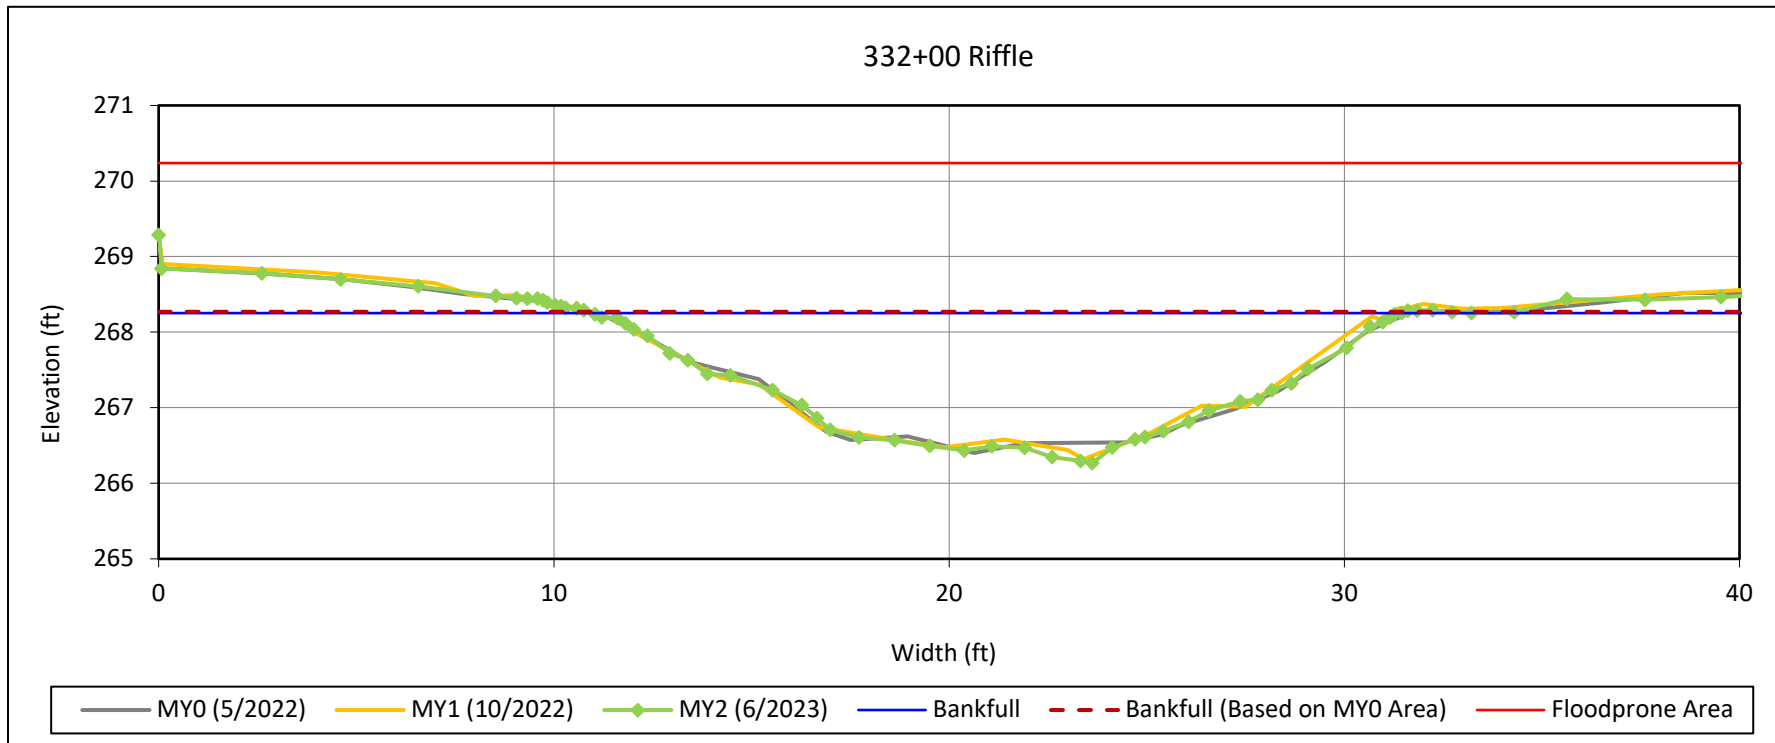
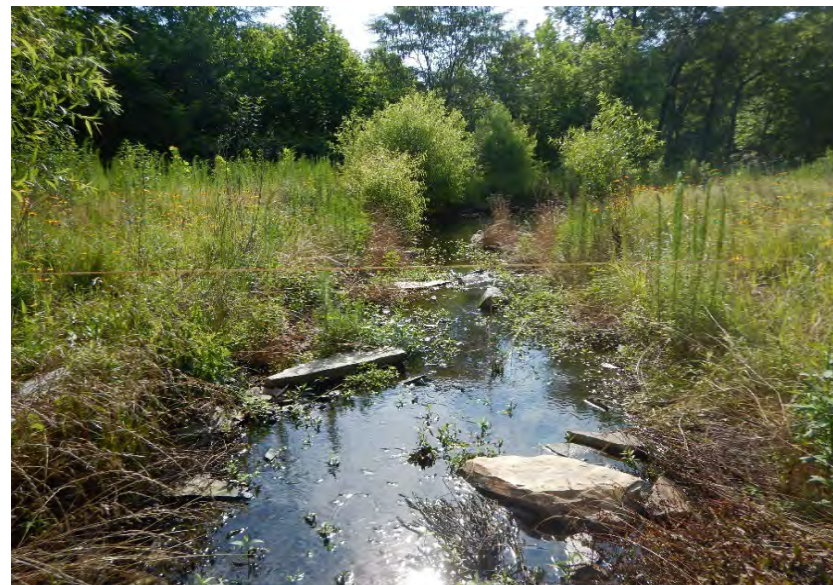
#### Cross-Section 7 - UT1 Reach 2

24.3	x-section area (ft.sq.)
20.5	width (ft)
1.2	mean depth (ft)
2.0	max depth (ft)
21.1	wetted perimeter (ft)
1.2	hydraulic radius (ft)
17.3	width-depth ratio
41.3	W flood prone area (ft)
2.0	entrenchment ratio
1.0	low bank height ratio

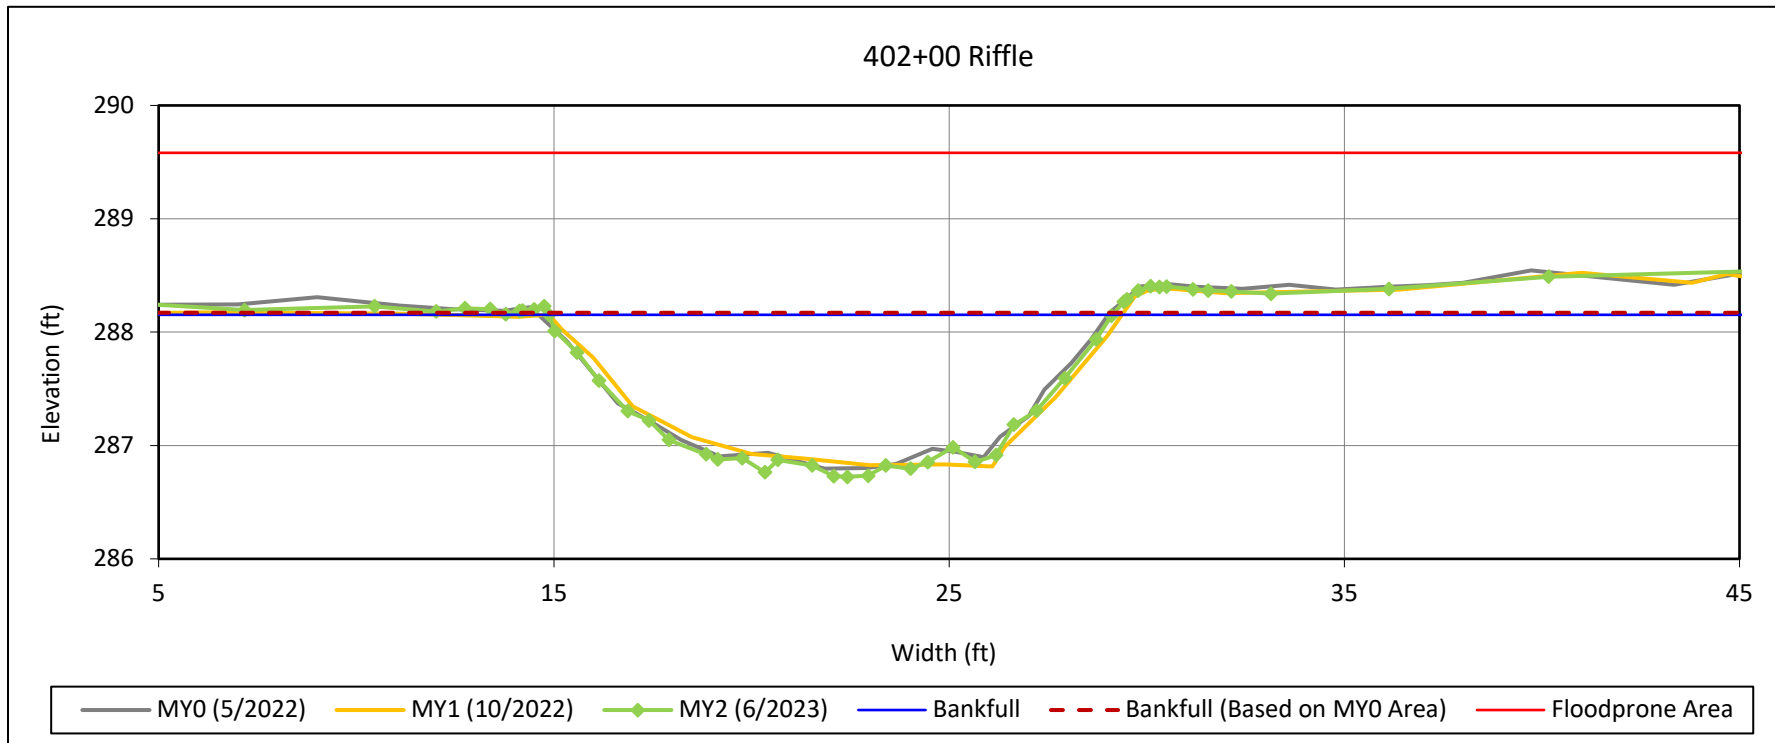
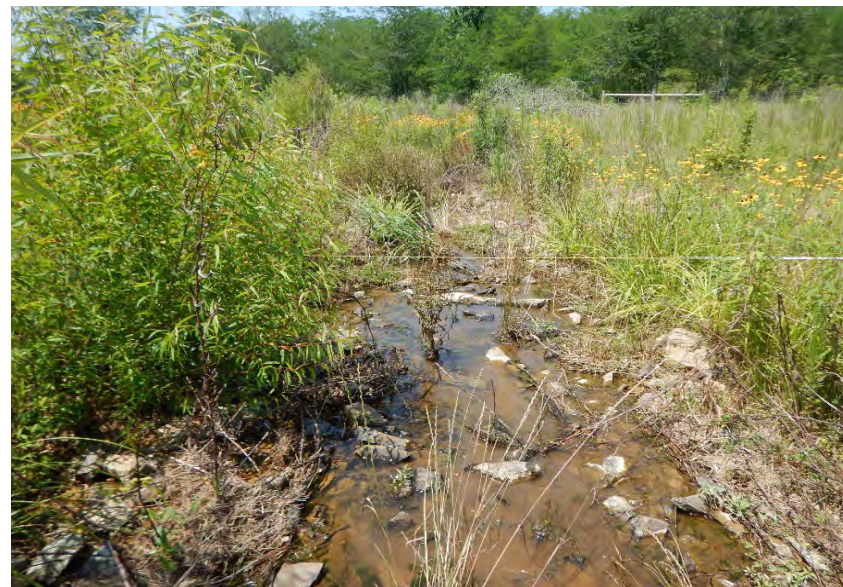
#### Cross-Section 8 - UT1B

14.5	x-section area (ft.sq.)
14.3	width (ft)
1.0	mean depth (ft)
1.4	max depth (ft)
14.8	wetted perimeter (ft)
1.0	hydraulic radius (ft)
14.0	width-depth ratio
45.5	W flood prone area (ft)
3.2	entrenchment ratio
1.0	low bank height ratio

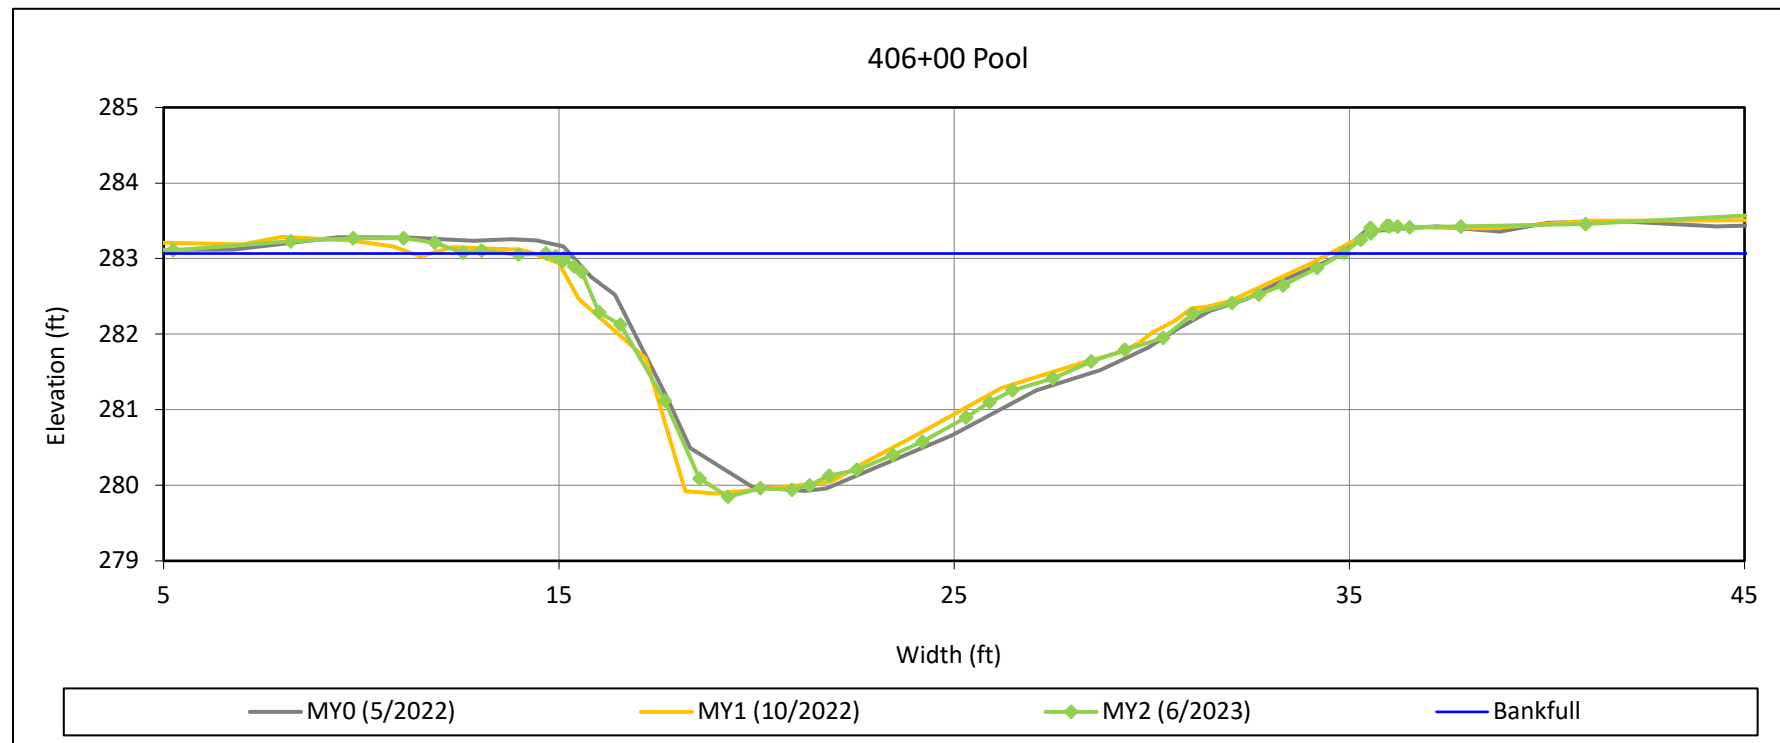
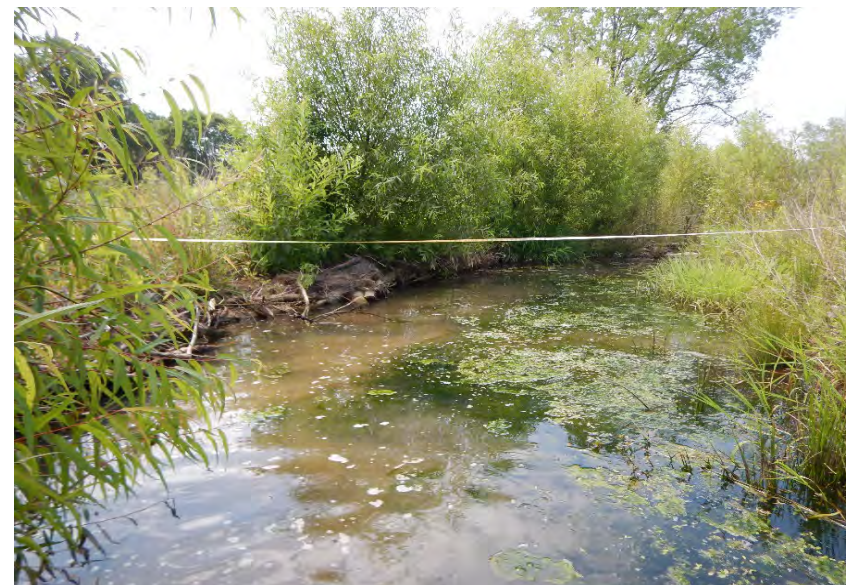
#### Cross-Section 9 - UT1B

34.2	x-section area (ft.sq.)
20.2	width (ft)
1.7	mean depth (ft)
3.2	max depth (ft)
21.8	wetted perimeter (ft)
1.6	hydraulic radius (ft)
11.9	width-depth ratio

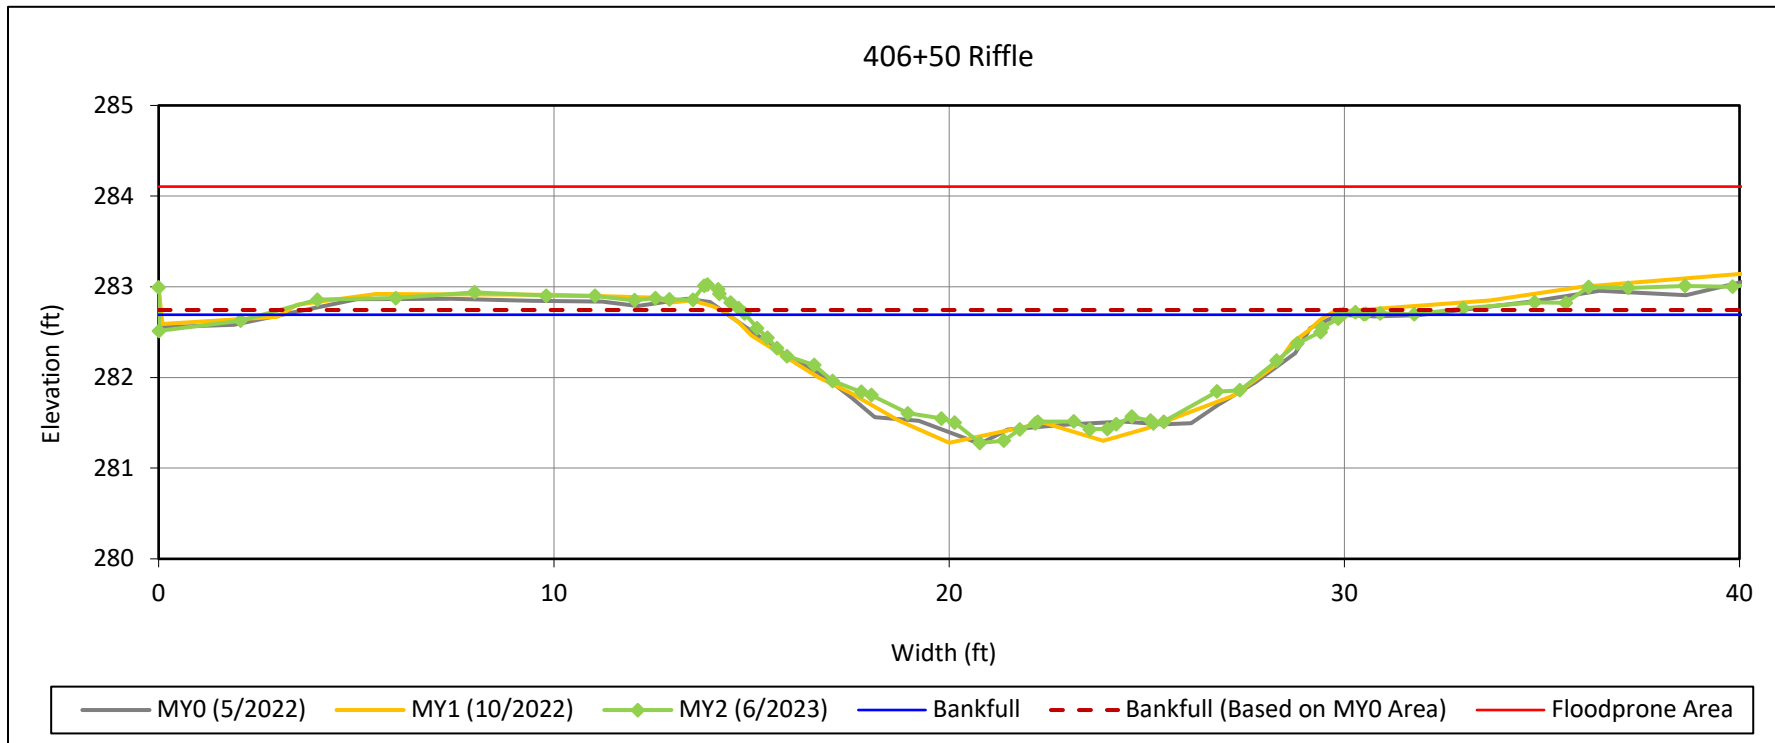
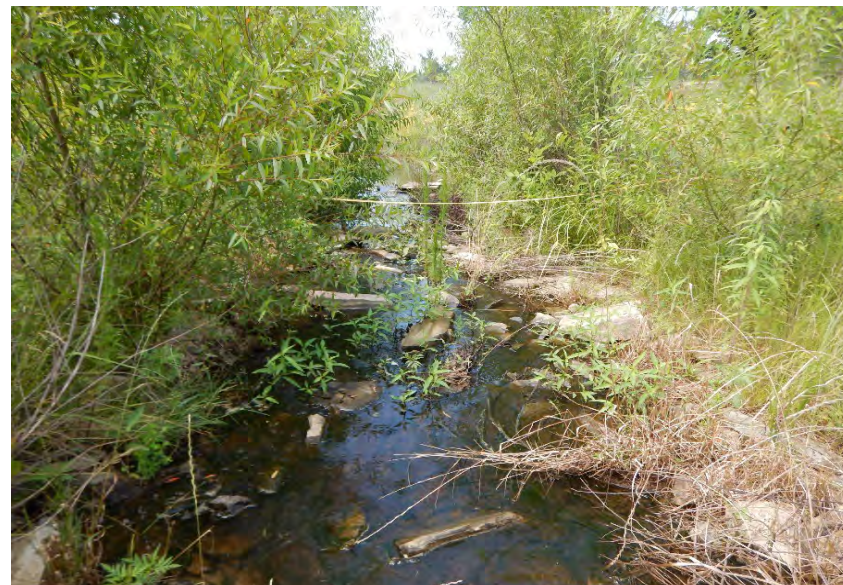
#### Cross-Section 10 - UT1B

13.4	x-section area (ft.sq.)
15.0	width (ft)
0.9	mean depth (ft)
1.4	max depth (ft)
15.5	wetted perimeter (ft)
0.9	hydraulic radius (ft)
16.9	width-depth ratio
42.6	W flood prone area (ft)
2.8	entrenchment ratio
1.0	low bank height ratio
