# MONITORING YEAR 2 ANNUAL REPORT

## CROSS CREEK RANCH SITE

Montgomery County, NC

DMS Project No. 100138

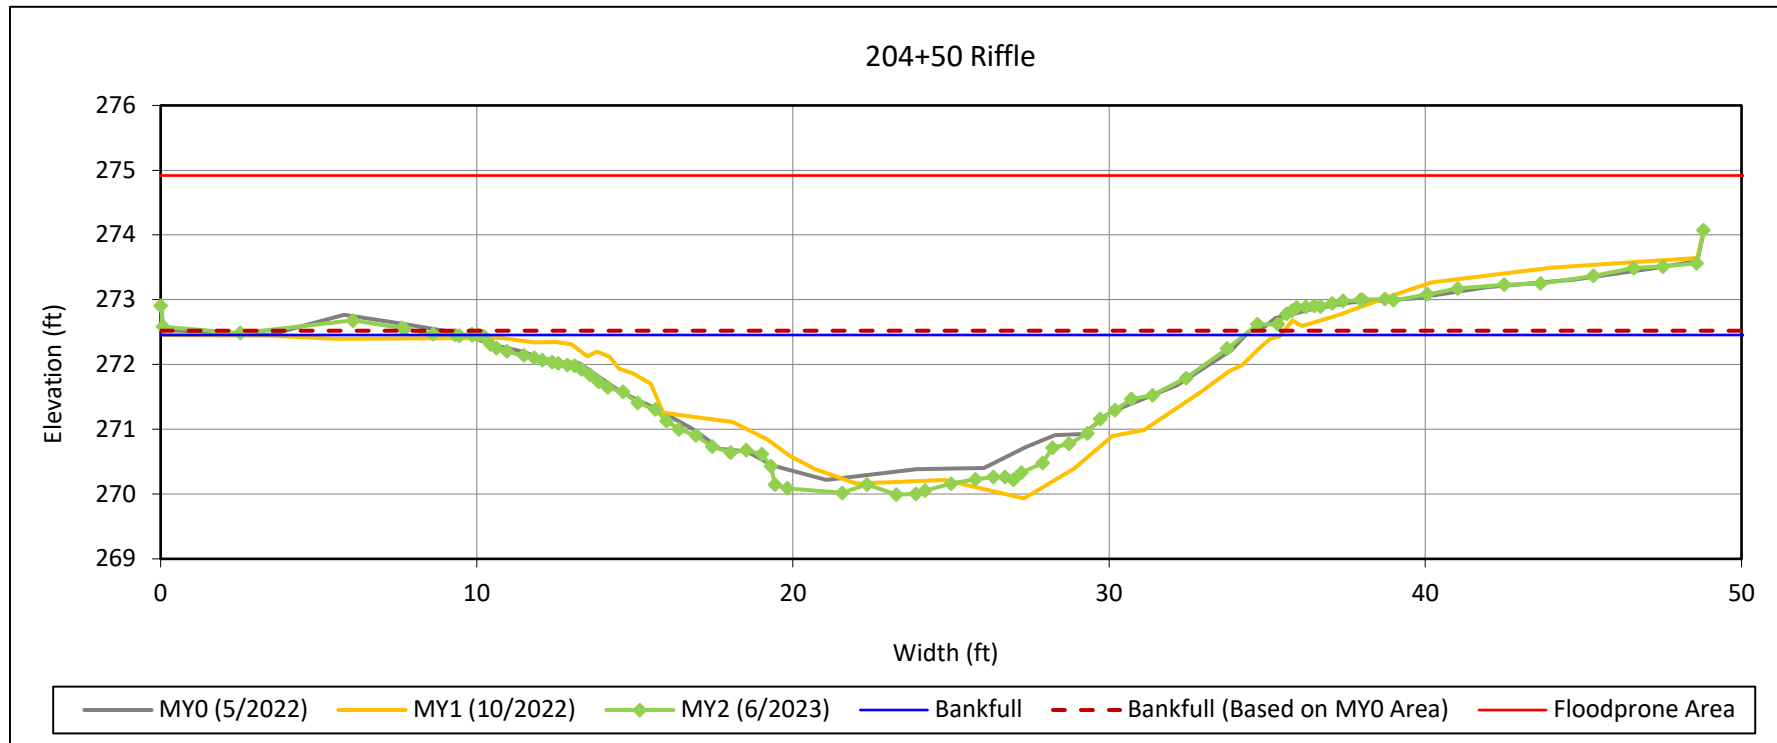
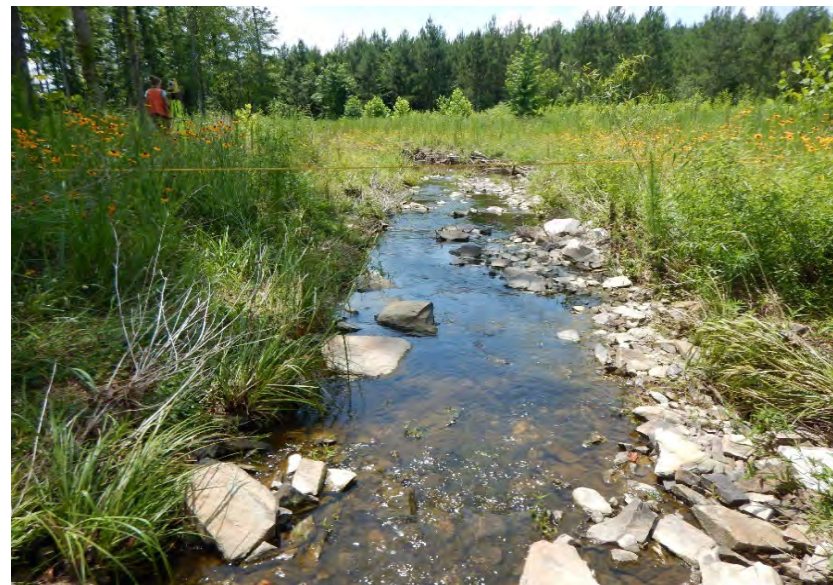
#### Cross-Section 11 - Big Branch

35.2	x-section area (ft.sq.)
24.2	width (ft)
1.5	mean depth (ft)
2.5	max depth (ft)
25.2	wetted perimeter (ft)
1.4	hydraulic radius (ft)
16.7	width-depth ratio
48.8	W flood prone area (ft)
2.0	entrenchment ratio
1.0	low bank height ratio

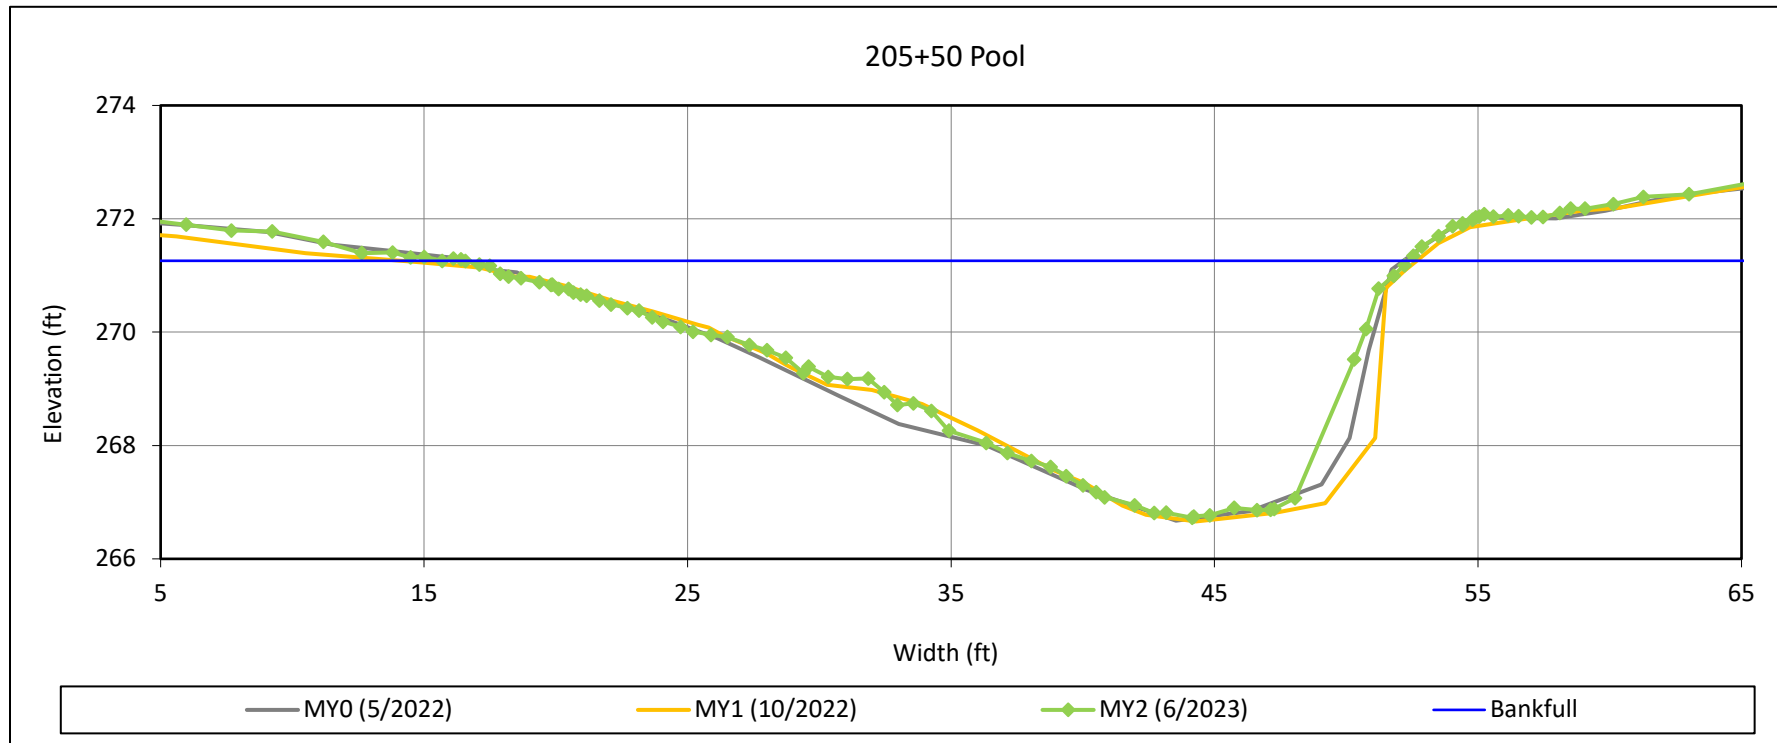
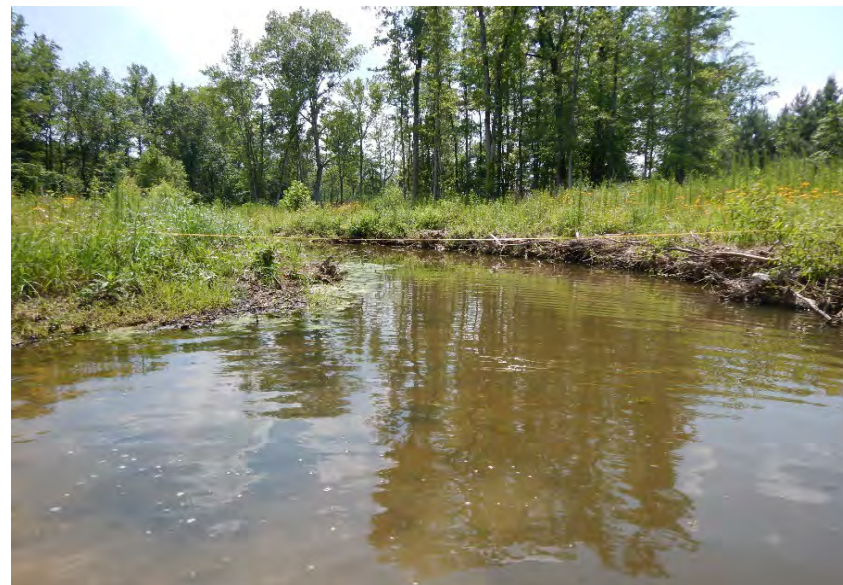
#### Cross-Section 12 - Big Branch

84.8	x-section area (ft.sq.)
35.8	width (ft)
2.4	mean depth (ft)
4.5	max depth (ft)
38.3	wetted perimeter (ft)
2.2	hydraulic radius (ft)
15.1	width-depth ratio

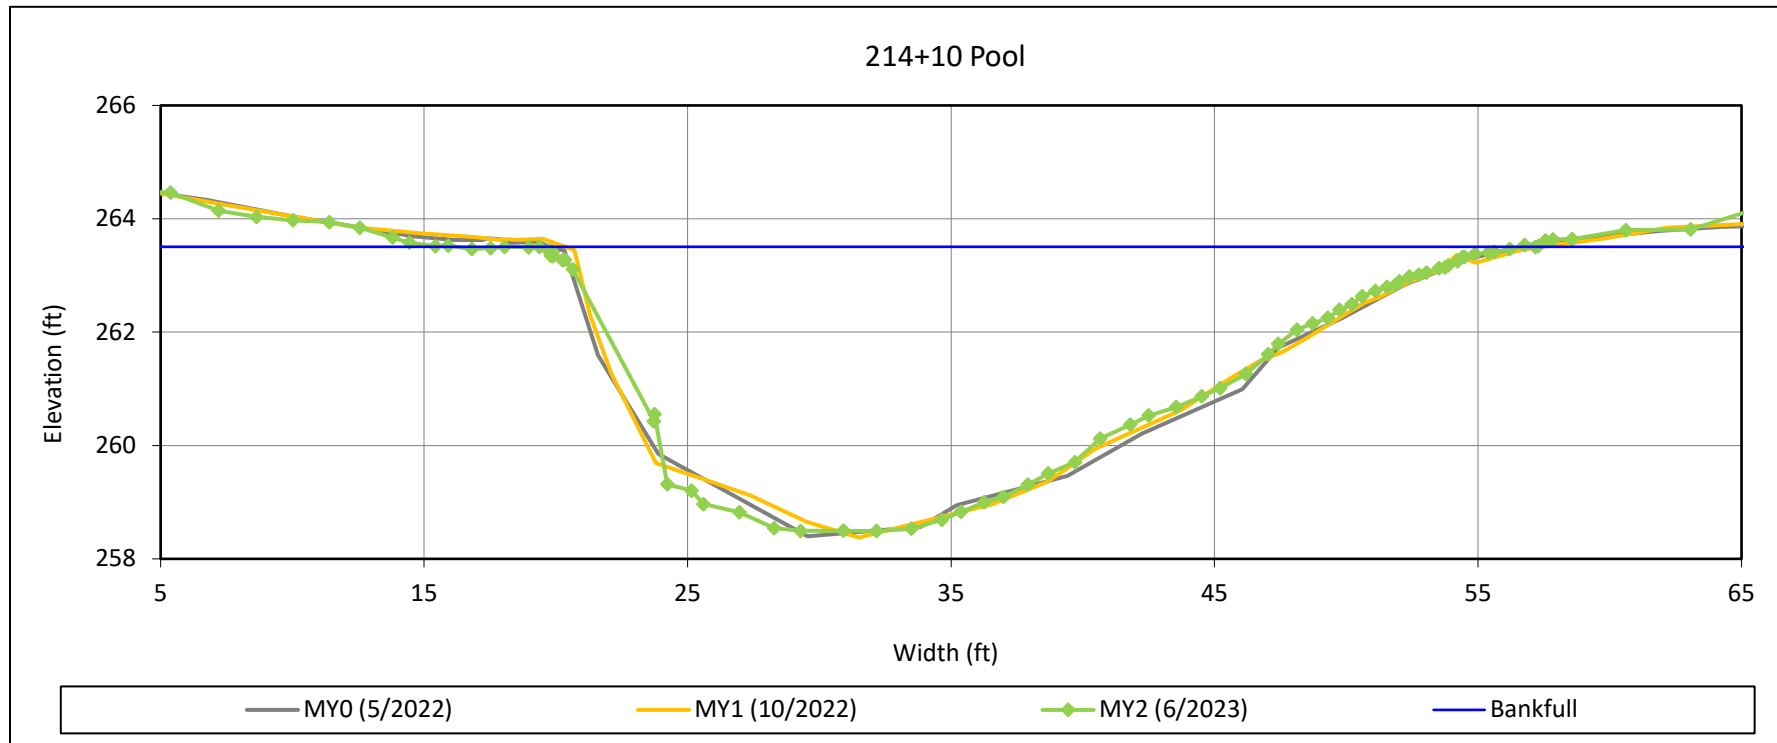
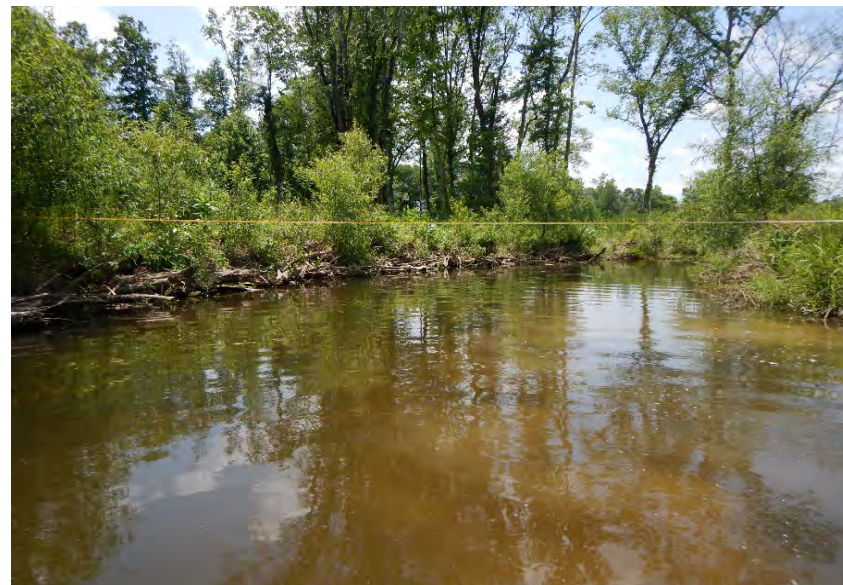
#### Cross-Section 13 - Big Branch

107.4	x-section area (ft.sq.)
38.5	width (ft)
2.8	mean depth (ft)
5.0	max depth (ft)
41.4	wetted perimeter (ft)
2.6	hydraulic radius (ft)
13.8	width-depth ratio

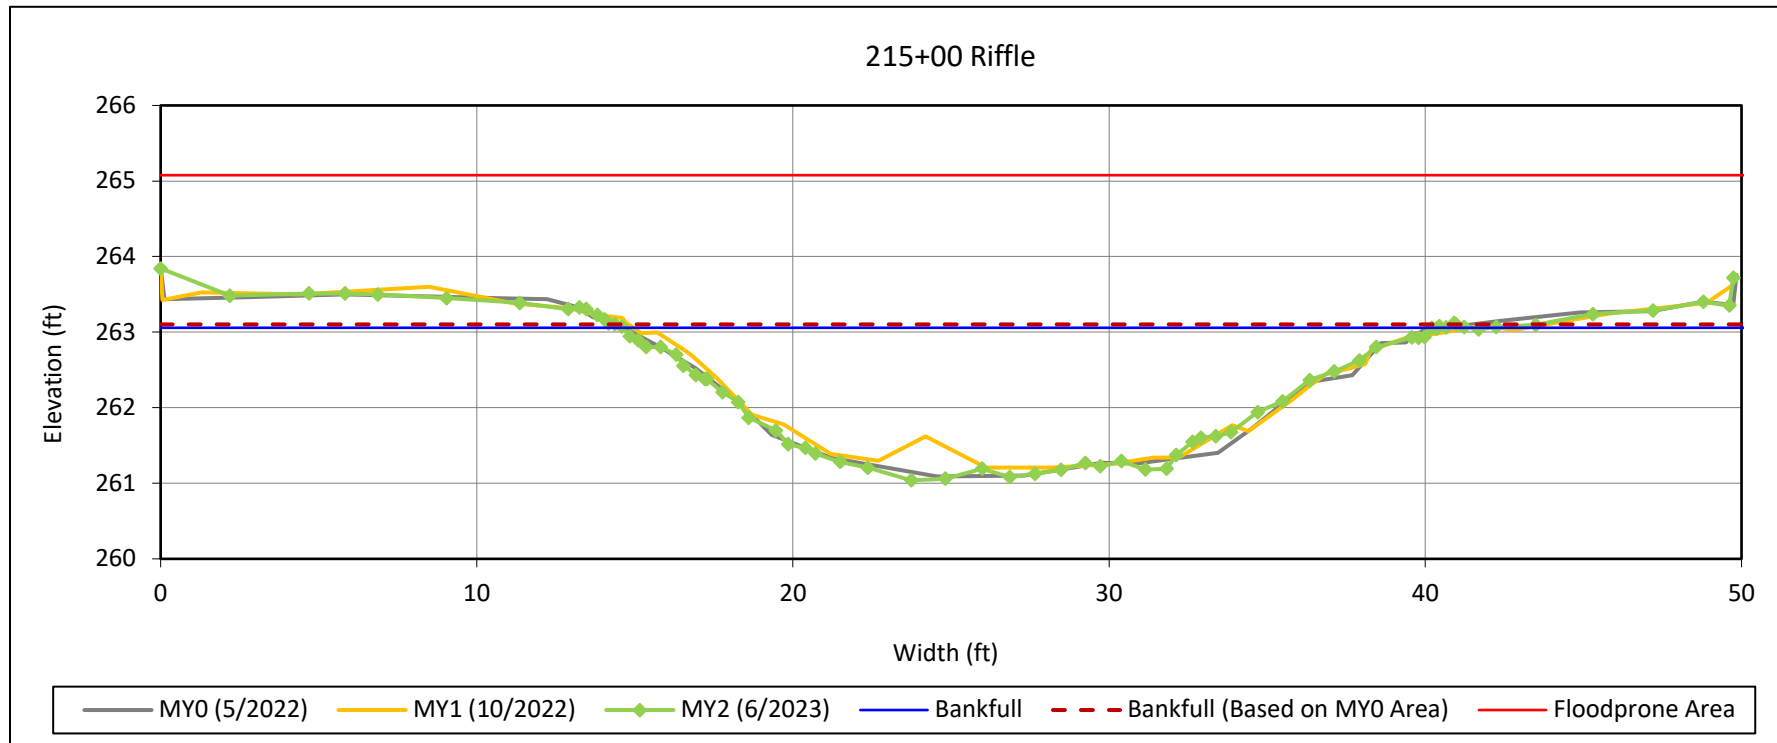
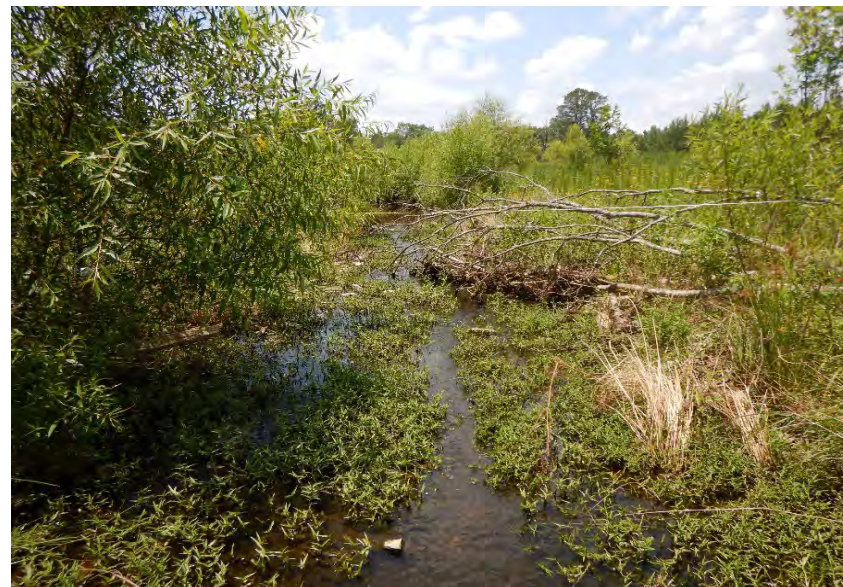
#### Cross-Section 14 - Big Branch

33.1	x-section area (ft.sq.)
25.6	width (ft)
1.3	mean depth (ft)
2.0	max depth (ft)
26.2	wetted perimeter (ft)
1.3	hydraulic radius (ft)
19.8	width-depth ratio
49.7	W flood prone area (ft)
1.9	entrenchment ratio
1.0	low bank height ratio

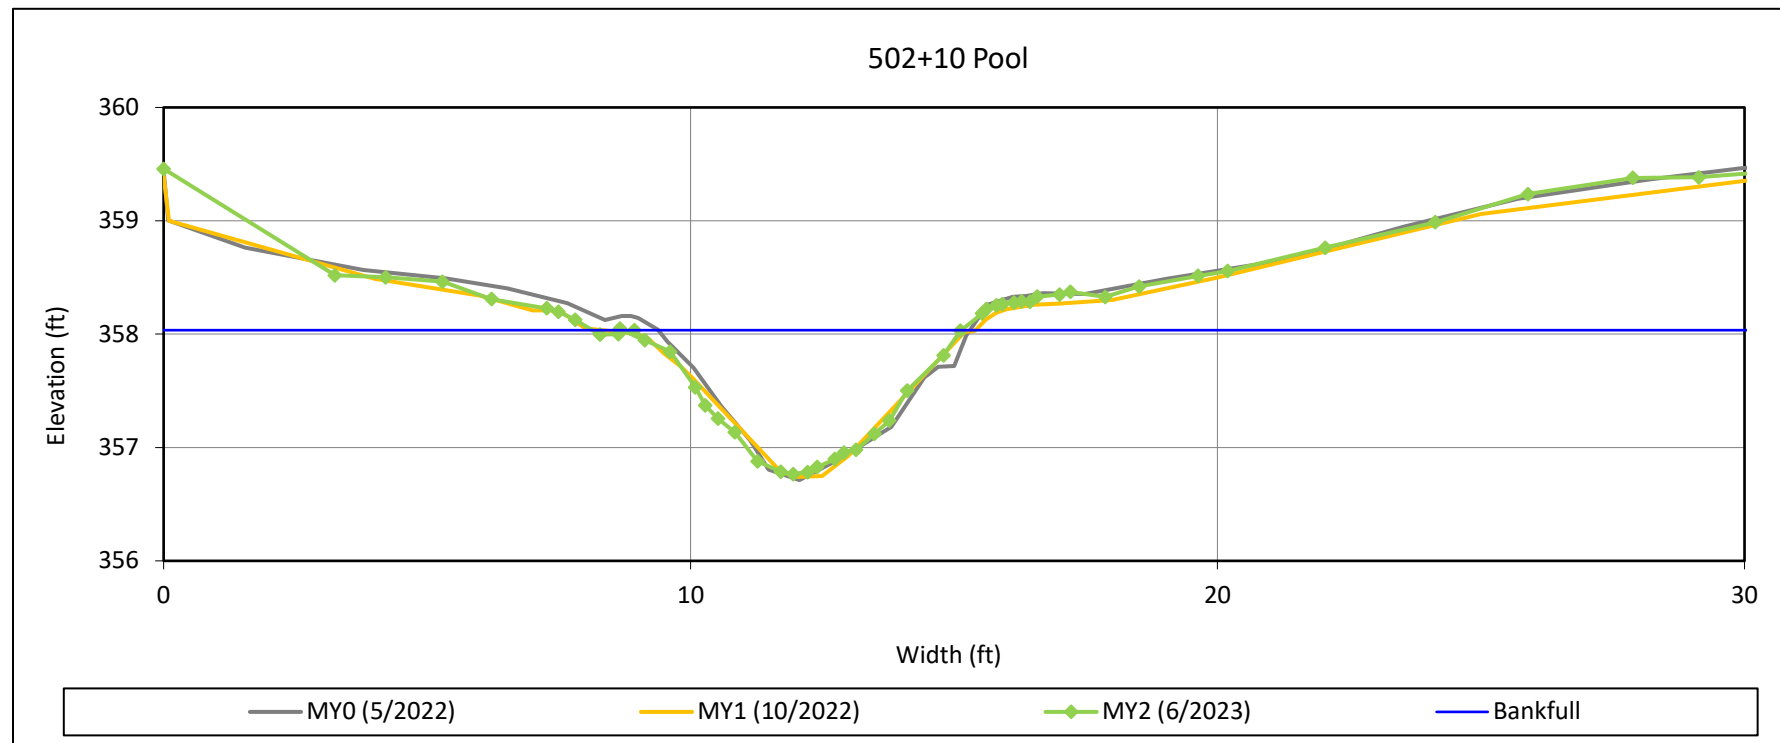
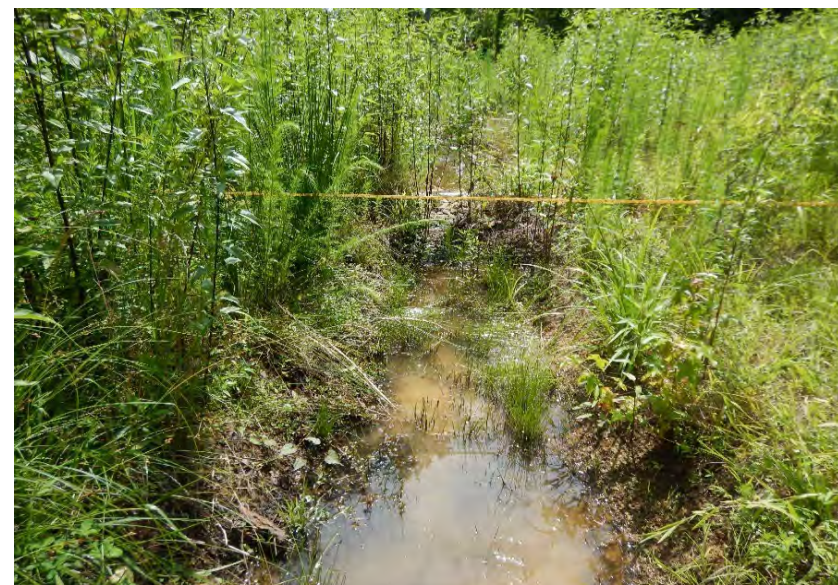
#### Cross-Section 15 - UT3 Reach 1

4.6	x-section area (ft.sq.)
6.2	width (ft)
0.7	mean depth (ft)
1.3	max depth (ft)
7.6	wetted perimeter (ft)
0.6	hydraulic radius (ft)
8.4	width-depth ratio

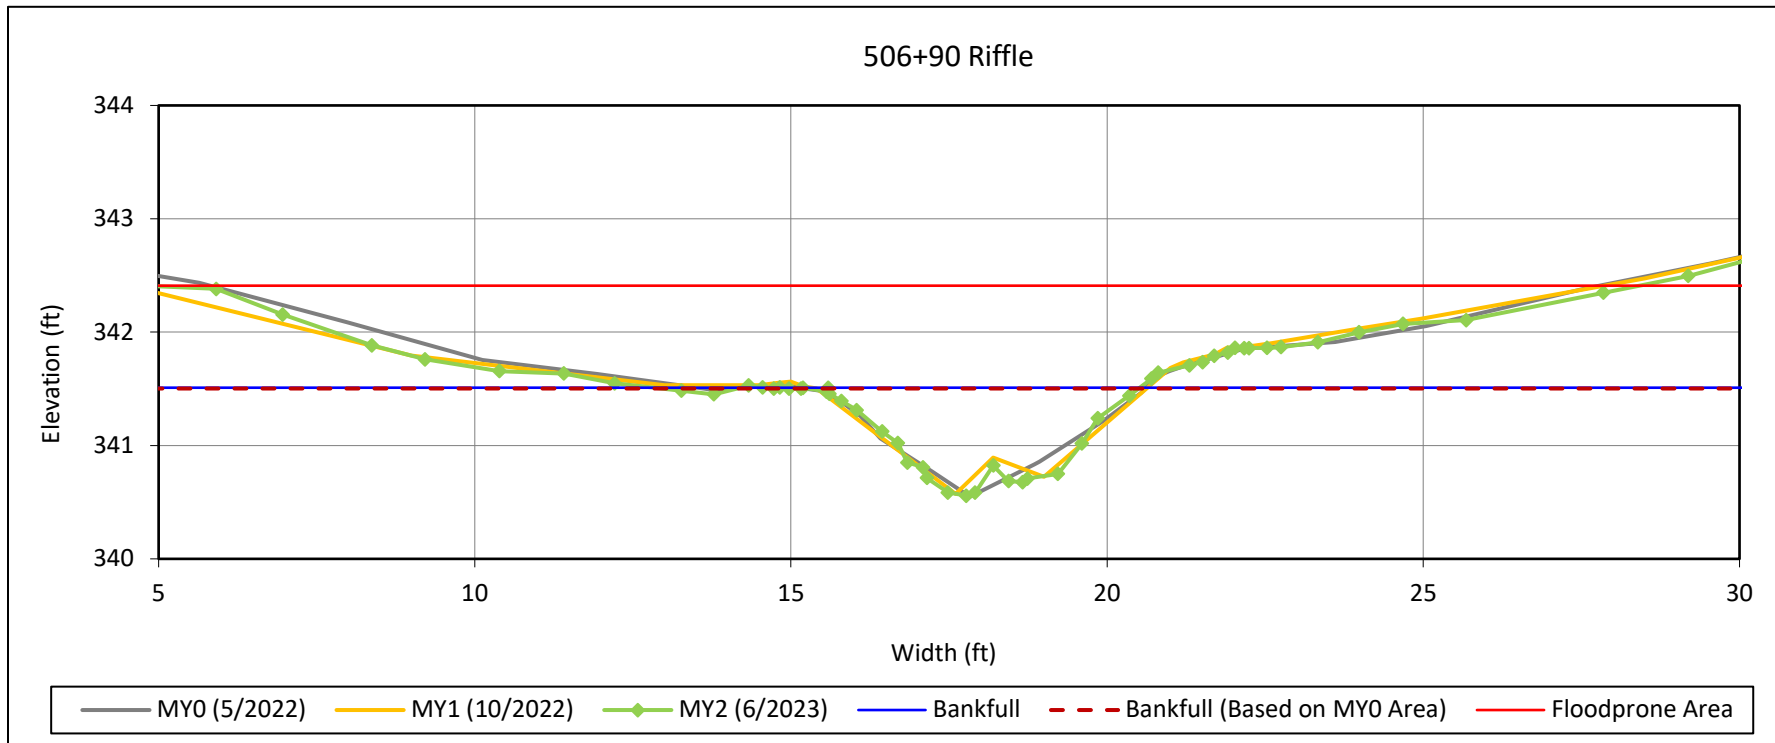
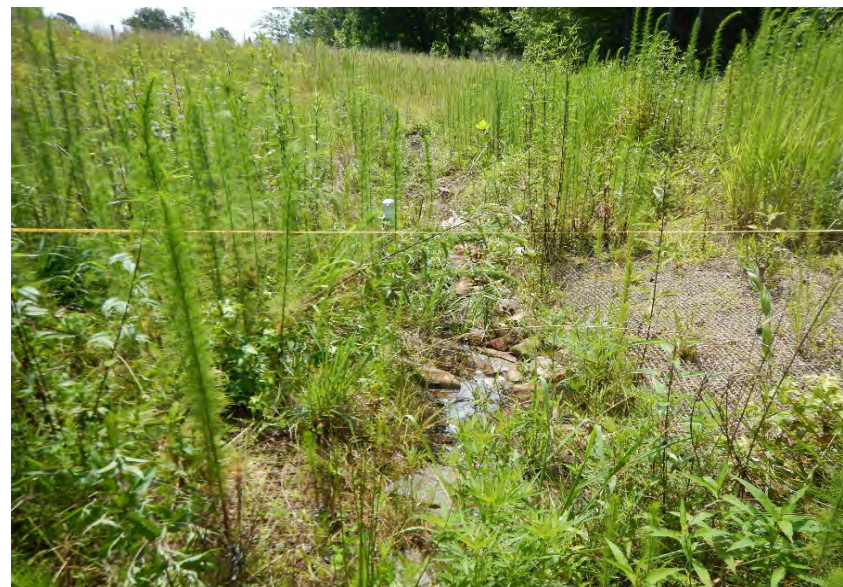
#### Cross-Section 16 - UT3 Reach 1

2.6	x-section area (ft.sq.)
4.8	width (ft)
0.5	mean depth (ft)
0.9	max depth (ft)
5.4	wetted perimeter (ft)
0.5	hydraulic radius (ft)
9.1	width-depth ratio
22.8	W flood prone area (ft)
4.7	entrenchment ratio
1.0	low bank height ratio

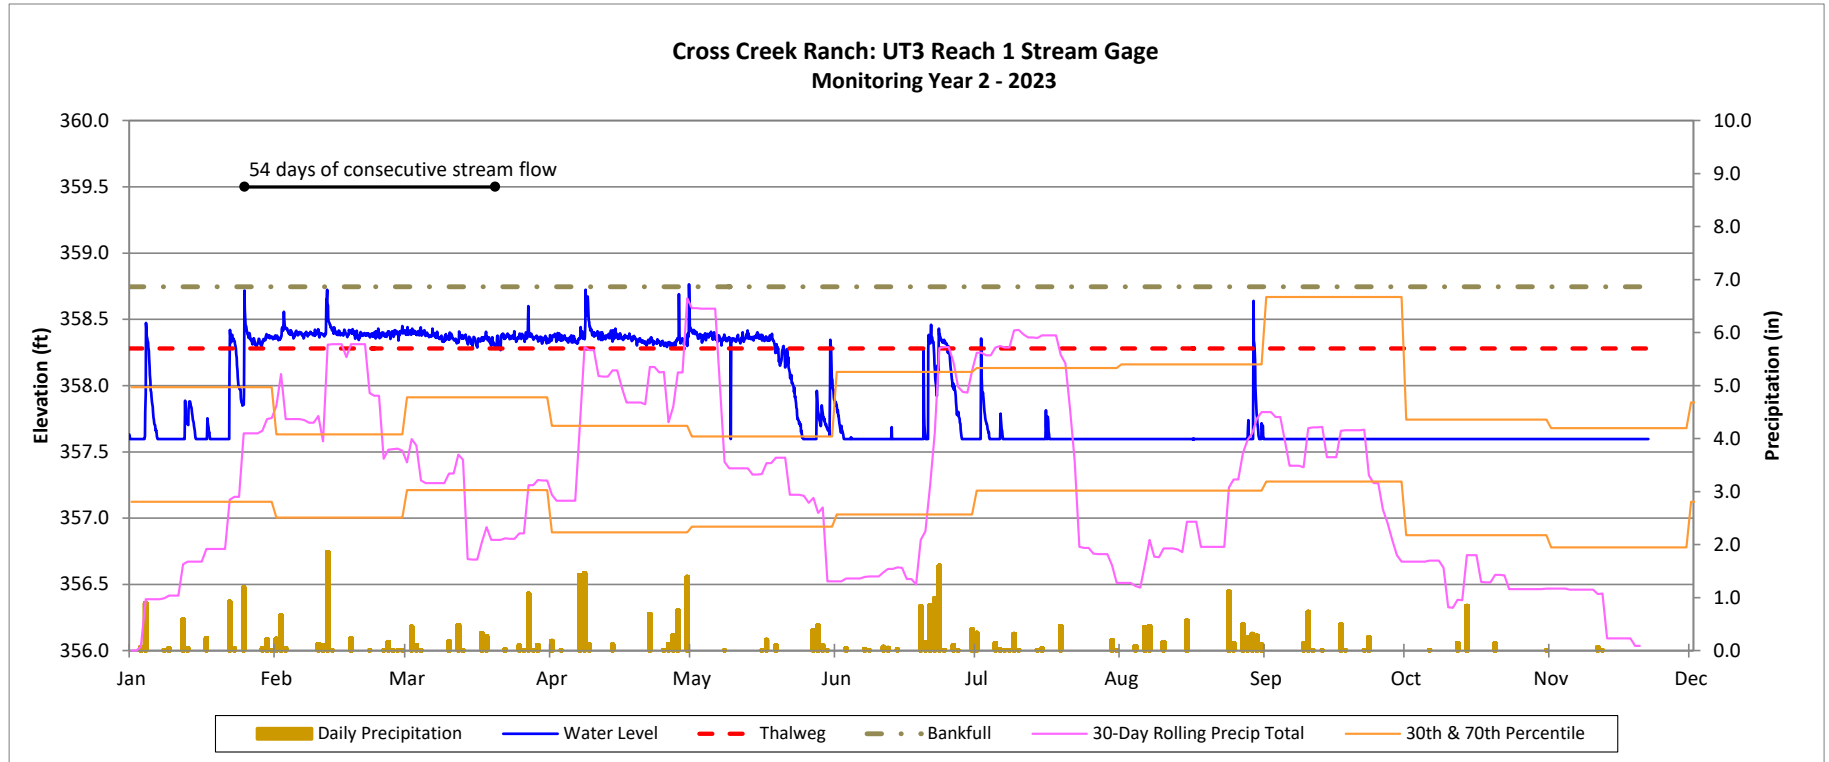
## Recorded In-Stream Flow Events Plot

Big Branch exhibited four bankfull events in MY2 as of November 20, 2023, and is on track to meet performance standards of four bankfull events in separate years during the 7-year monitoring period for restored streams. Though UT3 R1, UT1 R1, and UT1B did not have a bankfull event in MY2, all three reaches exhibited consistent baseflow at the crest gage locations throughout the year. Due to the low flow conditions at the upstream extent of UT3 R1, a stream gage was installed to ensure that the reach maintained at least 30 days of consecutive baseflow. Results in MY2 show that the reach met and exceeded the minimum baseflow requirement with 54 days of consecutive flow. Refer to Appendix D for additional stream hydrology data.

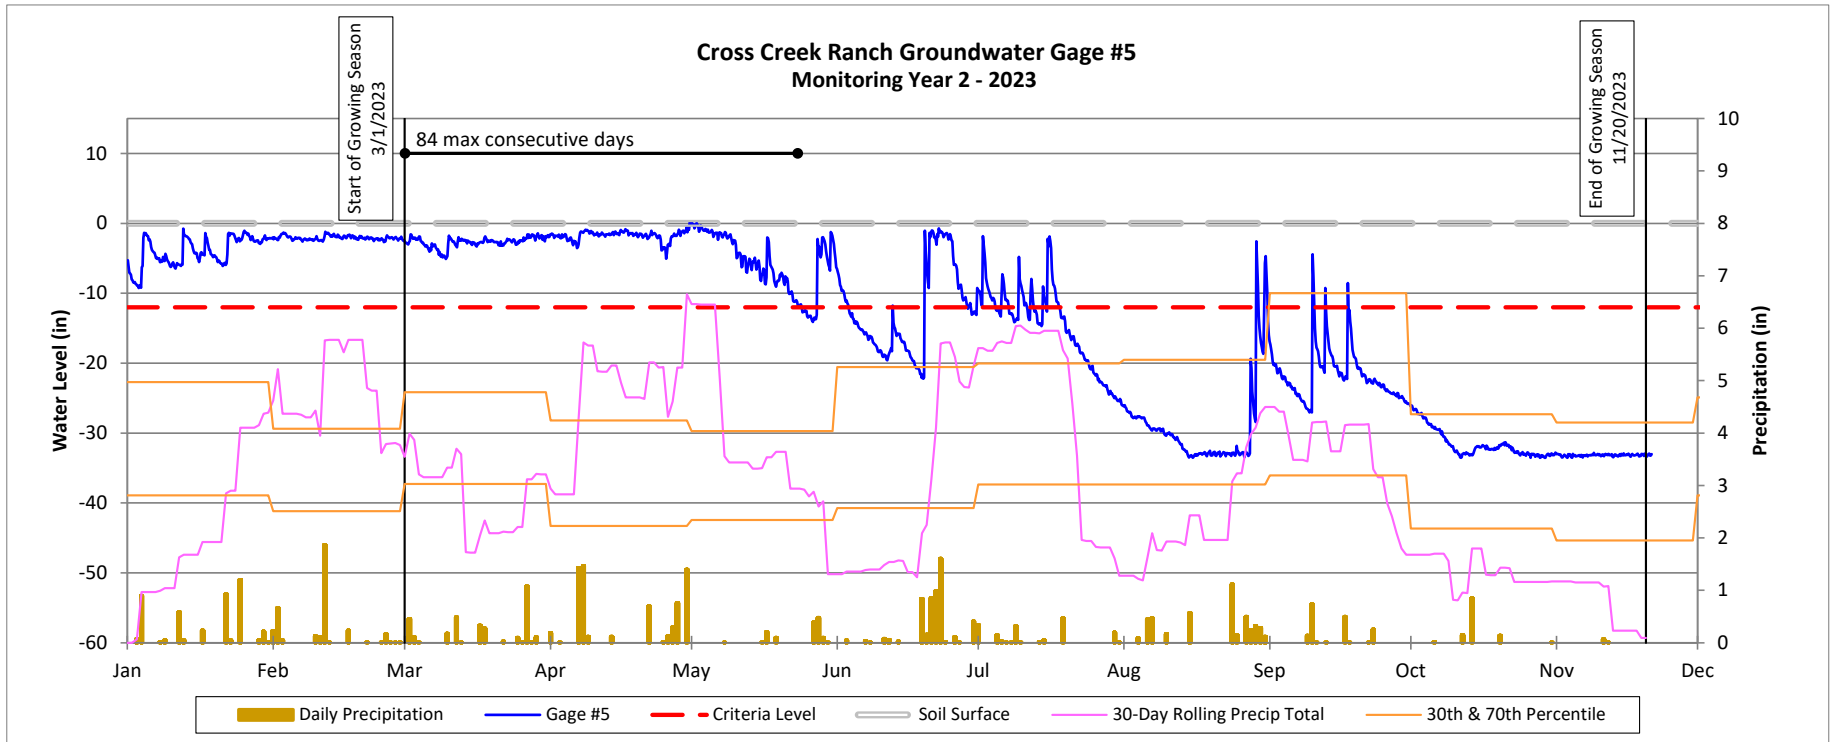
## Groundwater Gage Plot

In MY2, seven of the nine GWGs met and/or exceeded the wetland hydrologic performance criteria at the Site. GWGs 5 & 6 within the wetland rehabilitation zones and GWGs 1, 3, 4, 8, and 9 in re-establishment zones are meeting criteria. While the majority of the rainfall at the Site was at or above the normal rainfall each month, most of July and the beginning of September of 2023 experienced moderate (D1) drought conditions (National Drought Mitigation Center, 2023). Though a few small rainfall events occurred in mid-September, moderate (D1) drought conditions continued from the end of September to the end of the growing season. Therefore, as drought conditions improve with winter rainfall and groundwater continues to recharge across the Site, it is anticipated that wetland hydrology will also improve; however, groundwater recharge will have to first overcome the water storage deficit.
