# CROWNS WEST STREAM RESTORATION PROJECT

## ANNUAL MONITORING REPORT FOR 2007 (YEAR 1)

Contract Number D06003-2

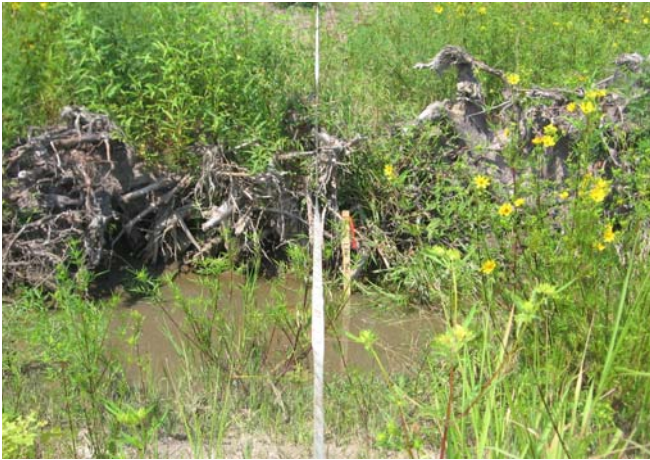
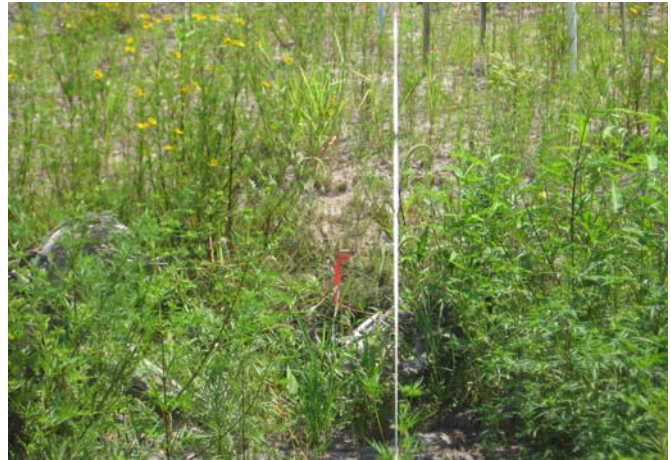
**Permanent Cross-section 6**  
 (Year 1 Data - Collected Aug. 2007)

Feature	Stream Type	BKF Area	BKF Width	BKF Depth	Max BKF Depth	W/D	BH Ratio	ER	BKF Elev	TOB Elev
Pool		20.6	14.17	1.45	2.63	9.75	1	5.2	53.05	53.1

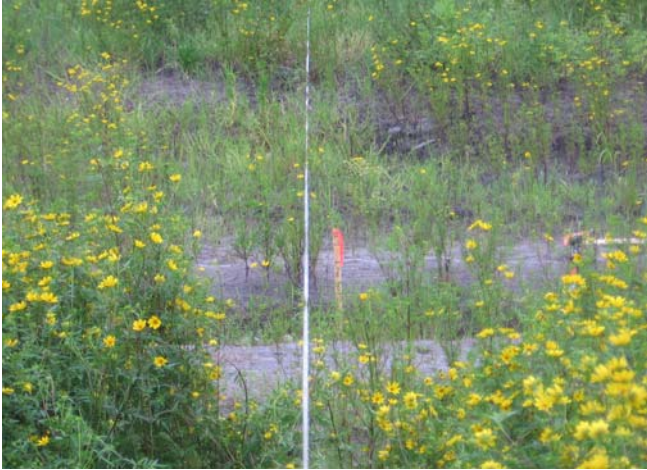
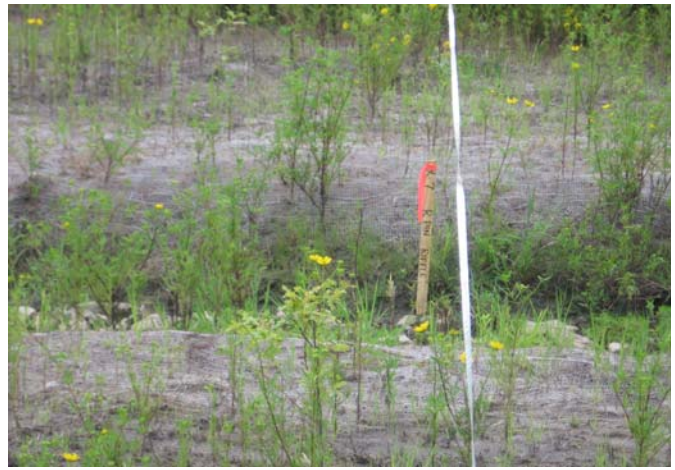
**Permanent Cross-section 7**  
 (Year 1 Data - Collected Aug. 2007)

Feature	Stream Type	BKF Area	BKF Width	BKF Depth	Max BKF Depth	W/D	BH Ratio	ER	BKF Elev	TOB Elev
Riffle	E	10.2	10.01	1.02	1.62	9.86	1	7.6	52.7	52.73
