CROWNS WEST STREAM RESTORATION PROJECT

ANNUAL MONITORING REPORT FOR 2008 (YEAR 2)

Contract Number D06003-2

December 2008

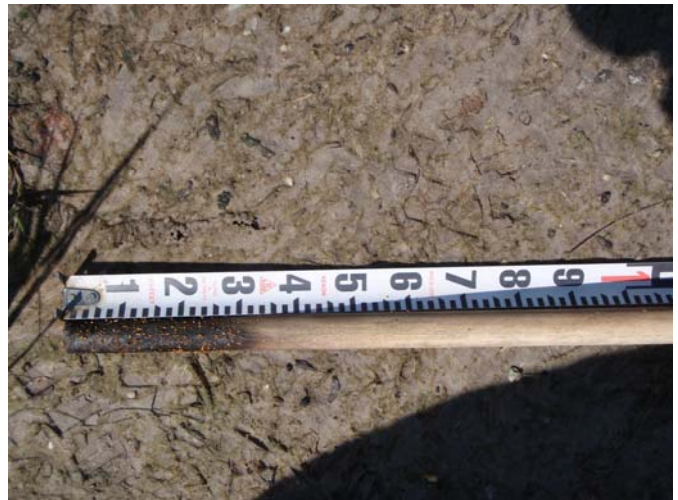
Crest gauge reading of 1.91 feet
