CROWNS WEST STREAM RESTORATION PROJECT

ANNUAL MONITORING REPORT FOR 2010 (YEAR 4)

Contract Number D06003-2

December 2010

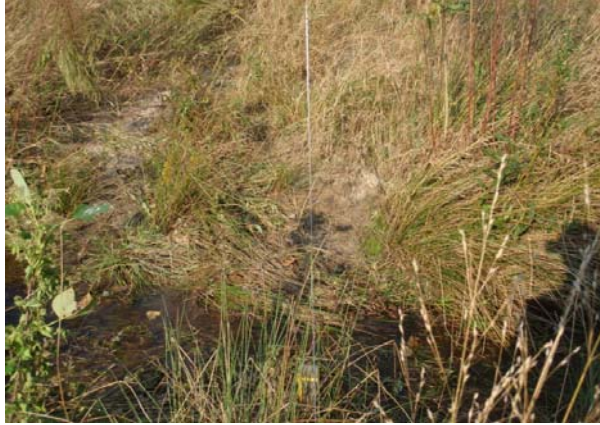
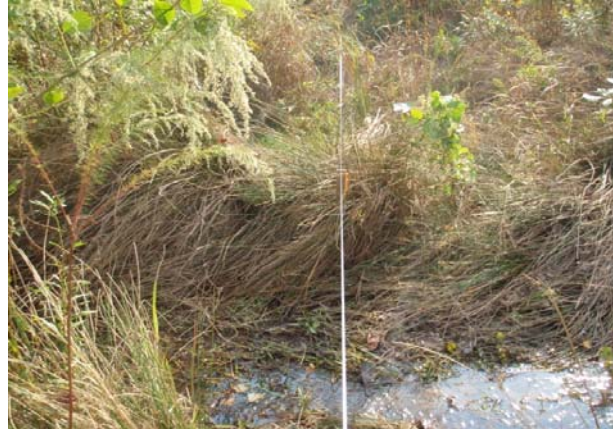
Permanent Cross-section 4
(Year 4 Data - Collected October 2010)

Feature	Stream Type	BKF Area	BKF Width	BKF Depth	Max BKF Depth	W/D	BH Ratio	ER	BKF Elev	TOB Elev
Riffle	C	6.1	9.08	0.67	1.07	13.62	1.1	6.4	58.92	58.98

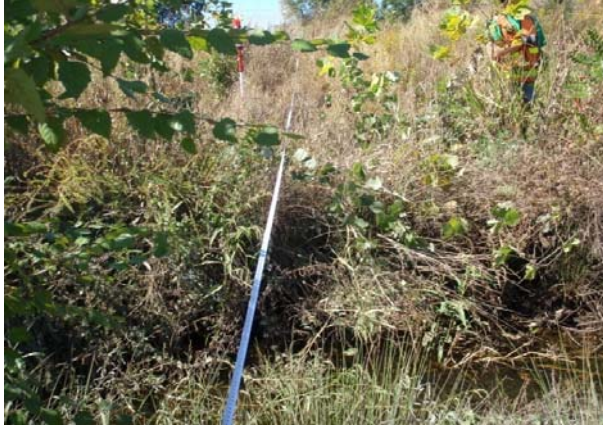
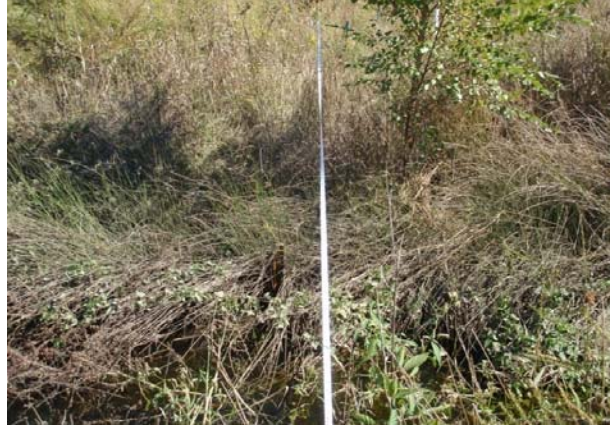
Permanent Cross-section 6
(Year 4 Data - Collected October 2010)

Feature	Stream Type	BKF Area	BKF Width	BKF Depth	Max BKF Depth	W/D	BH Ratio	ER	BKF Elev	TOB Elev
Pool		16.3	13.42	1.21	2	11.05	1.1	5.1	53.05	53.28

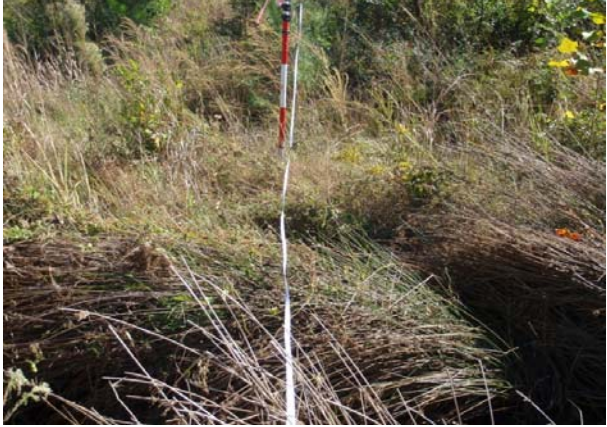
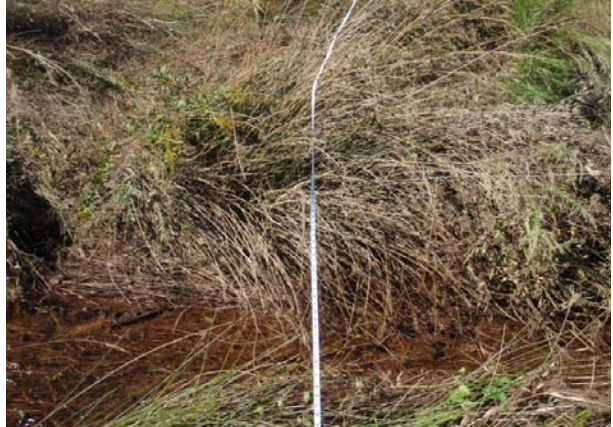
Permanent Cross-section 7
(Year 4 Data - Collected October 2010)

Feature	Stream Type	BKF Area	BKF Width	BKF Depth	Max BKF Depth	W/D	BH Ratio	ER	BKF Elev	TOB Elev
Riffle	C	8.3	11.01	0.76	1.47	14.58	1	6.7	52.8	52.78
