**CUTAWHISKIE CREEK STREAM AND WETLAND RESTORATION SITE  
2012 ANNUAL MONITORING REPORT (YEAR 5)**

**HERTFORD COUNTY, NORTH CAROLINA  
NCEEP CONTRACT NO. D06066-A (IMS NO. 92547)**

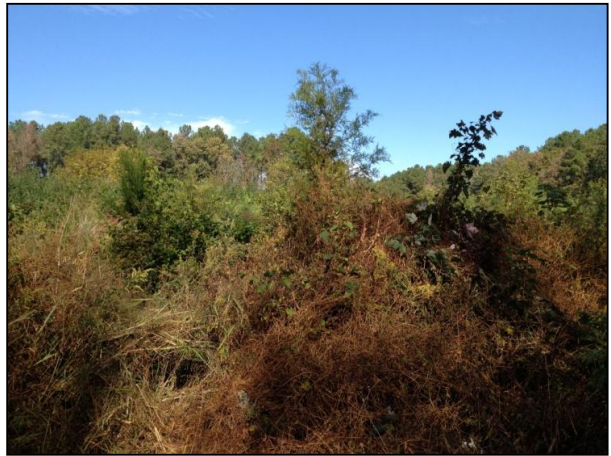
Vegetation Plot 4

<b>plot</b>	<b>All Damage Categories</b>	<b>(no damage)</b>	<b>Cut</b>	<b>Unknown</b>
	D06066a-12345-0001-year:5	1	16	1	
	D06066a-12345-0002-year:5	0	18		
	D06066a-12345-0003-year:5	0	16		
	D06066a-12345-0004-year:5	6	2		6
	D06066a-12345-0005-year:5	0	9		
<b>TOT:</b>	<b>5</b>	<b>7</b>	<b>61</b>	<b>1</b>	<b>6</b>

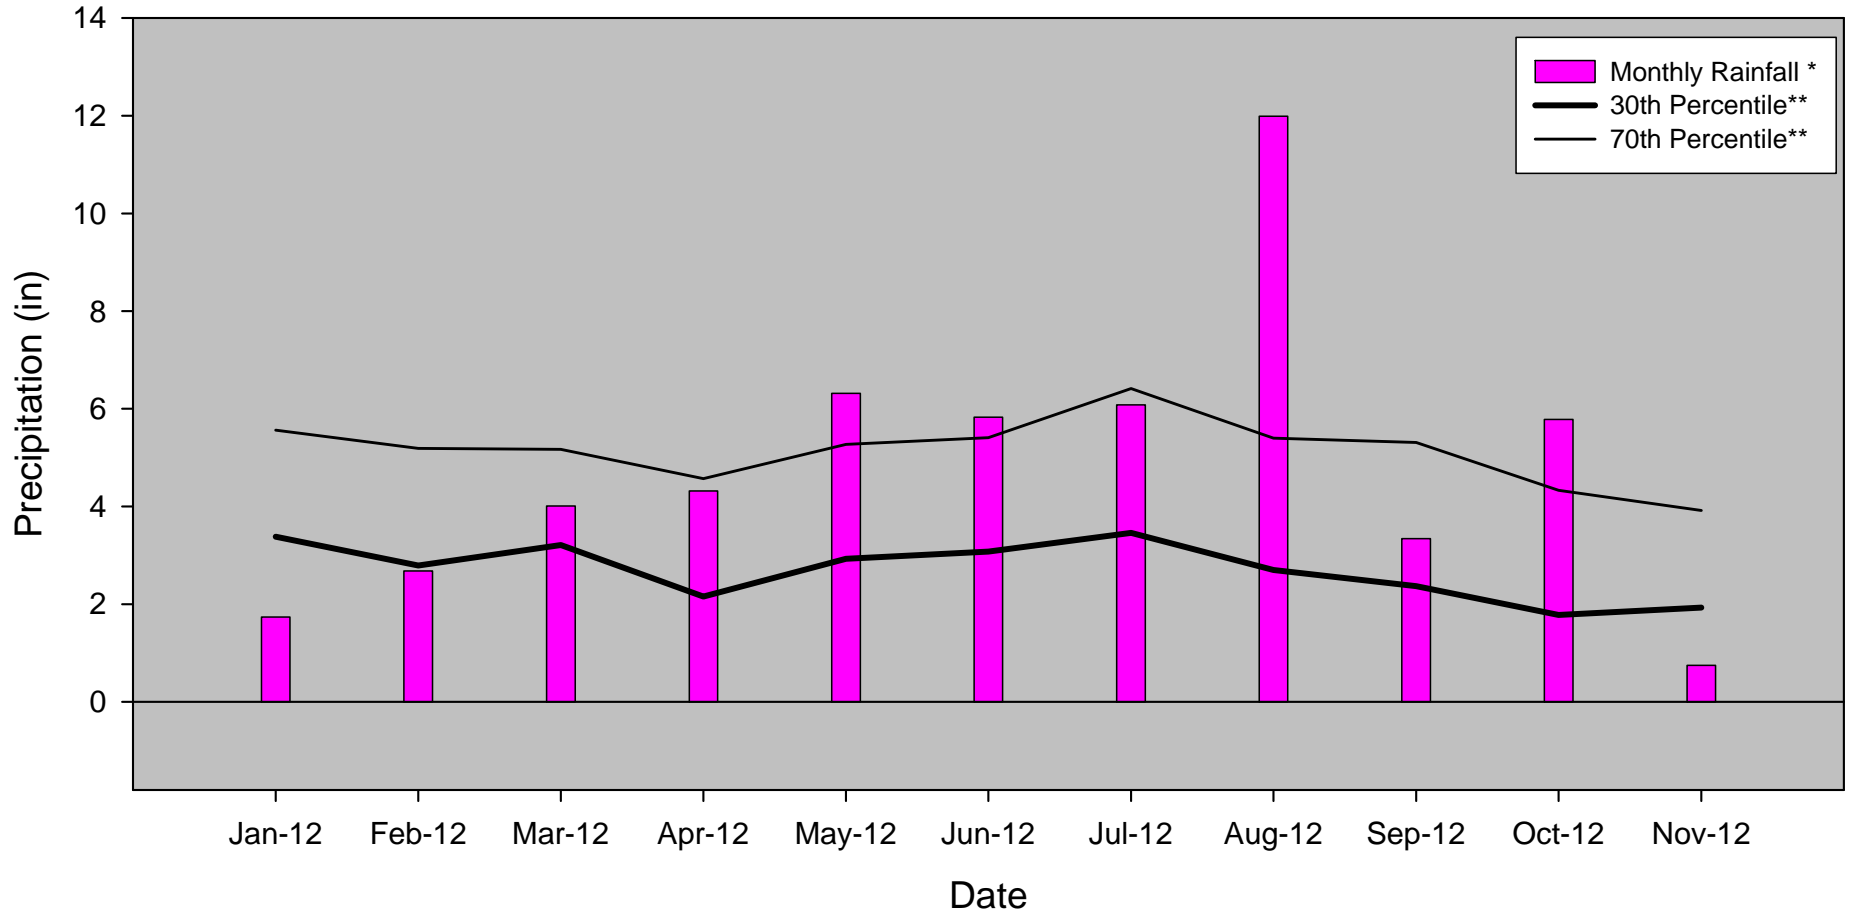
### Figure 3. Monthly Precipitation (Jan-Nov 2012) Hertford County, NC 2012

Figure 3 (Appendix C) shows a comparison of 2012 monthly rainfall to historical precipitation for Hertford County. The figure shows average rainfall data collected between 1948 and 2012 and compares 30 percent and 70 percent of all observations with the actual 2012 monthly rainfall amounts to determine average. Monthly rainfall amounts were below the 30<sup>th</sup> percentile during four months of the growing season. Table X summarizes wetland hydrology criteria for Year 5 monitoring.
