# **Year 1 Monitoring Report for Stream Restoration of Davis Branch and Unnamed Tributary**

Union County, NC  
SCO # D06054-F

**Submitted:** December 2009

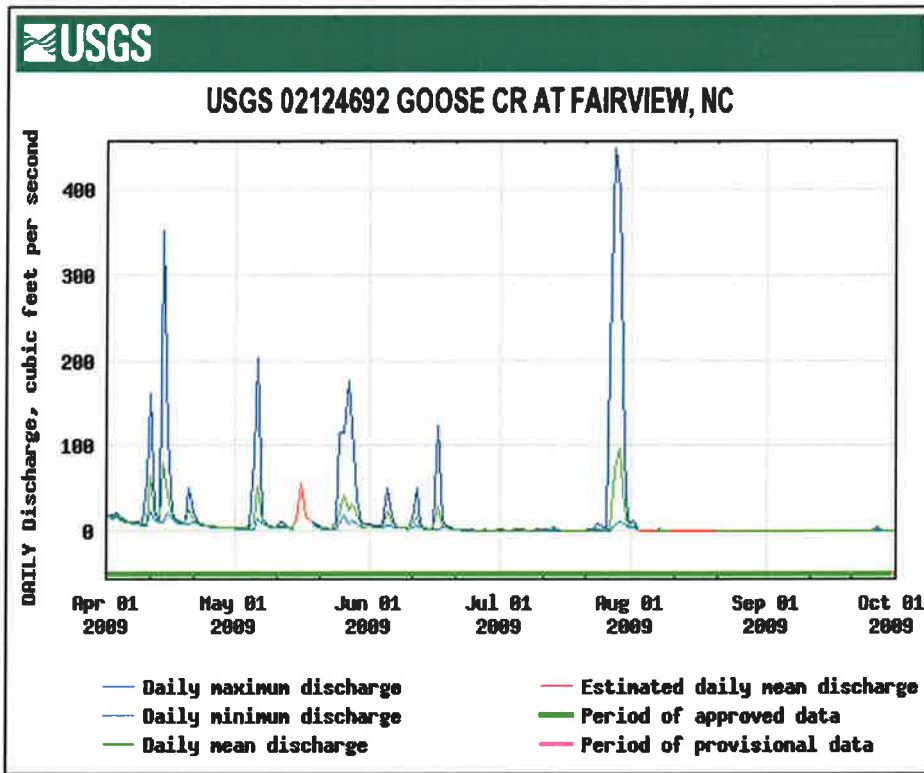
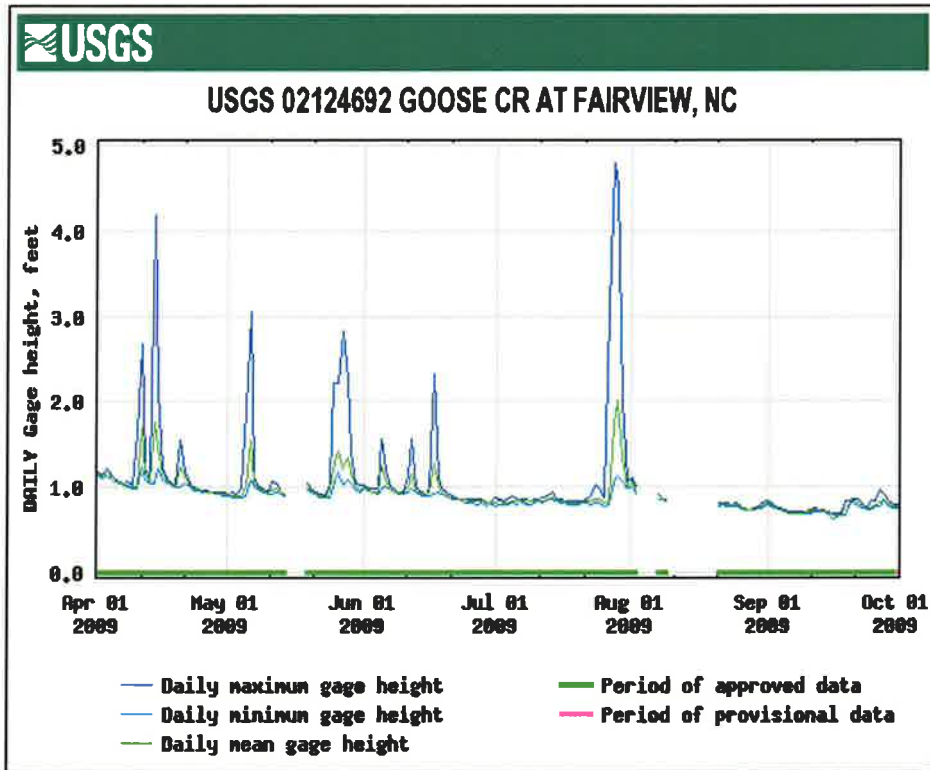
The most likely date for the bankfull event was after the rain event that occurred on July 28, 2009. On this date, rainfall as recorded in Monroe, NC totaled 1.2 inches. As this was the largest precipitation event of significance since the crest gages were installed in April 2009, this is likely the bankfull event recorded by both crest gages. This corresponds to a high discharge event on July 28, as recorded at USGS Gage 02124692 Goose Creek at Fairview, NC, which lies approximately 15 miles west of the project site. The discharge and gage height recorded at the Fairview station are shown on the hydrographs below.

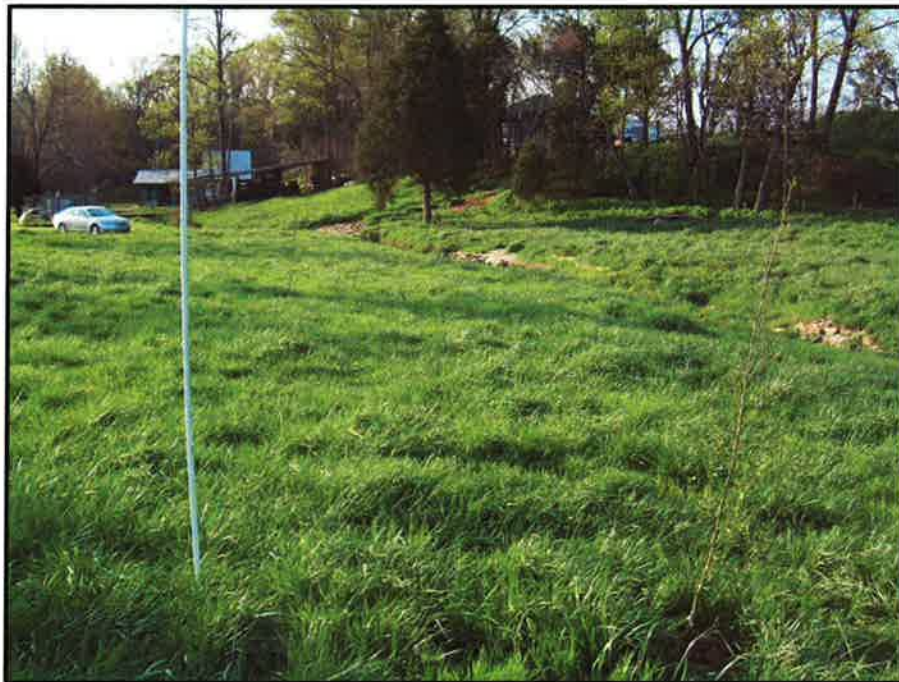
**Vegetation Plot 8**  
**No photo for Monitoring Year 1; Photo above shows the as-built condition**  
(EMH&T, Inc. 4/8/09)
