Year 2 Monitoring Report for Stream Restoration of Davis Branch and Unnamed Tributary

Union County, NC
SCO # D06054-F

Submitted: January 2011

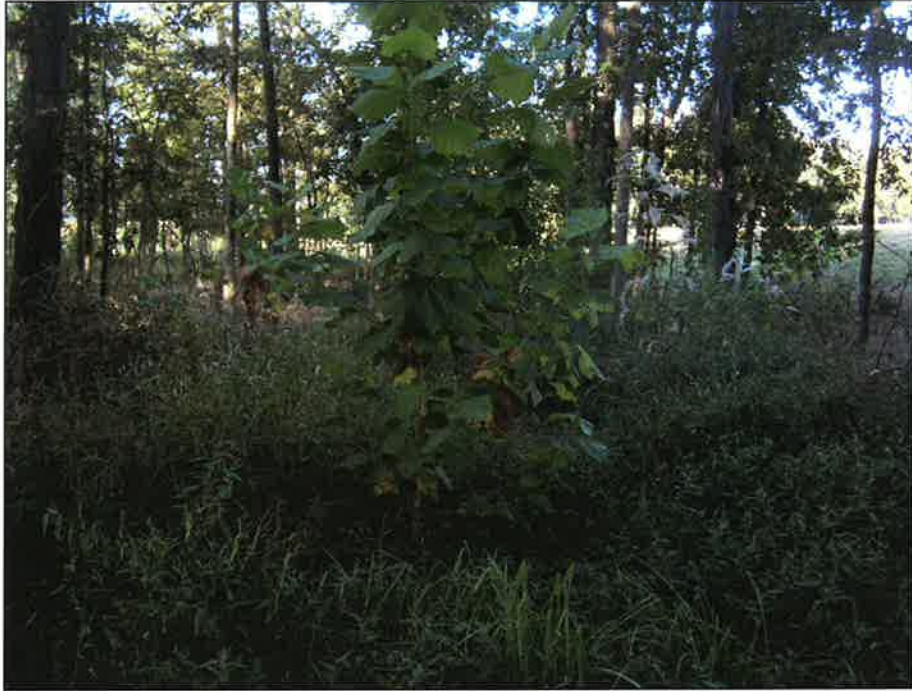
Fixed Station 1
Overview of Davis Branch, looking downstream at Station 7+80.
(EMH&T, Inc. 9/20/10)

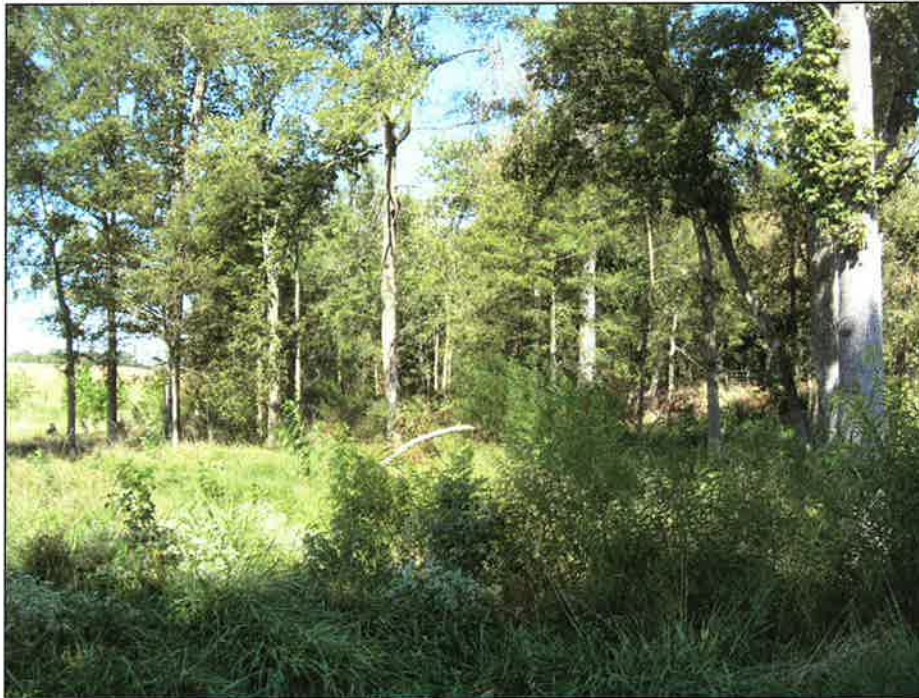
Fixed Station 2
Overview of Davis Branch, looking downstream near Station 14+75.
(EMH&T, Inc. 9/20/10)

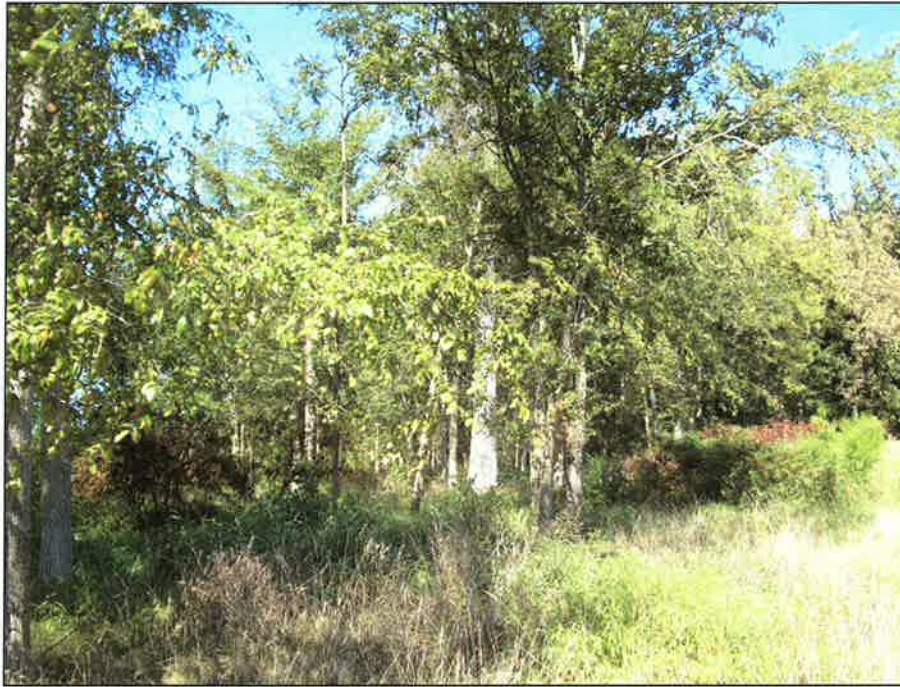
Fixed Station 3
Overview of Davis Branch, looking downstream near Station 15+50.
(EMH&T, Inc. 9/20/10)

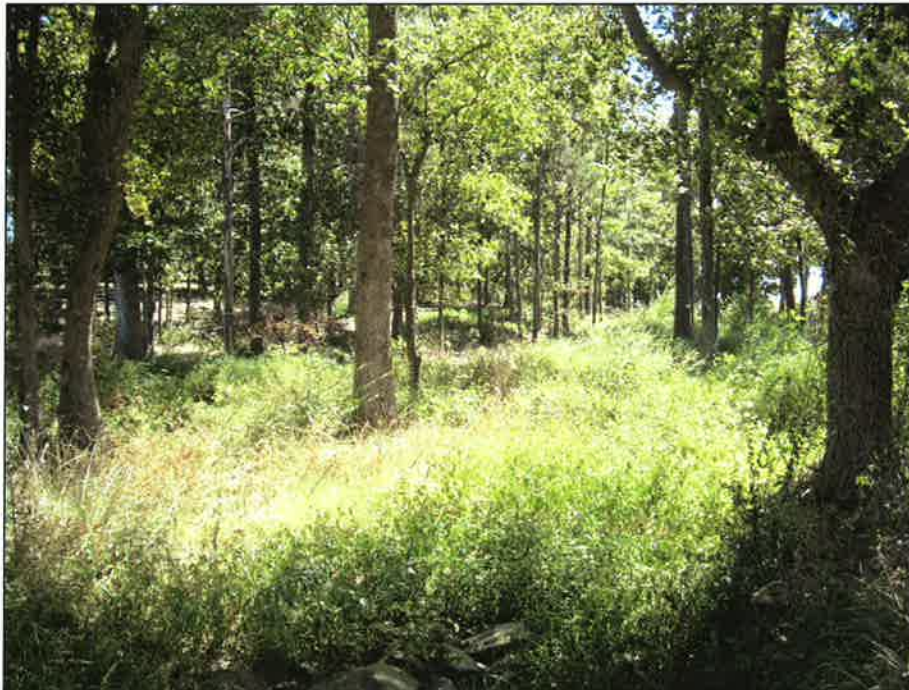
Fixed Station 4
Overview of Davis Branch, looking upstream near Station 25+75.
(EMH&T, Inc. 9/20/10)

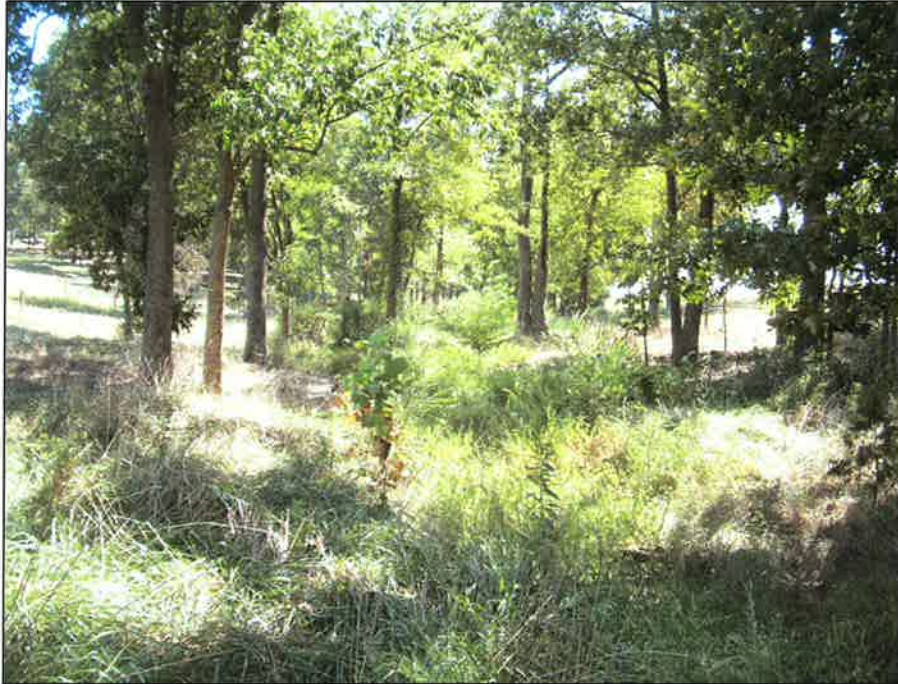
Fixed Station 5
Overview of Davis Branch, looking upstream near Station 27+25.
(EMH&T, Inc. 9/20/10)

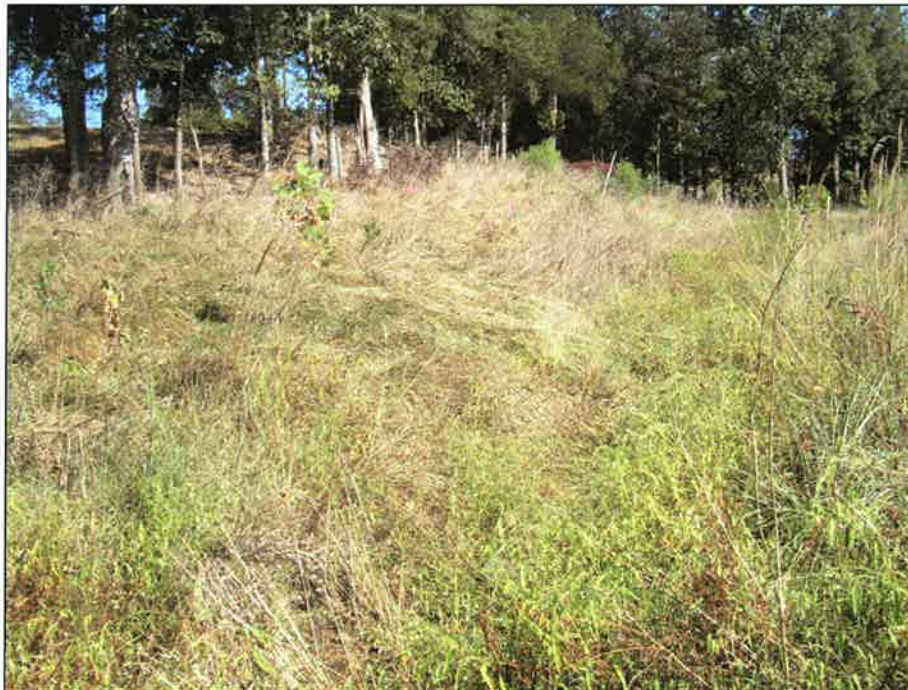
Fixed Station 6
Overview of Davis Branch, looking upstream near Station 38+75.
(EMH&T, Inc. 9/20/10)

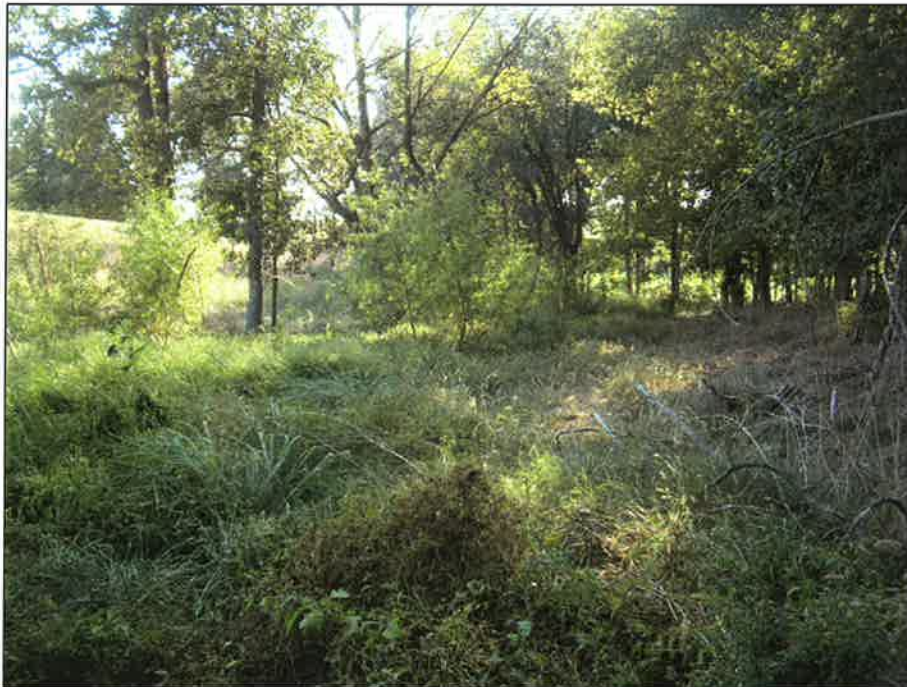
Fixed Station 8
Overview of UT1, looking downstream near Station 4+50.
(EMH&T, Inc. 9/20/10)
