Subject: Year 3 Monitoring Report for Stream Mitigation of Davis Branch
SCO# D06054-F

Year 3 Monitoring Report for Stream Restoration of Davis Branch and Unnamed Tributary

Union County, NC
SCO # D06054-F

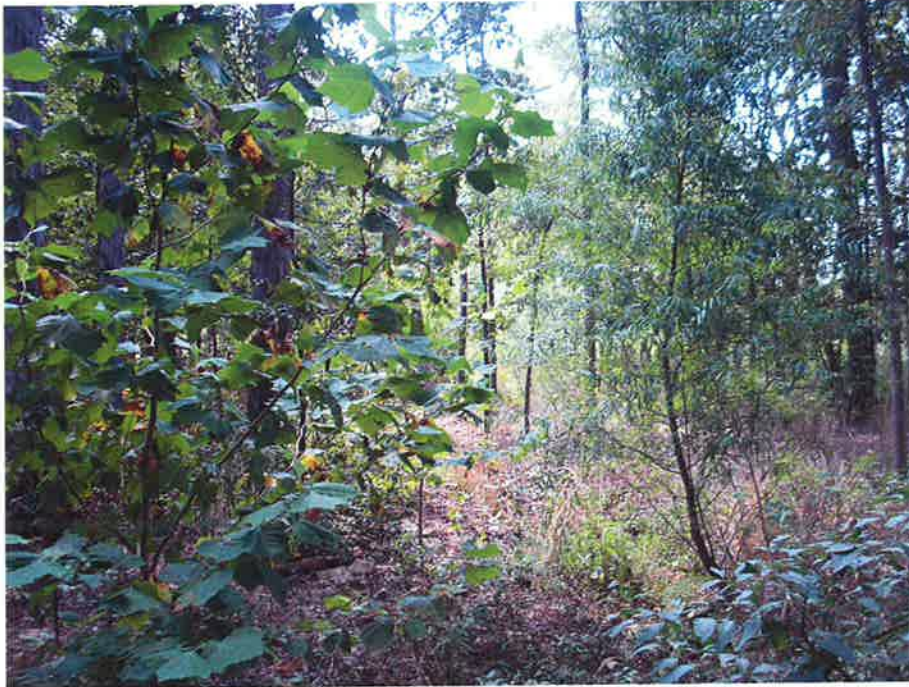
Fixed Station 1
Overview of Davis Branch, looking downstream at Station 7+80.
(EMH&T, 9/14/11)

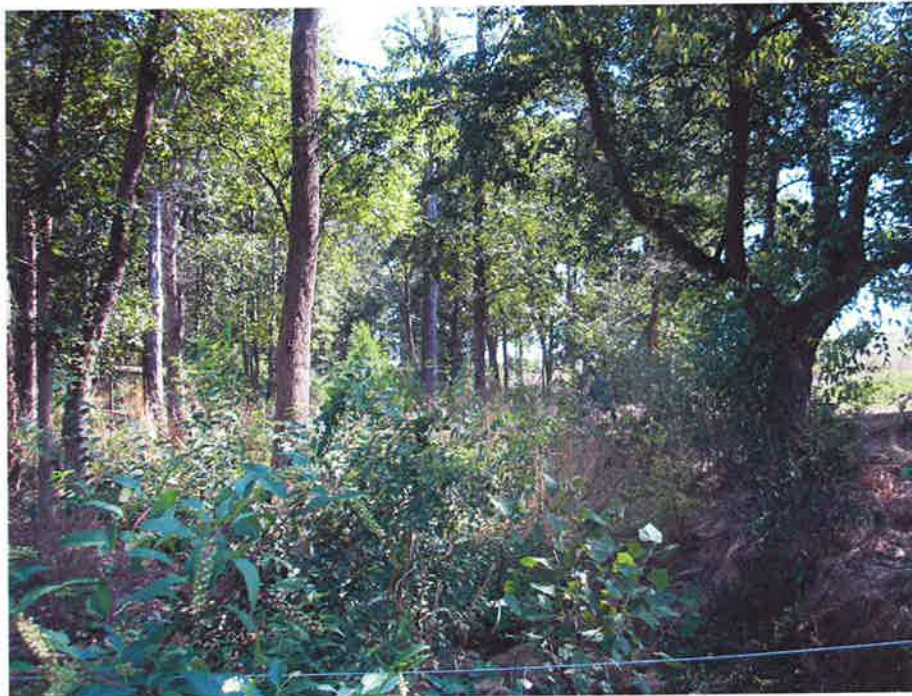
Fixed Station 4
Overview of Davis Branch, looking upstream near Station 25+75.
(EMH&T, 9/14/11)

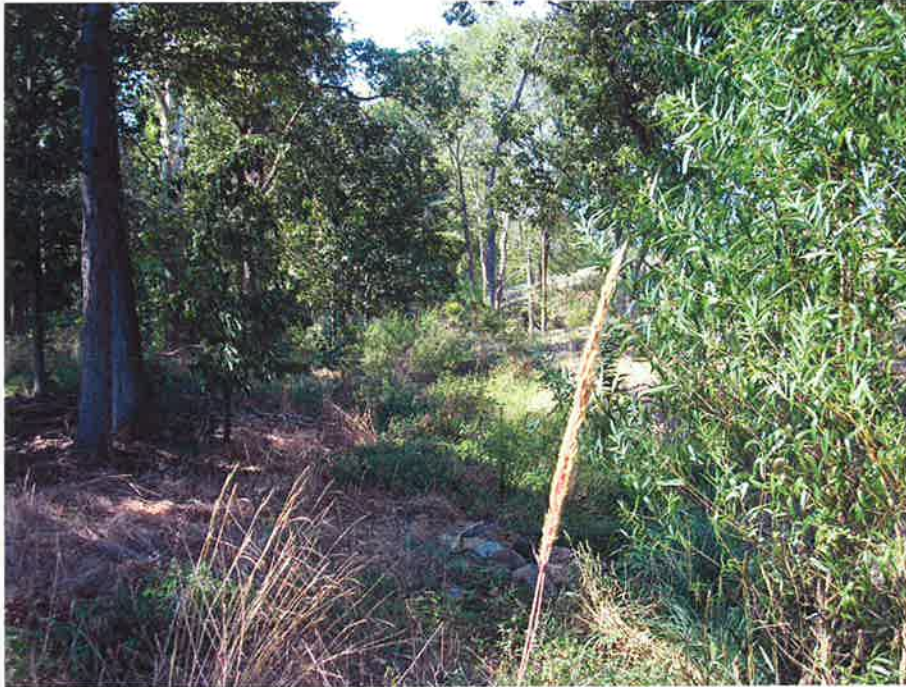
Fixed Station 5
Overview of Davis Branch, looking upstream near Station 27+25.
(EMH&T, 9/14/11)

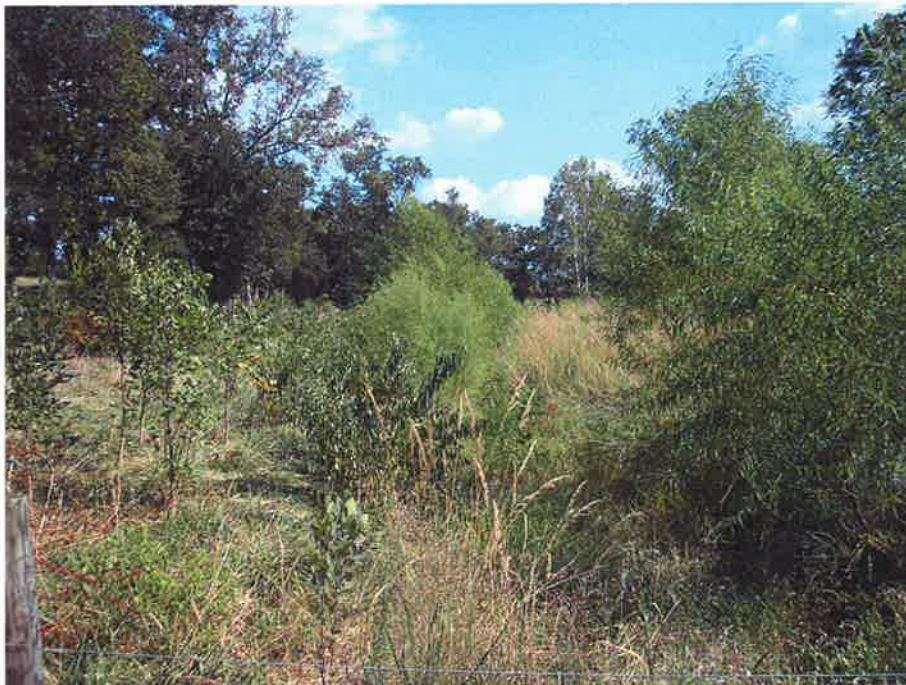
Fixed Station 6
Overview of Davis Branch, looking upstream near Station 38+75.
(EMH&T, 9/14/11)

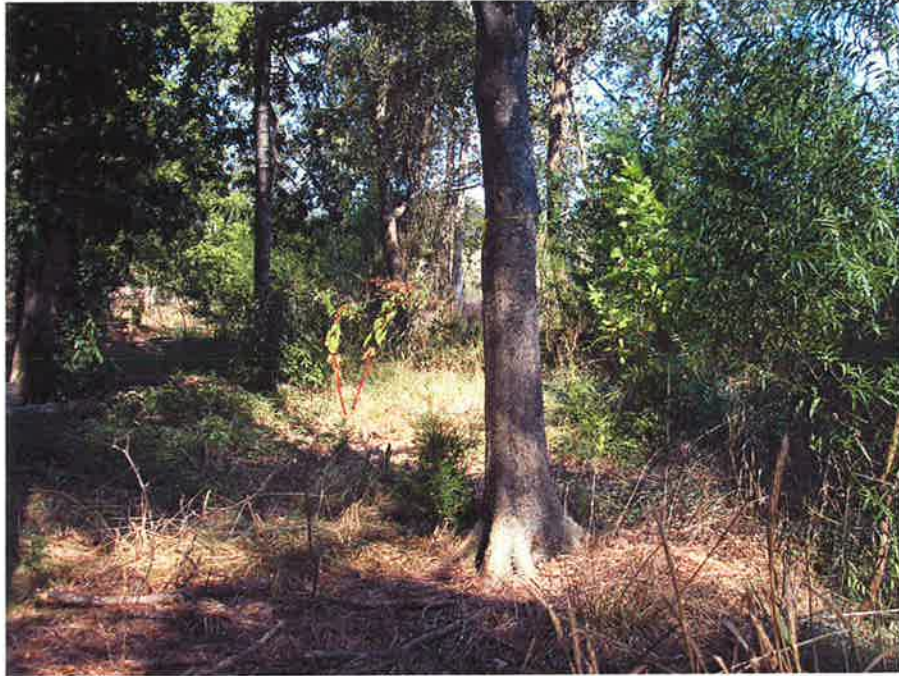
Fixed Station 7
Overview of UT1, looking upstream near Station 6+50.
(EMH&T, 9/14/11)

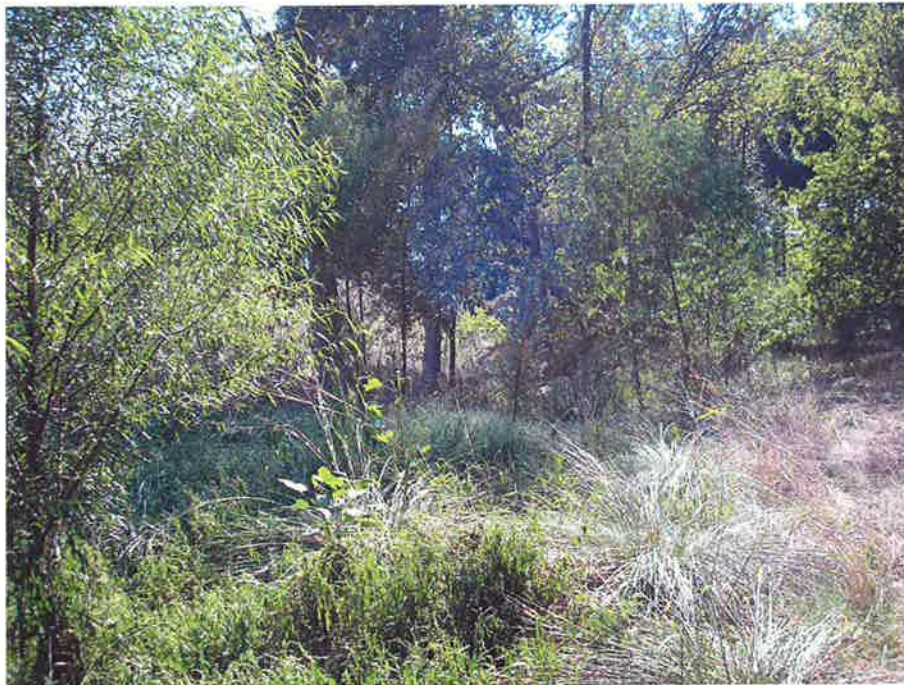
Fixed Station 8
Overview of UT1, looking downstream near Station 4+50.
(EMH&T, 9/14/11)
