Subject: Year 4 Monitoring Report for Stream Mitigation of Davis Branch
SCO# D06054-F

Year 4 Monitoring Report for Stream Restoration of Davis Branch and Unnamed Tributary

Union County, NC
SCO # D06054-F

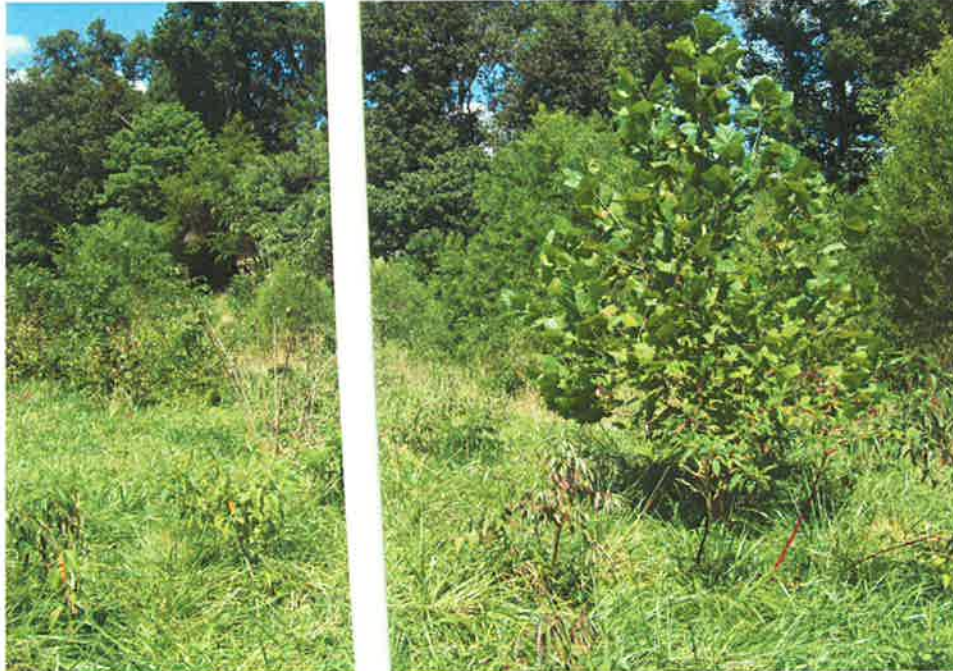
Vegetation Plot 8 - note that flagging tape signifies the location of a bare root planting
Monitoring Year 4
(EMH&T, 9/13/12)

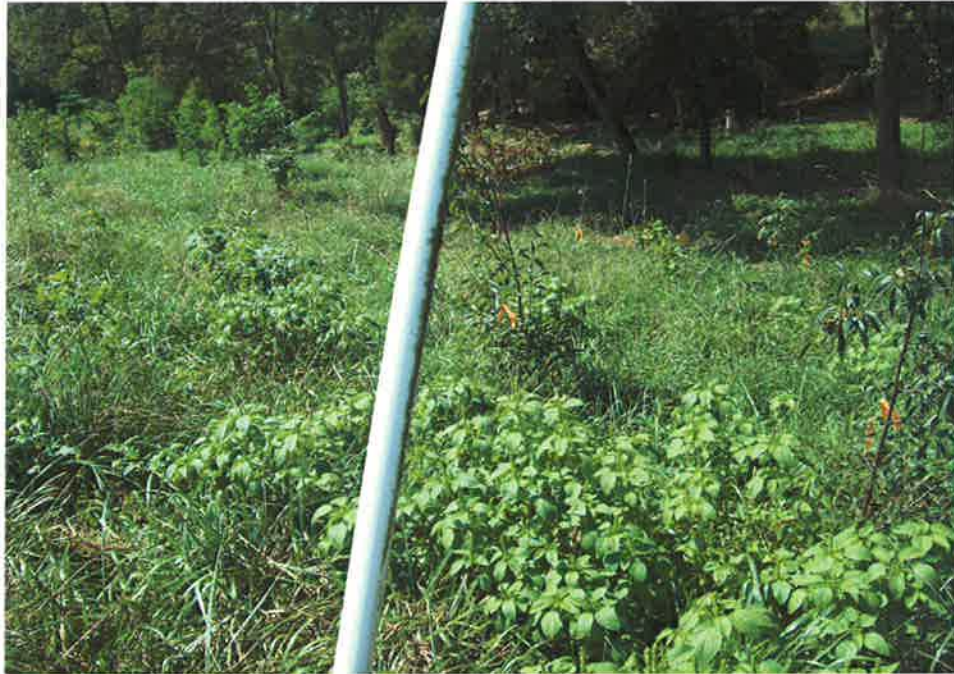
Vegetation Plot 9 – note that flagging tape signifies the location of a bare root planting
Monitoring Year 4
(EMH&T, 9/13/12)

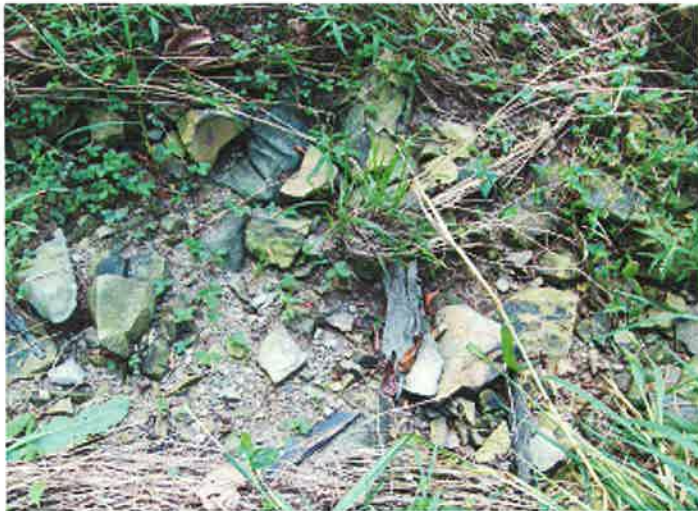
CROSS SECTION: 9
FEATURE: Riffle

Cross-section photo – looking across the channel from right bank to left bank

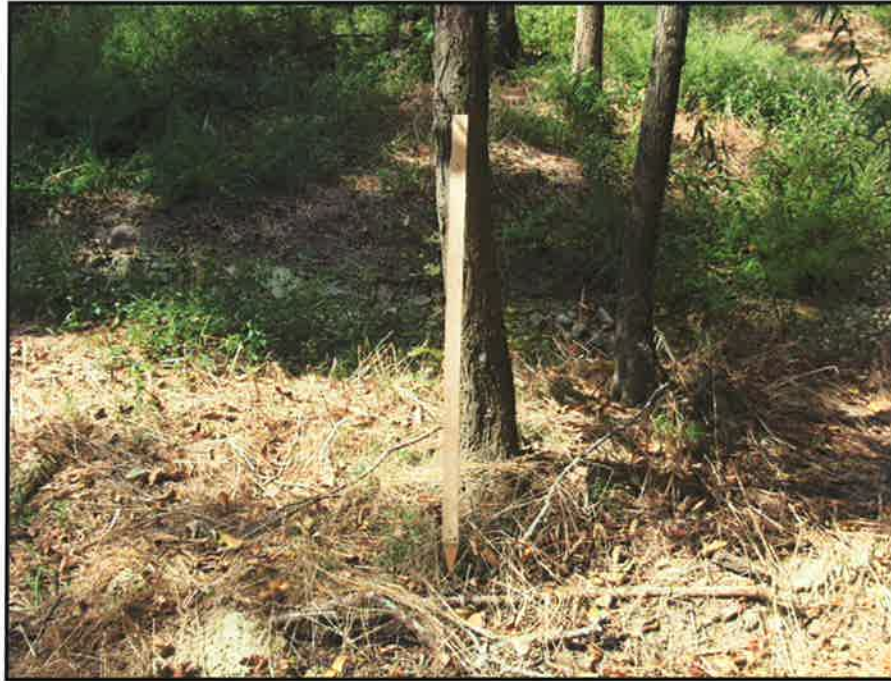
On September 14, 2011, the crest gage on UT1 was observed and indicated a bankfull event at a level of 6 and 5/8 inches above the bottom of the crest gage. The crest gage on the Davis Branch mainstem reach also documented the bankfull event, with a height of 6 and 3/8 inches above the bottom of the crest gage. These crest gages are set at or above the bankfull elevation of each stream channel. Photographs of the crest gages are shown in Appendix B.

BF 1
Crest Gage on the mainstem of Davis Branch (Year 1).
(EMH&T, 9/20/09)

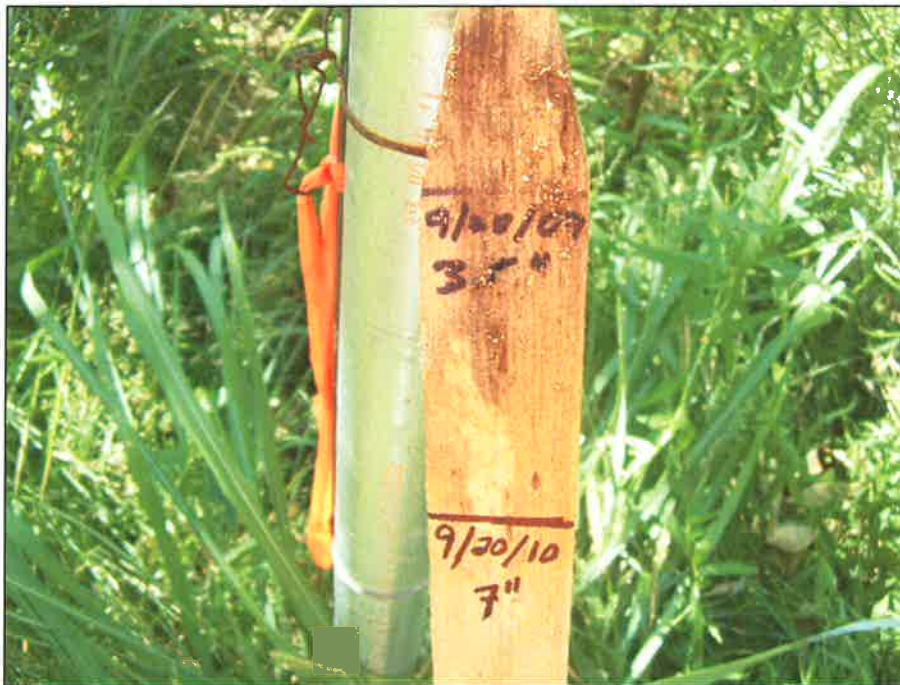
BF 2
Crest Gage on the mainstem of Davis Branch (Year 2).
(EMH&T, 9/20/10)
