Subject: Year 5 Monitoring Report for Stream Mitigation of Davis Branch and UT1; Union County, NC; SCO# D06054-F

# **Year 5 Monitoring Report for Stream Restoration of Davis Branch and Unnamed Tributary**

Union County, NC  
SCO # D06054-F

**Submitted:** January 6, 2014

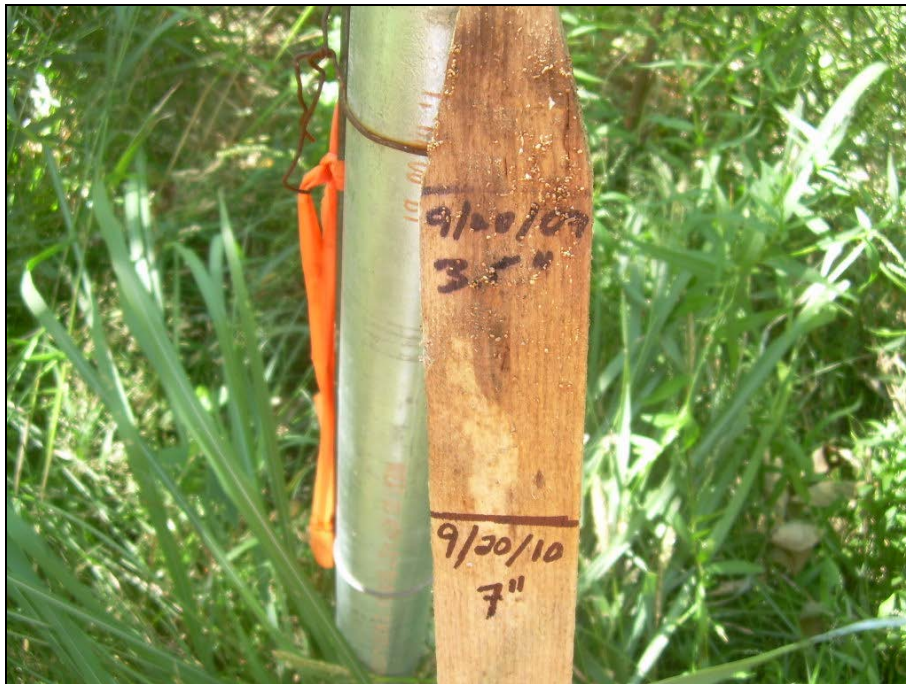
**BF 2**  
**Crest Gage on the mainstem of Davis Branch (Year 2).**  
(EMH&T, 9/20/10)

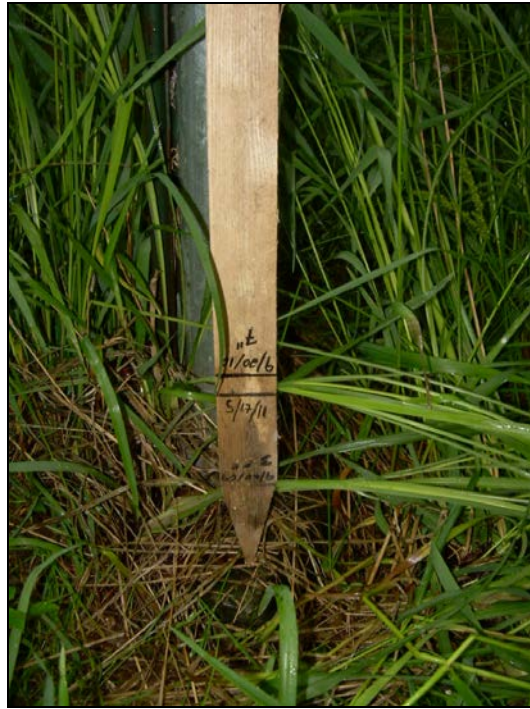
**BF 3**  
**Crest Gage on the mainstem of Davis Branch (Year 3).**  
(EMH&T, 9/14/11)
