ANNUAL REPORT FOR 2004

Fork Creek Tributaries Stream Mitigation Site (Deaton Site)
Randolph County
WBS Element 34820.4.1
TIP No. R-2417WM

Prepared By:
Office of Natural Environment & Roadside Environmental Unit
North Carolina Department of Transportation
October 2004

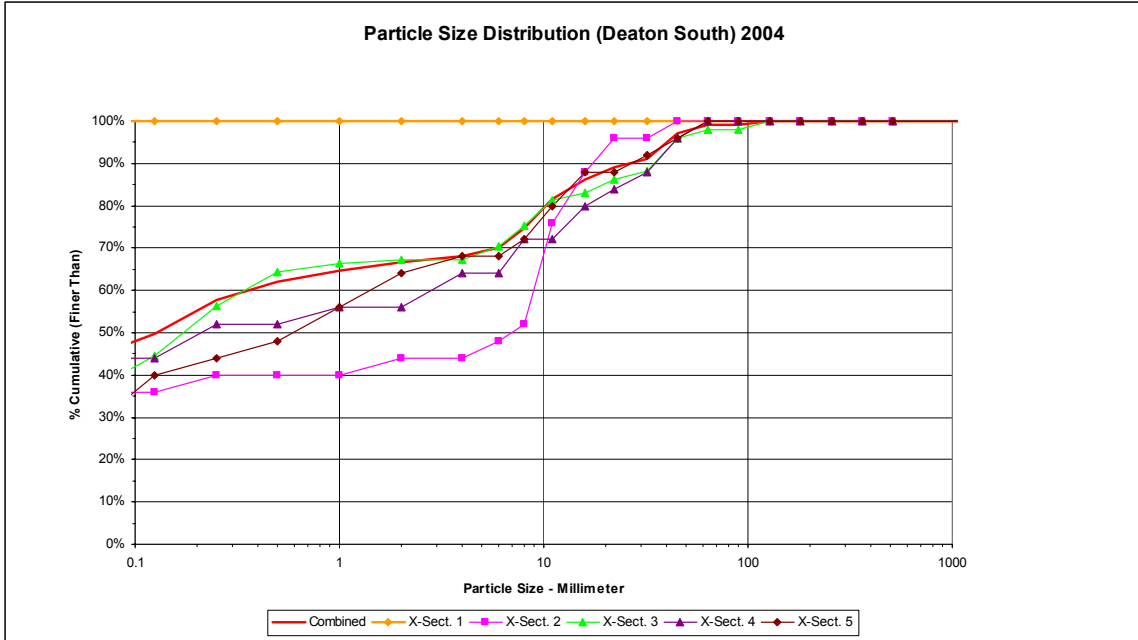
Note: Particle size distribution at Cross Section #1 in 2004 reflects the high level of silt/clay and fine sand in the bed material that is associated with herbaceous vegetation in the active channel.

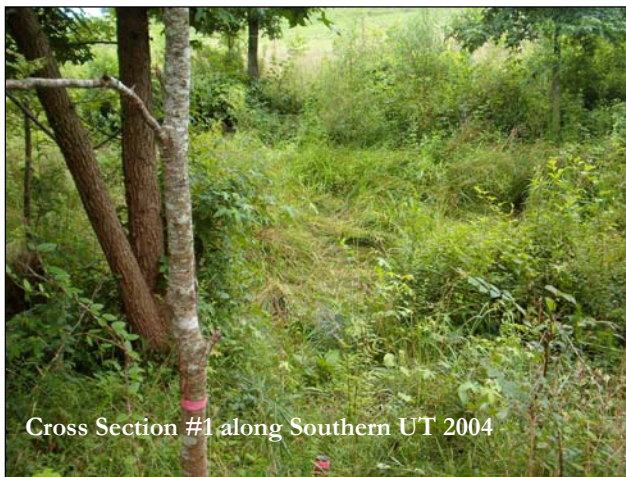
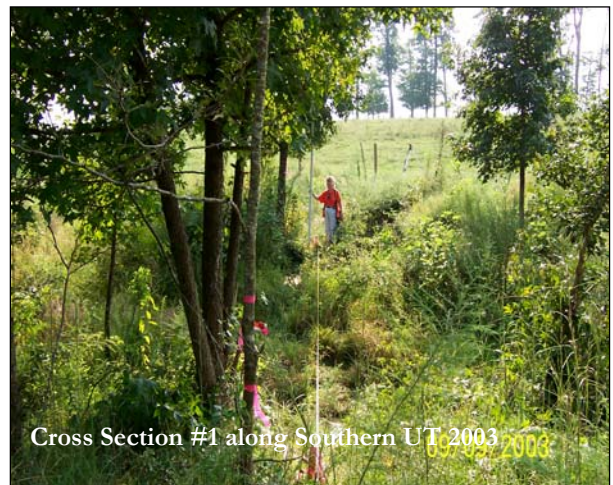
Cross-Section #1 (Pool) Abbreviated Morphological Summary*

2003	2004	2005	2006	2007
Bankfull Cross Sectional Area (ft ²)	6.3	8			
Maximum Bankfull Depth (ft)	1.4	1.5			
Bankfull Mean Depth (ft)	0.7	0.8			
Bankfull Width (ft)	9.2	10.6

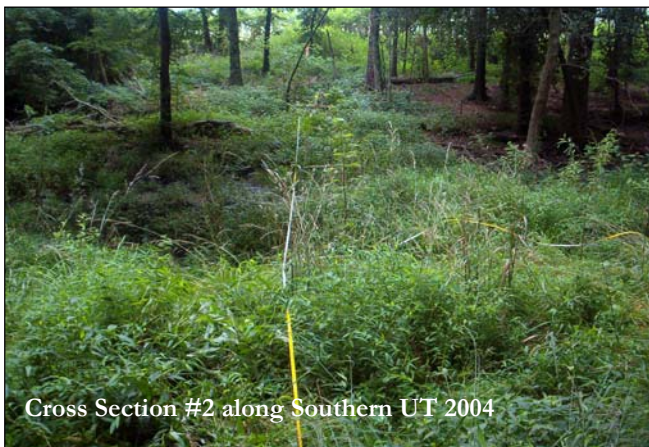
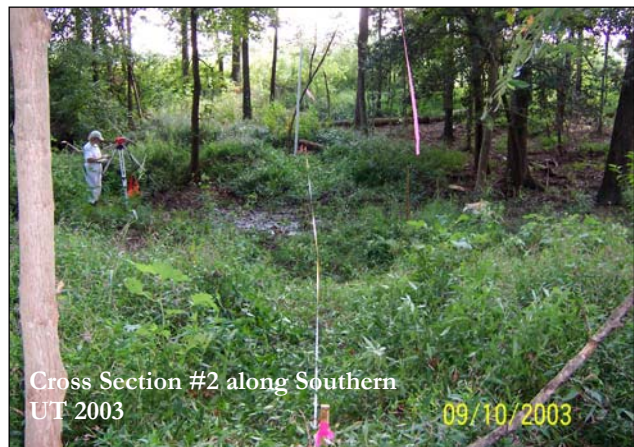
Cross-Section #2 (Riffle) Abbreviated Morphological Summary

2003	2004	2005	2006	2007
Bankfull Cross Sectional Area (ft ²)	3.3	8.2			
Maximum Bankfull Depth (ft)	0.7	1.1			
Bank Height (ft)	0.3	0.4			
Width/Depth Ratio	46	43.4			
Entrenchment Ratio	2.6	1.7			
Bankfull Width (ft)	12.3	18.9

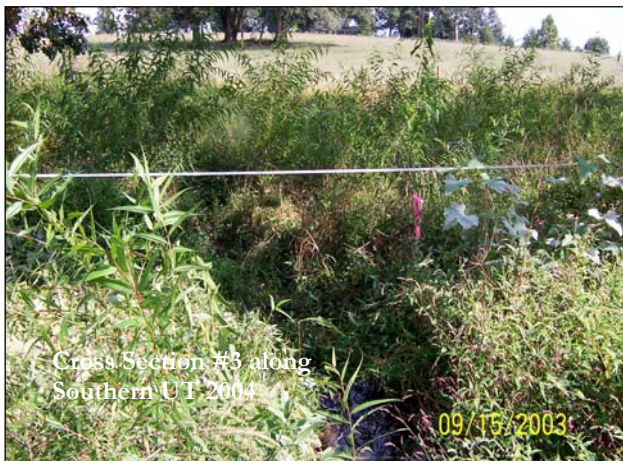
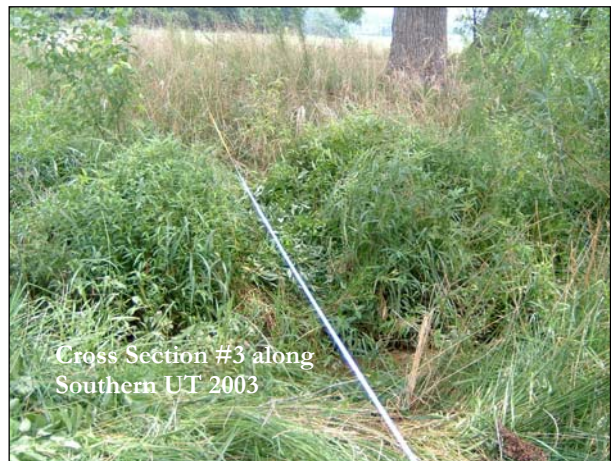
Cross-Section #3 (Glide) Abbreviated Morphological Summary*

2003	2004	2005	2006	2007
Bankfull Cross Sectional Area (ft²)	4.8	4			
Maximum Bankfull Depth (ft)	0.9	1.3			
Bankfull Mean Depth (ft)	0.3	0.6			
Bankfull Width (ft)	16.1	6.3

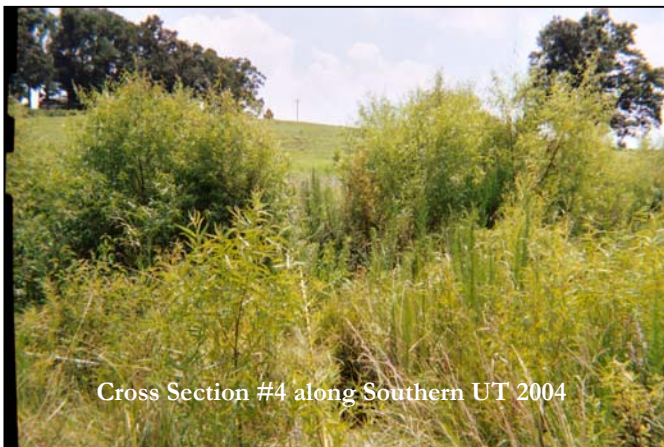
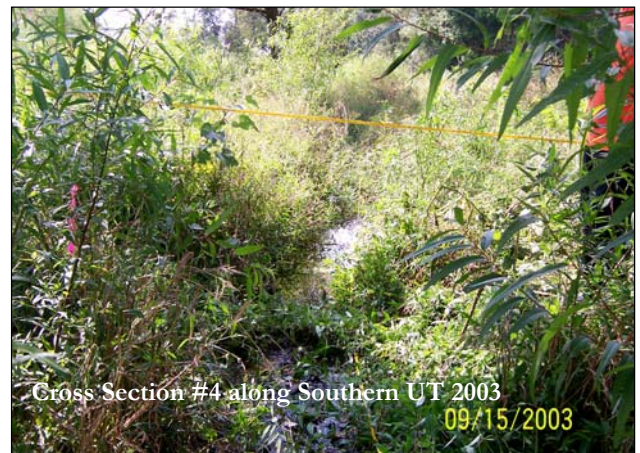
Cross-Section #4 (Rifle) Abbreviated Morphological Summary

2003	2004	2005	2006	2007
Bankfull Cross Sectional Area (ft ²)	4.6	1.6			
Maximum Bankfull Depth (ft)	1	0.6			
Bankfull Mean Depth (ft)	0.6	0.3			
Width/Depth Ratio	13.4	18.7			
Entrenchment Ratio	7.6	10.8			
Bankfull Width (ft)	7.9	5.5

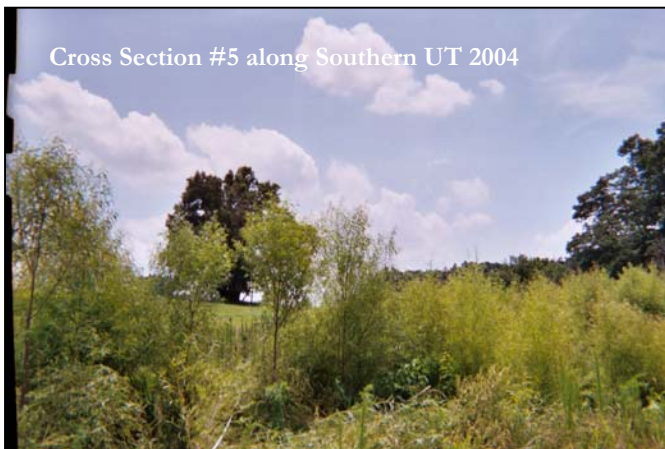
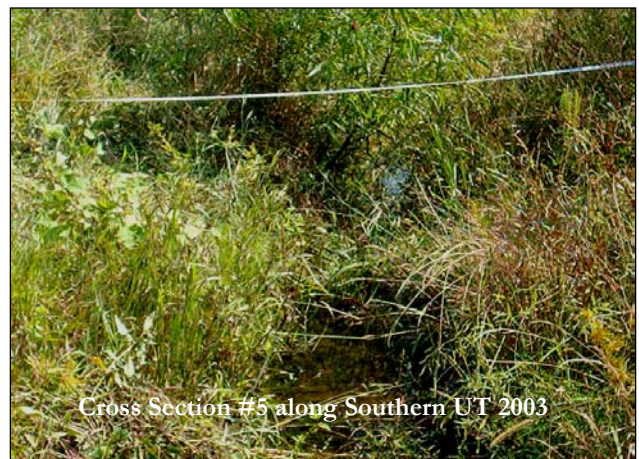
Cross-Section #5 (Pool) Abbreviated Morphological Summary*

2003	2004	2005	2006	2007
Bankfull Cross Sectional Area (ft²)	12.2	7.9			
Maximum Bankfull Depth (ft)	2.3	1.7			
Bankfull Mean Depth (ft)	1.1	0.9			
Bankfull Width (ft)	10.9	8.5

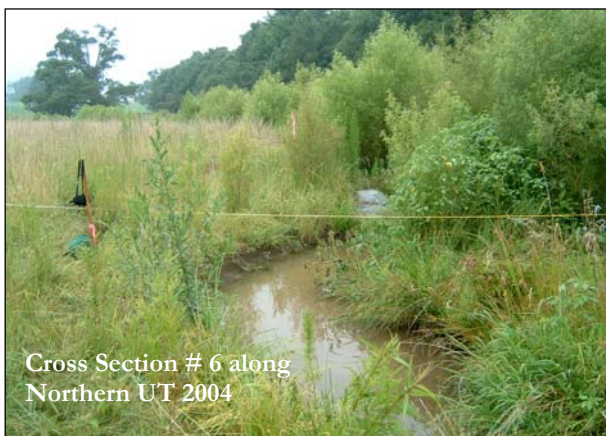
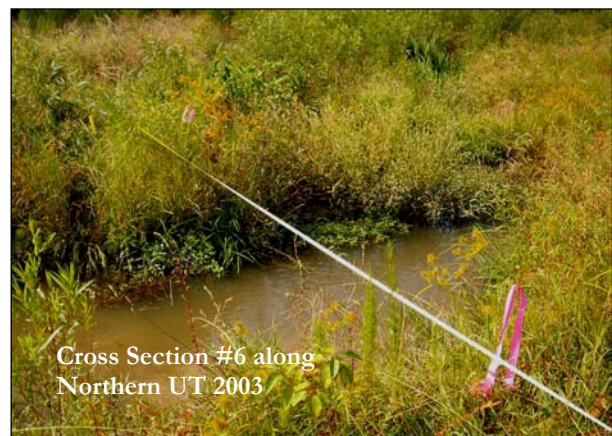
Cross-Section #6 (Pool) Abbreviated Morphological Summary*

2003	2004	2005	2006	2007
Bankfull Cross Sectional Area (ft²)	11.5	19.9			
Maximum Bankfull Depth (ft)	2.2	2.9			
Bankfull Mean Depth (ft)	1	1.4			
Bankfull Width (ft)	11	13.9

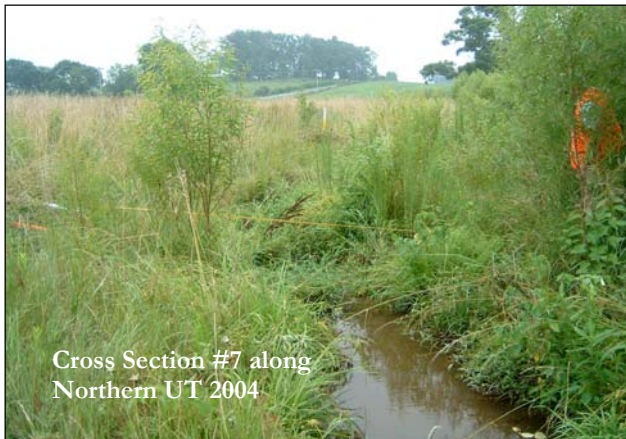
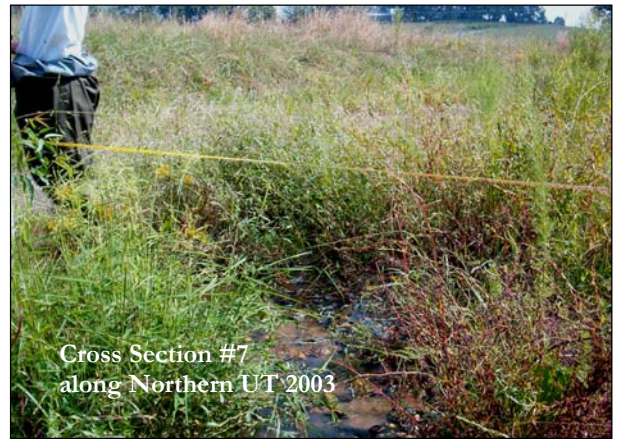
Cross-Section #7 (Riffle) Abbreviated Morphological Summary

2003	2004	2005	2006	2007
Bankfull Cross Sectional Area (ft ²)	10.7	12.3			
Maximum Bankfull Depth (ft)	1.5	1.6			
Bankfull Mean Depth (ft)	0.9	0.8			
Width/Depth Ratio	14.8	19.4			
Entrenchment Ratio	8	6.5			
Bankfull Width (ft)	12.6	15.5

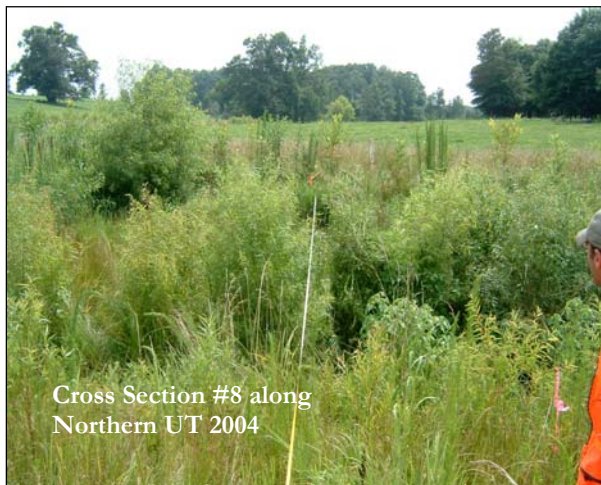
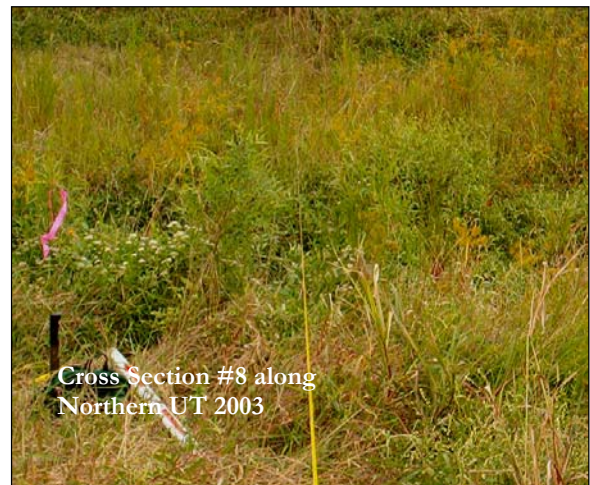
Cross-Section #8 (Riffle) Abbreviated Morphological Summary

2003	2004	2005	2006	2007
Bankfull Cross Sectional Area (ft ²)	10	12.3			
Maximum Bankfull Depth (ft)	1.3	1.5			
Bankfull Mean Depth (ft)	0.9	0.8			
Width/Depth Ratio	13.2	17.1			
Entrenchment Ratio	3.4	2.8			
Bankfull Width (ft)	11.8	14.5

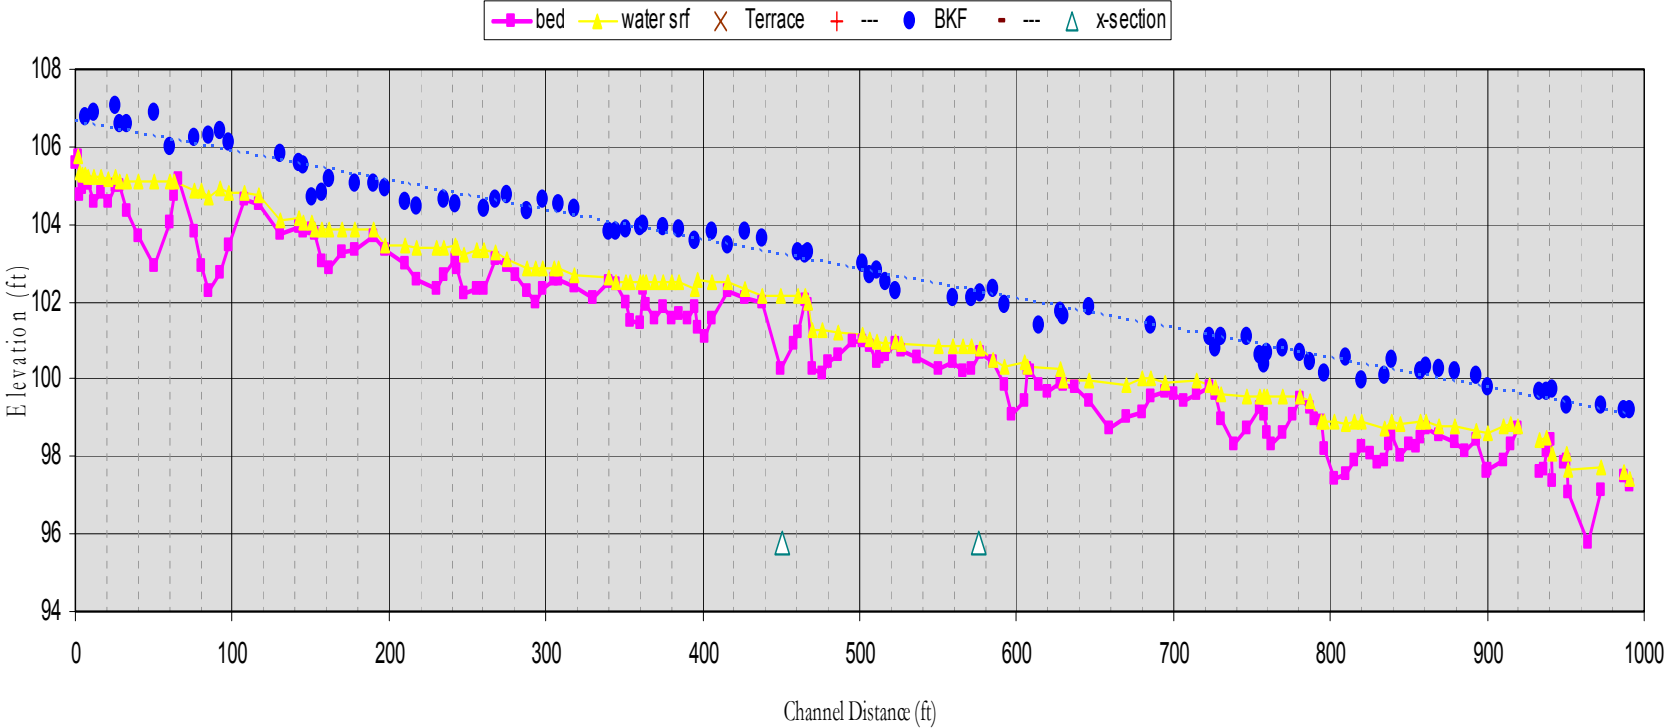
Longitudinal Profile of Deaton North Branch Monitoring Site, 2004

- ◆ Station 1+90 DN. A small transverse bar was observed in the middle of the channel through the riffle section in 2003. As a result, the right bank is exhibiting minor toe scour. This area has become vegetated in 2004 with no areas of scour noted.

- ◆ Station 4+40 DN. Active erosion was noted on the left bank just upstream from the maximum pool depth in 2003. Most of the erosion is due to overland flow spilling over banks with minimal vegetation. This area has become vegetated in 2004 with no areas of scour noted.

- ◆ Station 10+60 DN. Active erosion was noted along right side of cross vane arm in 2003. No erosion was noted in 2004.
- ◆ Pool migration into cattle crossing area was noted in 2004. This should be assessed during the next monitoring period to determine remedial actions, if necessary.

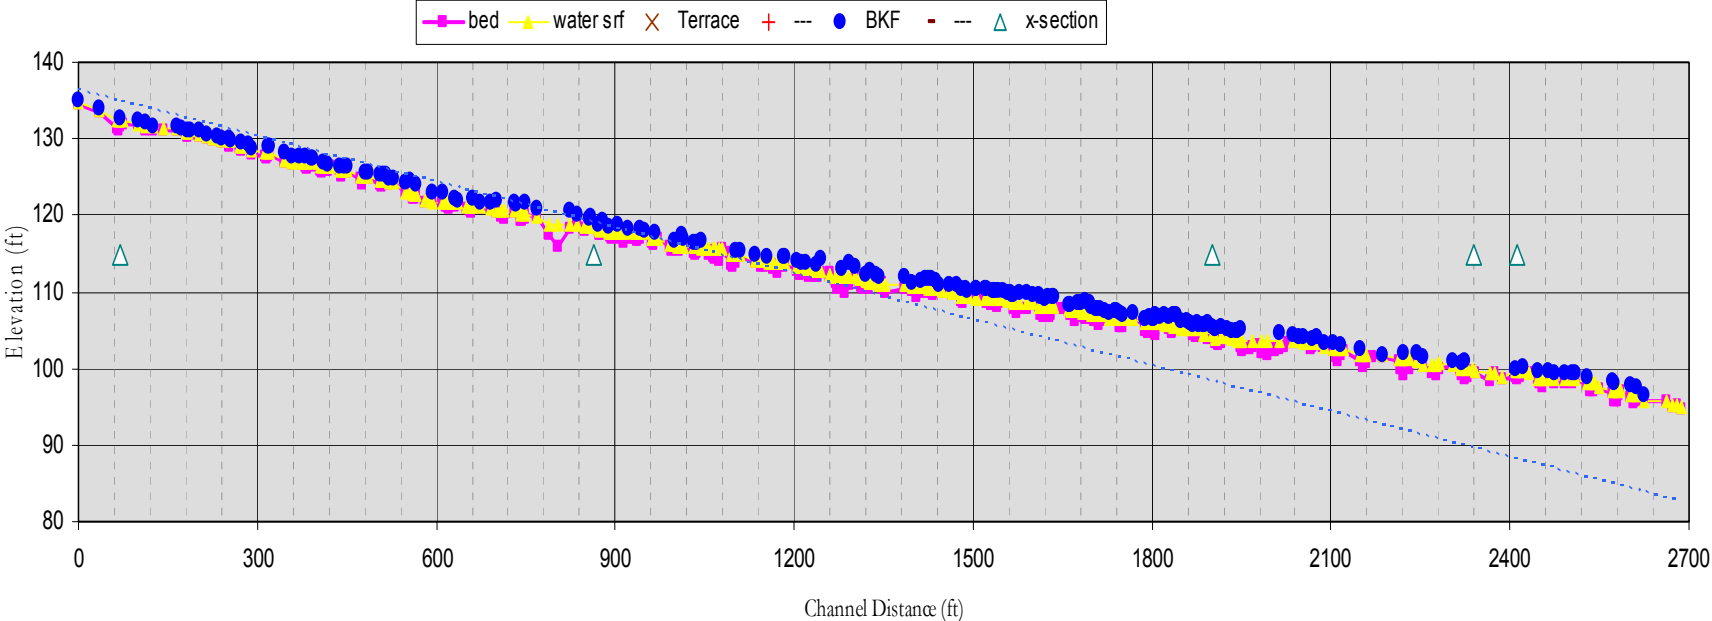
Longitudinal Profile of Deaton South Branch Monitoring Site 2004

- ◆ Station 5+64 DS. Scour was noted around the cross vane structure in 2004. This location should be assessed during the next monitoring period.
- ◆ Station 5+77 DS. Sediment has accumulated and filled the pool below the cross vane. This sediment is not the result of eroding side slopes, rather it is most likely due to a high sediment load dropping out from upstream in the watershed. In addition, the increased amount of vegetation in the channel slows the velocity of water causing sediment to drop out. This location should be assessed during the next monitoring period to determine remedial actions, if necessary.

- ◆ Station 6+06 DS. Active scour was undercutting the outside of the meander bend in 2003. This area has become vegetated in 2004 with no areas of scour noted.

- ◆ Station 7+73 DS. Scour was noted around the cross vane structure in 2004. This location should be assessed during the next monitoring period to determine remedial actions, if necessary.

- ◆ Station 13+47 DS. Several rocks from the cross vane structure had fallen into the middle of the channel in 2003. No erosion was noted, possibly due to the thick herbaceous vegetation growing along the banks and across the channel. This area remained stable in 2004.

- ◆ Station 13+89 DS. The formation of a center bar was observed in 2004. This area is stable and does not warrant any remedial action at this time.
- ◆ Station 14+48 DS. Sediment has accumulated and filled the pool below the cross vane. This sediment is not the result of eroding side slopes; rather it is most likely due to a high sediment load dropping out from upstream in the watershed. This location should be assessed during the next monitoring period to determine remedial actions, if necessary.

- ◆ Station 19+12 DS. A possible headcut was observed between Stations 19+12 and 19+15 in 2003. This has stabilized in 2004 and no remedial action is necessary.

- ◆ Station 23+67 DS. Scour associated with the outside of the meander bend had undercut the bank behind the erosion control matting in 2003. This area has become vegetated in 2004 with no areas of scour noted; no remedial action is necessary.

- ◆ Station 24+67 DS. Several rocks from the cross vane structure have fallen into the middle of the channel on 2003. No erosion was noted, possibly due to the thick herbaceous vegetation growing along the banks and across the channel. This area appeared stable in 2004 and no remedial action is required at this time.
