ANNUAL REPORT FOR 2006 (Year 4)

Fork Creek Tributaries Stream Mitigation Site (Deaton Site)
Randolph County
EEP Project No. 110

January 2007

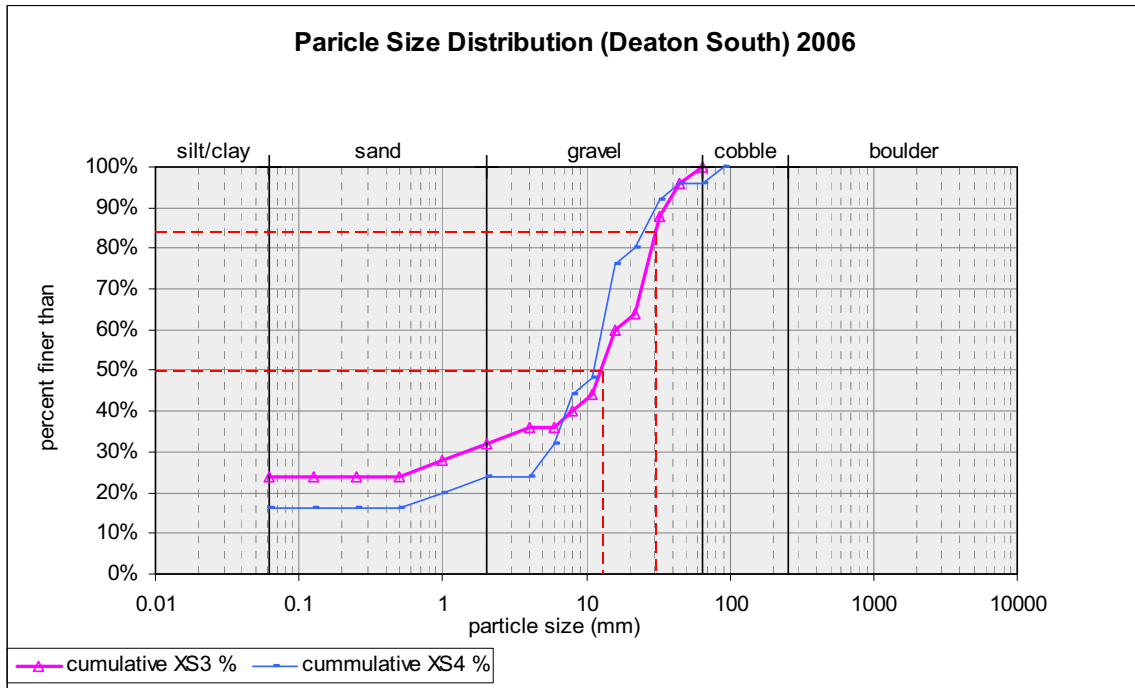
Figure 2. 2006 Deaton South Particle Size Distribution

Pebble counts were conducted at each riffle cross section to determine the composition of bed material during the monitoring period. The comparison of pre-construction bed material data with subsequent monitoring data indicates that a drop in particle size in years 2 and 3 may have been temporary. Charts noting the particle size distributions are presented for the northern and southern UTs in Figures 2 and 3.

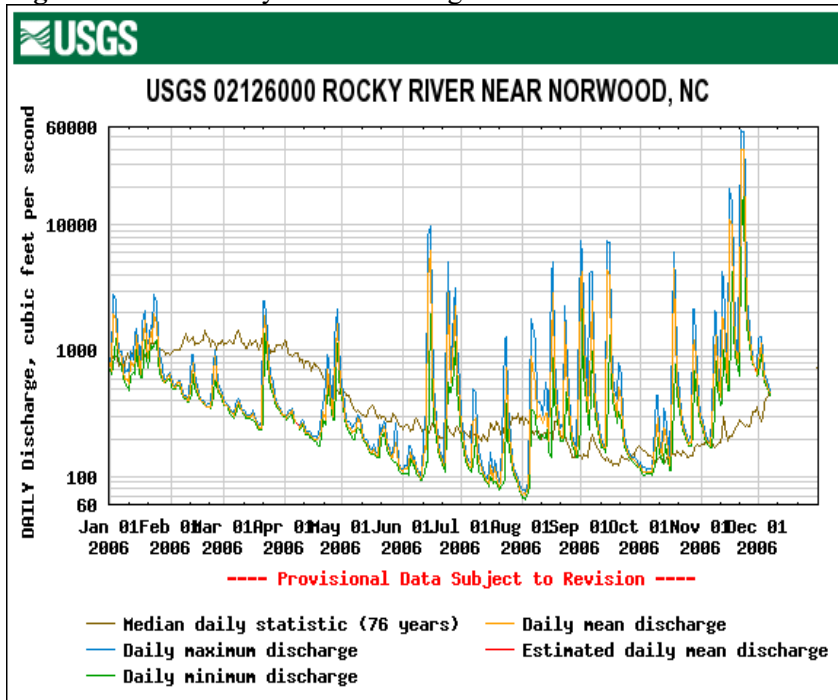
Figure 4. 2006 Rocky River Discharge

Monitoring requirements state that at least two bankfull discharge events must be documented during the five year monitoring period in order for the project to be deemed successful. No stream gauging station exists on Fork Creek or the two unnamed tributaries restored as a result of this project. No crest gauge was installed during monitoring set up. Previous monitoring reports identified the Rocky River USGS stream gauge (02126000) as a suitable gauge to make inferences about flow events at the Deaton project site (Figure 4). This stream gauge has been used to establish the occurrence of bankfull flows for the history of this project. The technique used involves the comparison of discharge data at the gauge site with North Carolina Rural Piedmont discharge regional curve predictions of bankfull discharge. The number of flow events that exceeded the regional curve prediction of bankfull discharge at the gauge was assumed to be the number of bankfull or out-of-bank flow events at the project site. The technique described above utilizing the Rocky River stream gauge would indicate that multiple bankfull or out-of-bank events occurred during 2006. Field observations of bankfull flows at Deaton include wrack lines and flattened vegetation

It is not possible to definitively establish the occurrence of a bankfull flow event at the project site utilizing the above methodology. WKD recommends that a crest gauge be properly installed on each of the two project reaches.
