MONITORING YEAR 3 ANNUAL REPORT

DEEP MEADOW MITIGATION SITE

Union County, NC
Yadkin River Basin
HUC 03040105

DMS Project No. 97131
NC DEQ Contract No. 6887
DWR Certification No. 18-0264
USACE Action ID No. SAW-2012-01107
Data Collection Period: March 2022 – November 2022
Final Submission Date: February 2023

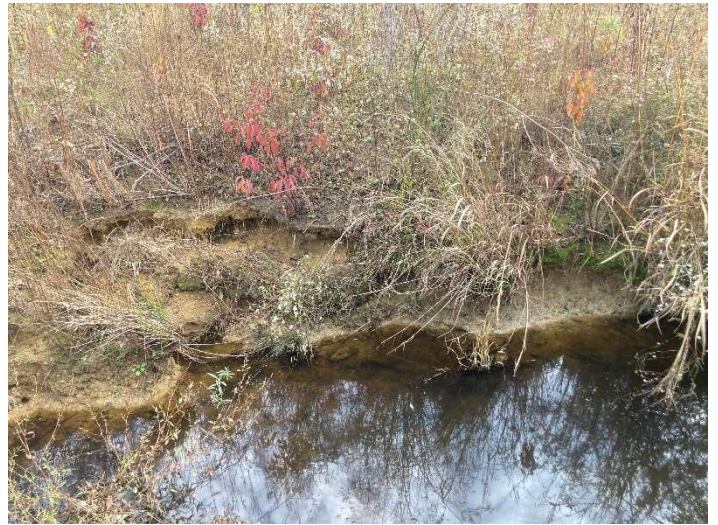
Meadow Branch, station 111+20 – Bank scour (11/02/2022)

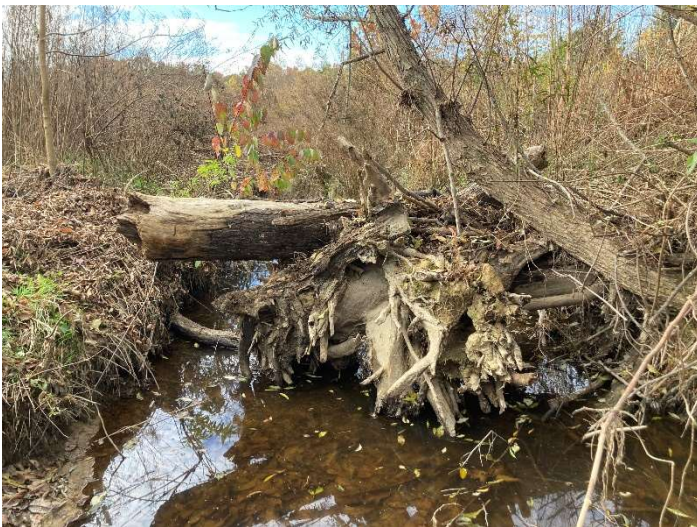
Meadow Branch, station 112+40 – Debris jam (11/02/2022)

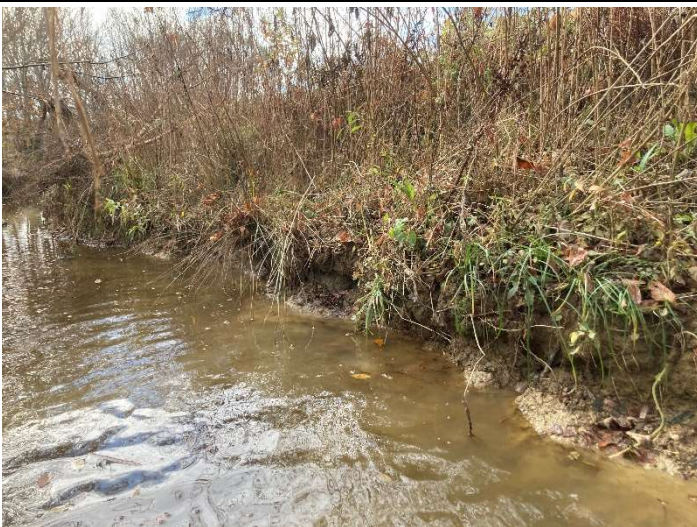
Meadow Branch, station 113+50 – Bank scour (11/02/2022)

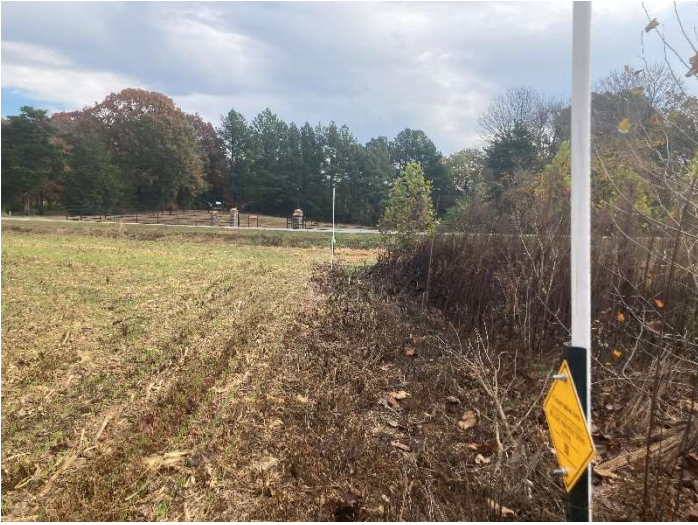
EF1, easement boundary – Encroachment (11/02/2022)

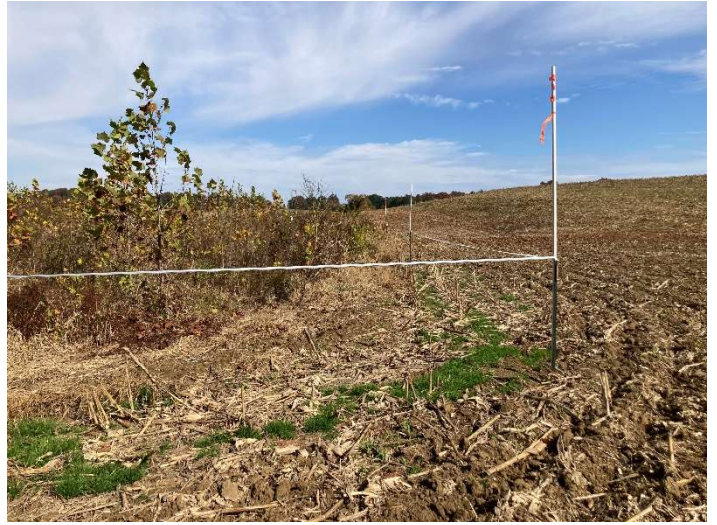
Meadow Branch, easement boundary – Encroachment (11/02/2022)
