MONITORING YEAR 1 ANNUAL REPORT

DEEP MEADOW MITIGATION SITE

Union County, NC

DMS Project No. 97131

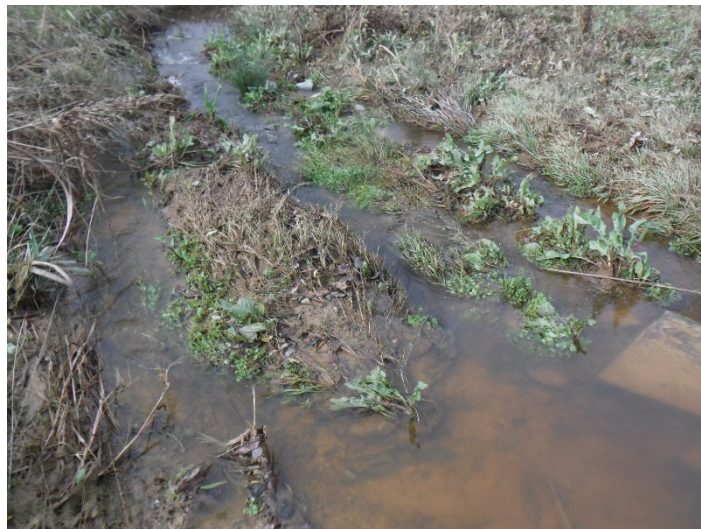
EF1 Vegetation in Channel at Station 212+70 (11/13/2020)

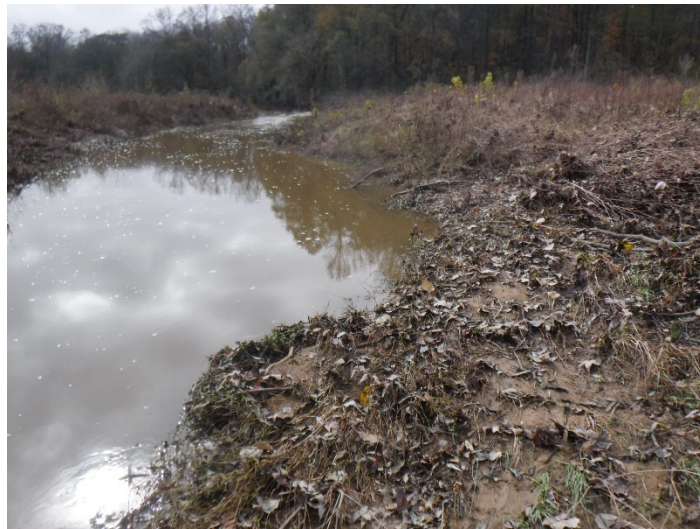
Issue: Structure washed out on Meadow Branch at station 103+50 (11/13/2020)
