# MONITORING YEAR 4 ANNUAL REPORT

## DEEP MEADOW MITIGATION SITE

Union County, NC  
Yadkin River Basin  
HUC 03040105

DMS Project No. 97131  
NC DEQ Contract No. 6887  
DWR Certification No. 18-0264  
USACE Action ID No. SAW-2012-01107  
Data Collection Period: January 2023 – November 2023

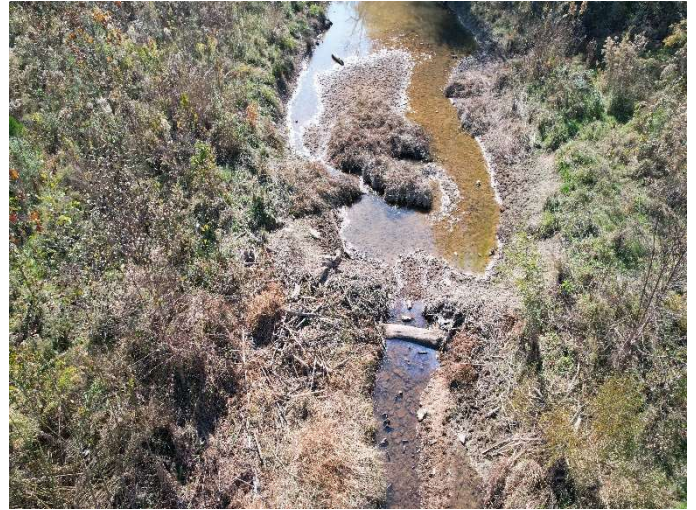
**Meadow Branch, station 101+80, aerial photo** – Recurring beaver dam and associated aggradation (11/7/2023)

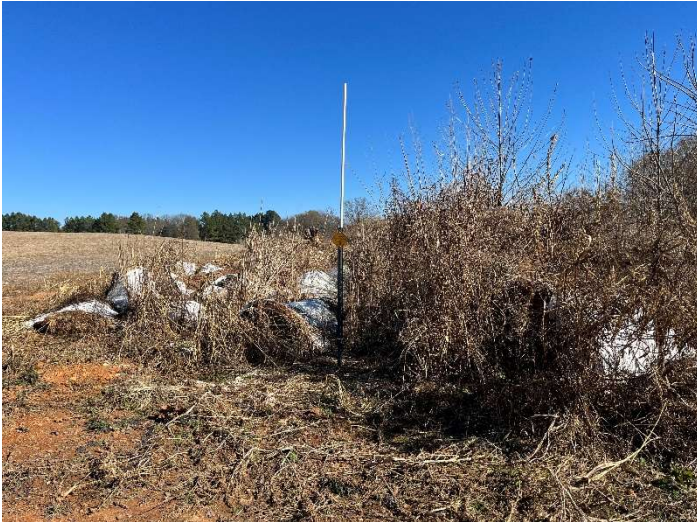
**Between Platted Corners 2 and 3 – Easement encroachment, haybales within easement (11/28/2023)**

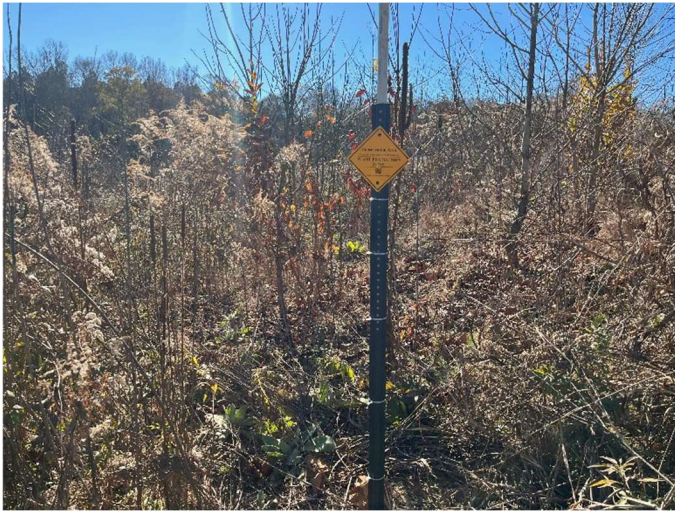
**Easement Corner 36** – New easement post (11/29/2023)

*Wildlands' response: Wildlands replaced missing and damaged signposts, PVC markers and easement signs in November 2023. New horse tape was pulled in areas where the tape was broken. Wildlands will continue to replace yellow plastic clips as the opportunity presents itself.*

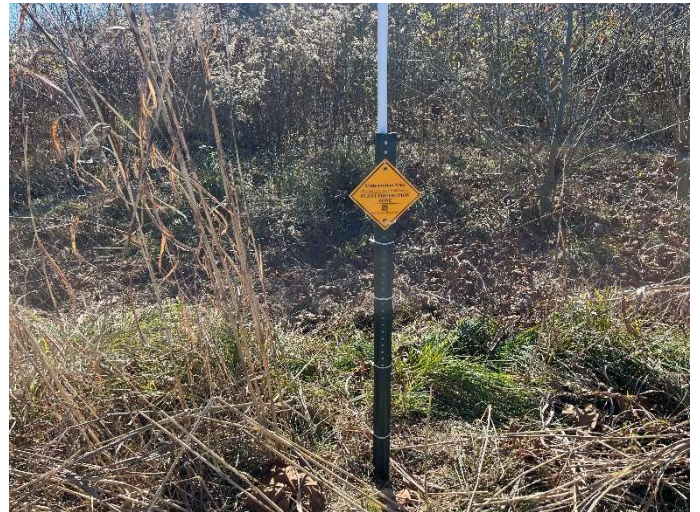
**Easement Corner 37** – New easement post (11/29/2023)

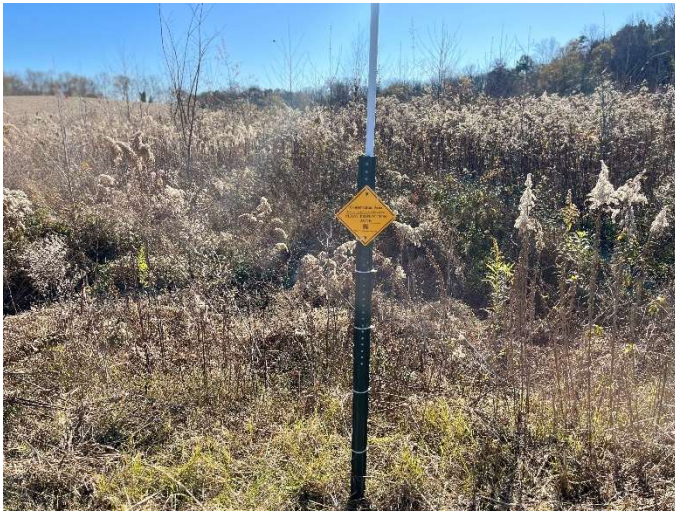
**Easement Corner 38** – New easement post (11/29/2023)

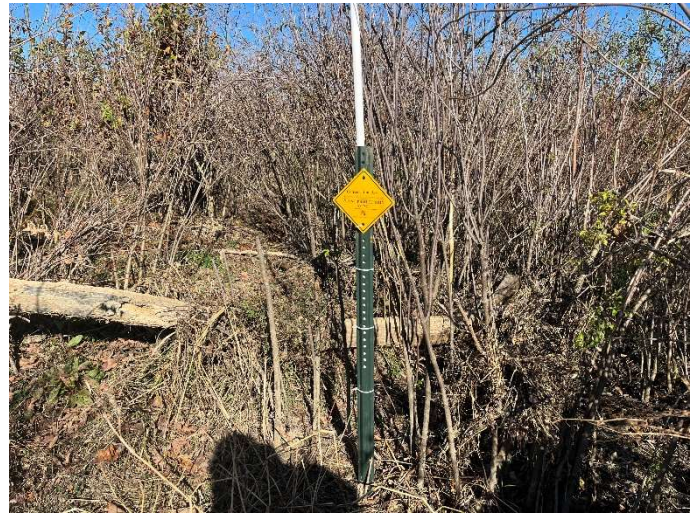
**Easement Corner 12** – New easement post (11/29/2023)

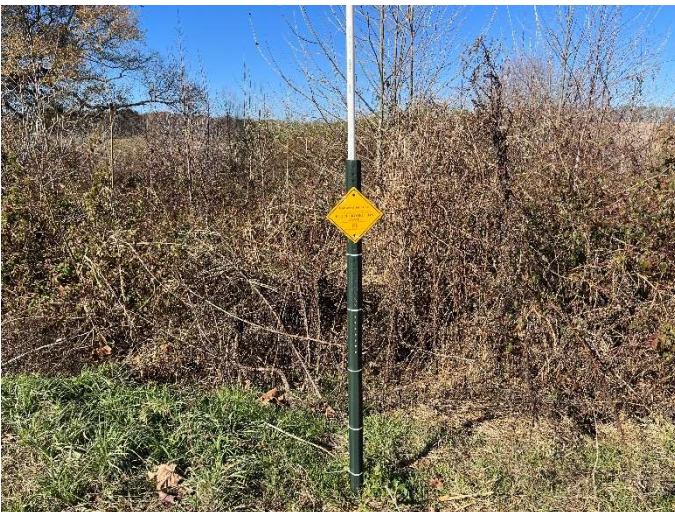
**Easement Corner 8** – New easement post (11/29/2023)

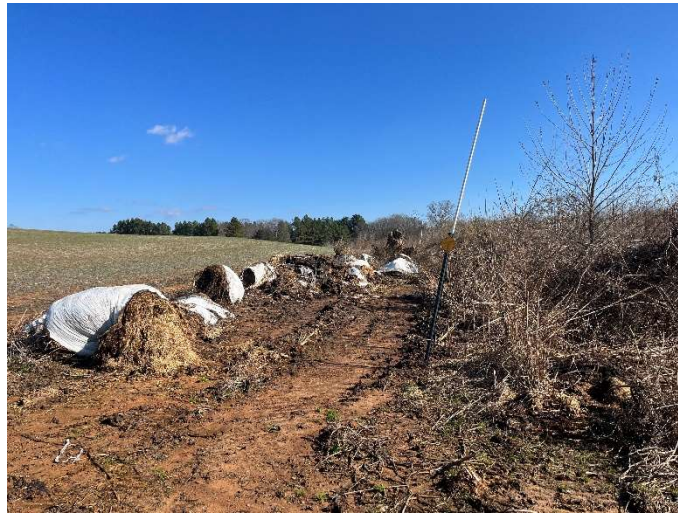
**Between Easement Corners 2 and 3 – Hay bales removed from easement boundary (01/04/2024)**

2. **DMS' comment: Remove equipment and hay from the easement, recommend additional marking or taping around this crossing area to deter equipment parking and hay encroachments.**
