MONITORING YEAR 4 ANNUAL REPORT

DEVIL'S RACETRACK MITIGATION SITE

Johnston County, NC

DMS Project Number 95021

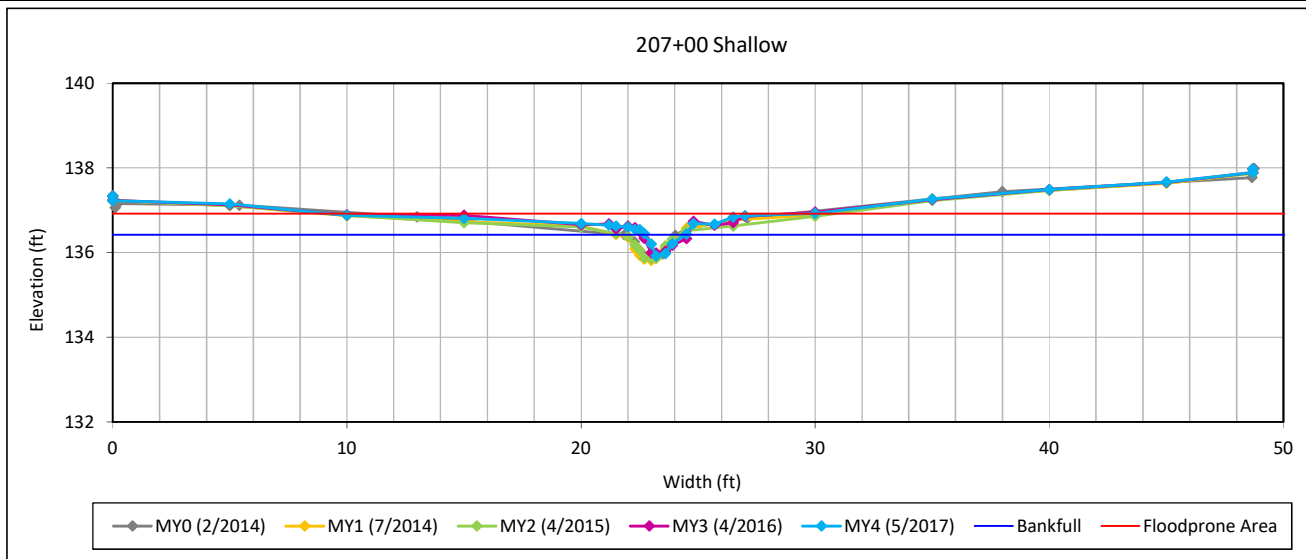
Cross Section 24-Middle Branch

0.4	x-section area (ft.sq.)
1.2	width (ft)
0.3	mean depth (ft)
0.5	max depth (ft)
1.5	wetted parimeter (ft)
0.3	hyd radi (ft)
3.5	width-depth ratio
50.0	W flood prone area (ft)
42.9	entrenchment ratio
1.0	low bank height ratio

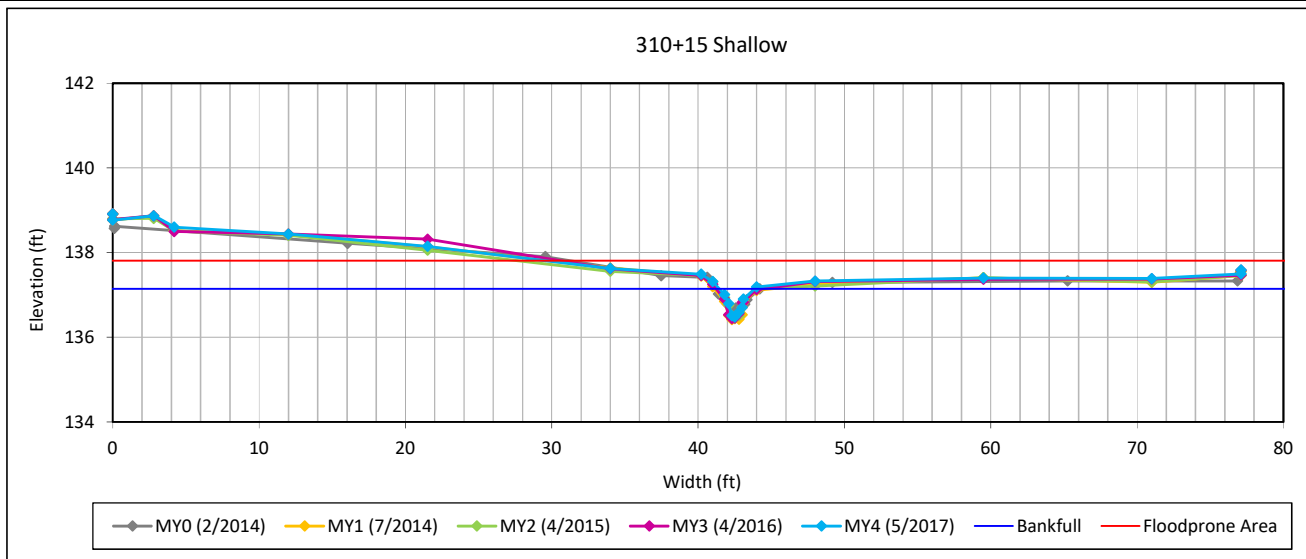
Cross Section 29-Southeast Branch

0.7	x-section area (ft.sq.)
2.4	width (ft)
0.3	mean depth (ft)
0.7	max depth (ft)
2.9	wetted parimeter (ft)
0.3	hyd radi (ft)
7.9	width-depth ratio
30.0	W flood prone area (ft)
12.5	entrenchment ratio
1.0	low bank height ratio

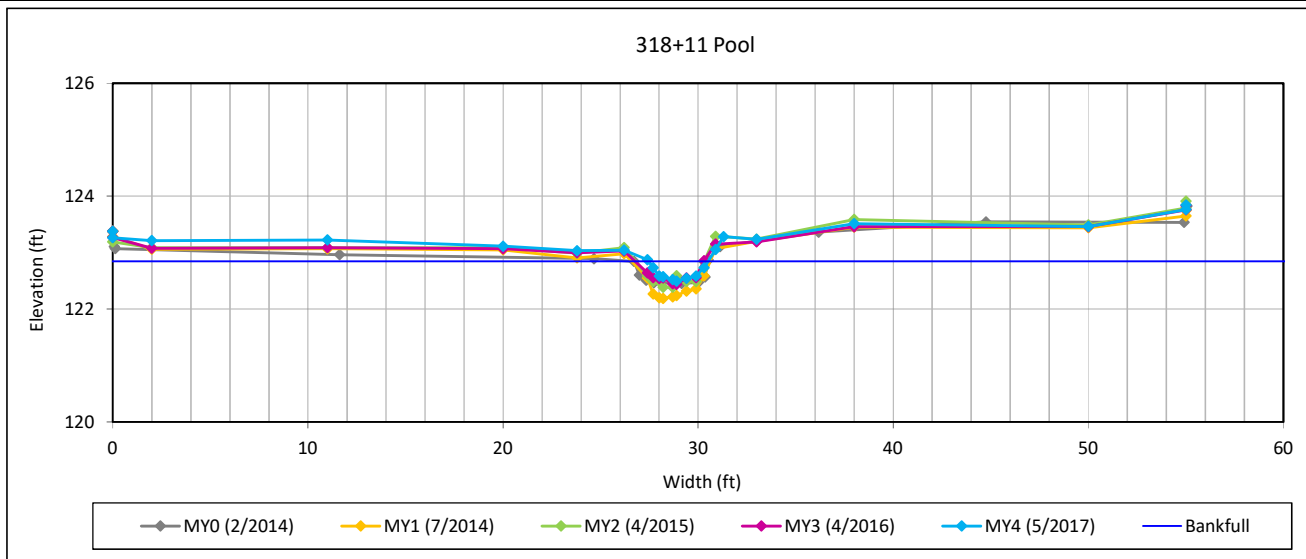
Cross Section 30-Southeast Branch

0.7	x-section area (ft.sq.)
3.0	width (ft)
0.2	mean depth (ft)
0.4	max depth (ft)
3.2	wetted parimeter (ft)
0.2	hyd radi (ft)
12.7	width-depth ratio

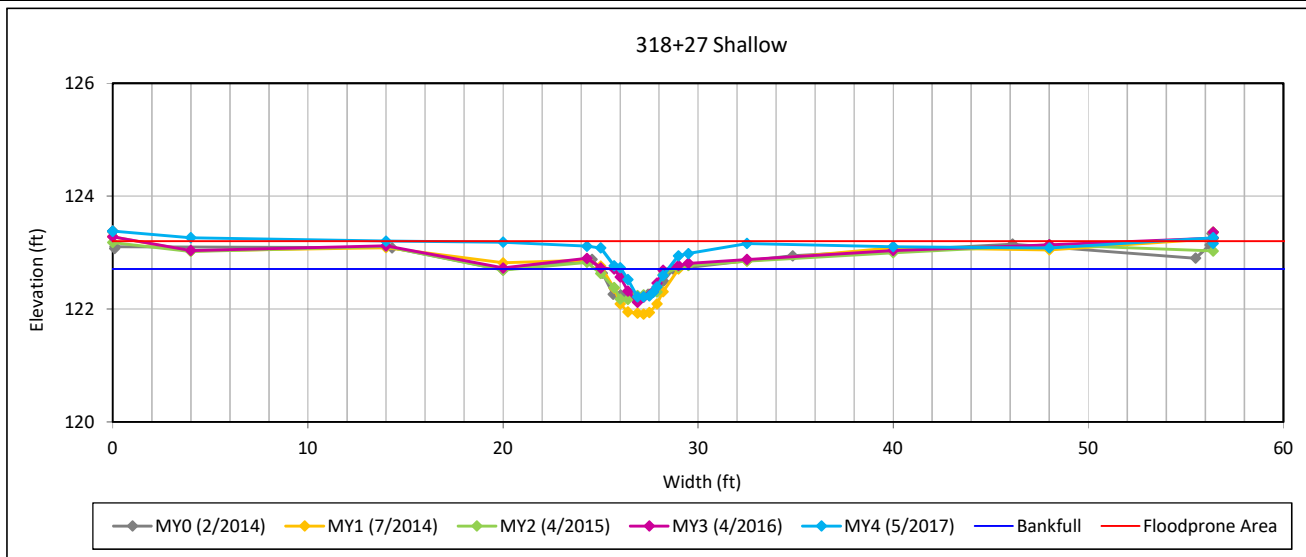
Cross Section 31-Southeast Branch

0.7	x-section area (ft.sq.)
2.4	width (ft)
0.3	mean depth (ft)
0.5	max depth (ft)
2.7	wetted parimeter (ft)
0.3	hyd radi (ft)
7.9	width-depth ratio
60.0	W flood prone area (ft)
24.9	entrenchment ratio
1.0	low bank height ratio

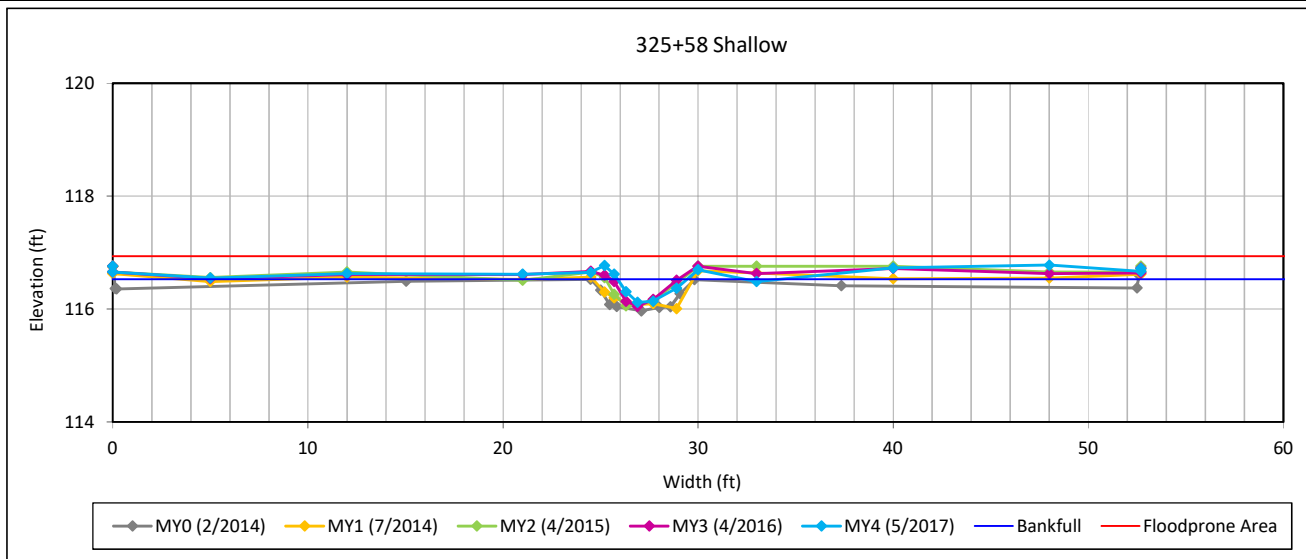
Cross Section 32-Southeast Branch

0.9	x-section area (ft.sq.)
3.5	width (ft)
0.3	mean depth (ft)
0.4	max depth (ft)
3.7	wetted parimeter (ft)
0.3	hyd radi (ft)
13.7	width-depth ratio
200.0	W flood prone area (ft)
56.4	entrenchment ratio
1.0	low bank height ratio

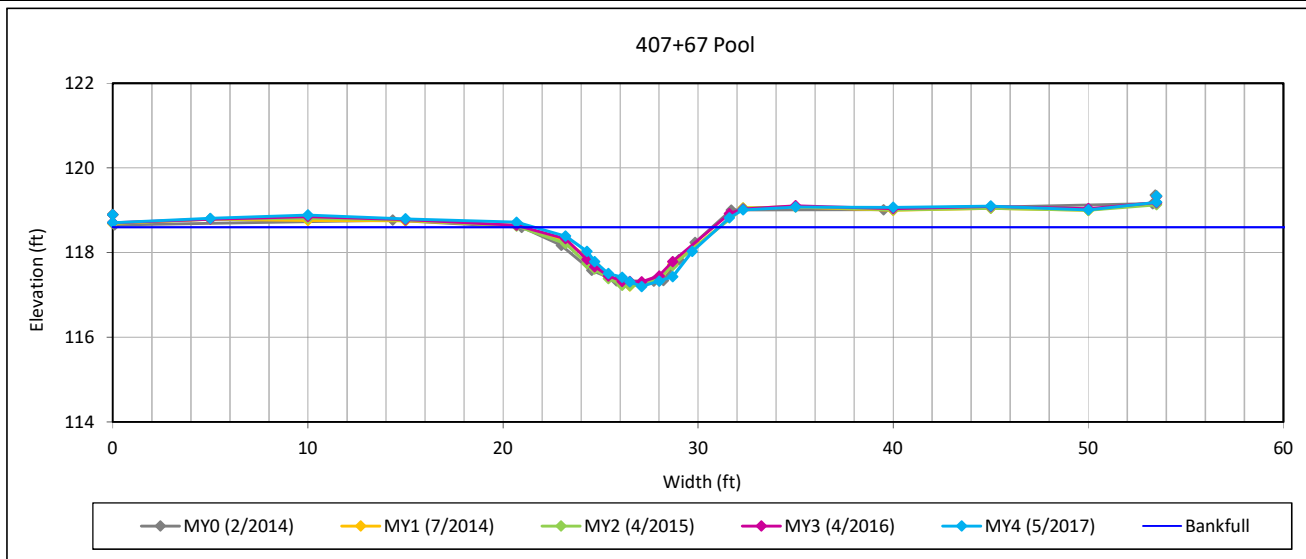
Cross Section 34-North Branch

6.9	x-section area (ft.sq.)
9.5	width (ft)
0.7	mean depth (ft)
1.4	max depth (ft)
10.0	wetted parimeter (ft)
0.7	hyd radi (ft)
12.9	width-depth ratio

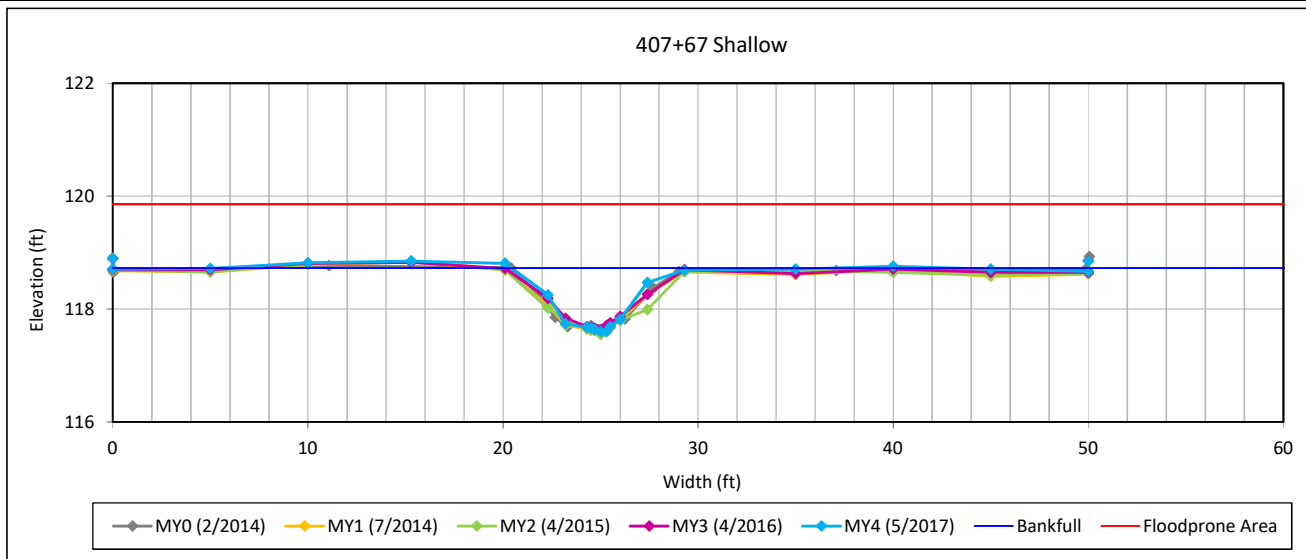
Cross Section 35-North Branch

5.1	x-section area (ft.sq.)
8.9	width (ft)
0.6	mean depth (ft)
1.1	max depth (ft)
9.3	wetted parimeter (ft)
0.6	hyd radi (ft)
15.4	width-depth ratio
200.0	W flood prone area (ft)
22.5	entrenchment ratio
1.0	low bank height ratio

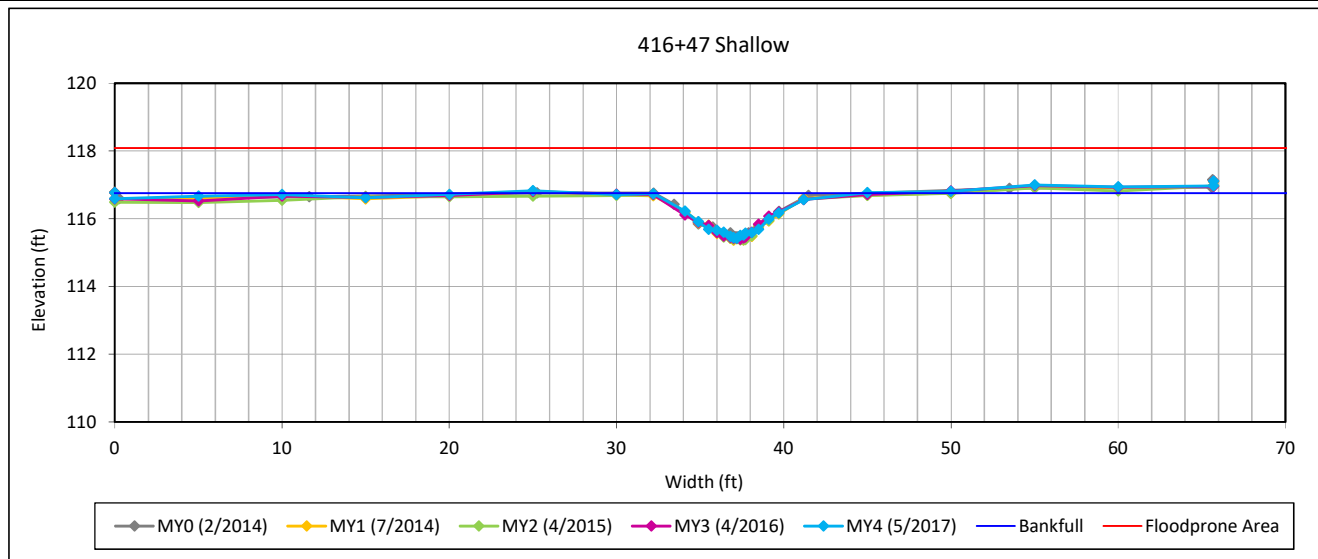
Cross Section 36-North Branch

6.7	x-section area (ft.sq.)
9.0	width (ft)
0.7	mean depth (ft)
1.3	max depth (ft)
9.4	wetted parimeter (ft)
0.7	hyd radi (ft)
12.0	width-depth ratio
200.0	W flood prone area (ft)
22.2	entrenchment ratio
1.0	low bank height ratio

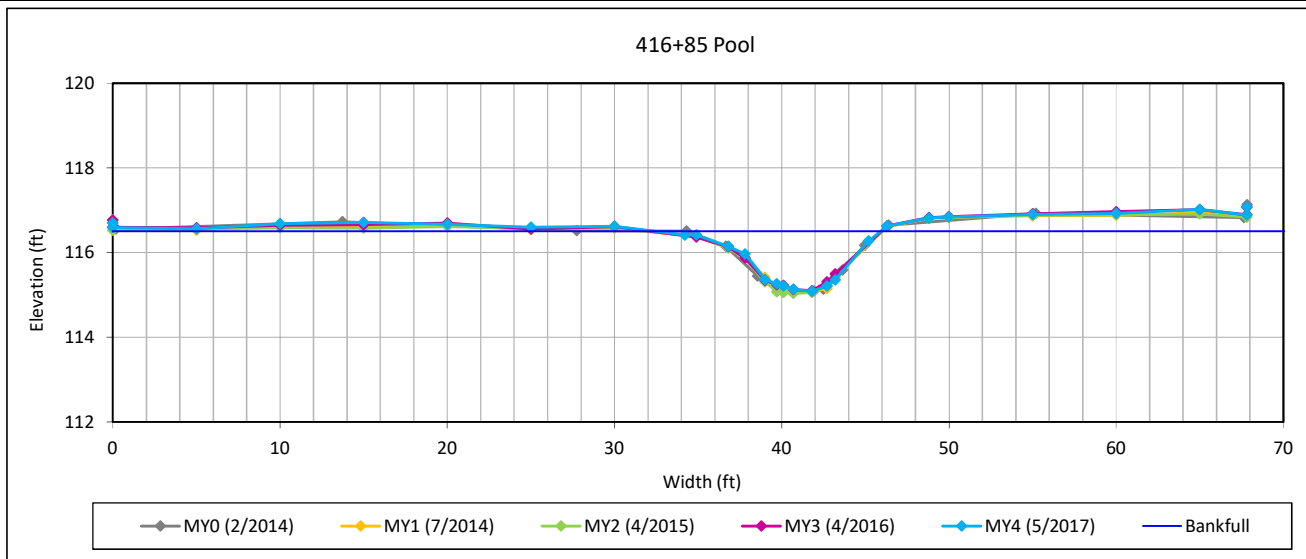
Cross Section 37-North Branch

8.9	x-section area (ft.sq.)
11.7	width (ft)
0.8	mean depth (ft)
1.4	max depth (ft)
12.2	wetted parimeter (ft)
0.7	hyd radi (ft)
15.4	width-depth ratio
