MONITORING YEAR 6 ANNUAL REPORT FINAL

DEVIL'S RACETRACK MITIGATION SITE

Johnston County, NC
NCDEQ Contract 003989
DMS Project Number 95021
USACE Action ID Number 2012-00810
NCDWR Project Number 12-0747

Data Collection Period: March - November 2019
Draft Submission Date: December 20, 2019
Final Submission Date: February 20, 2020

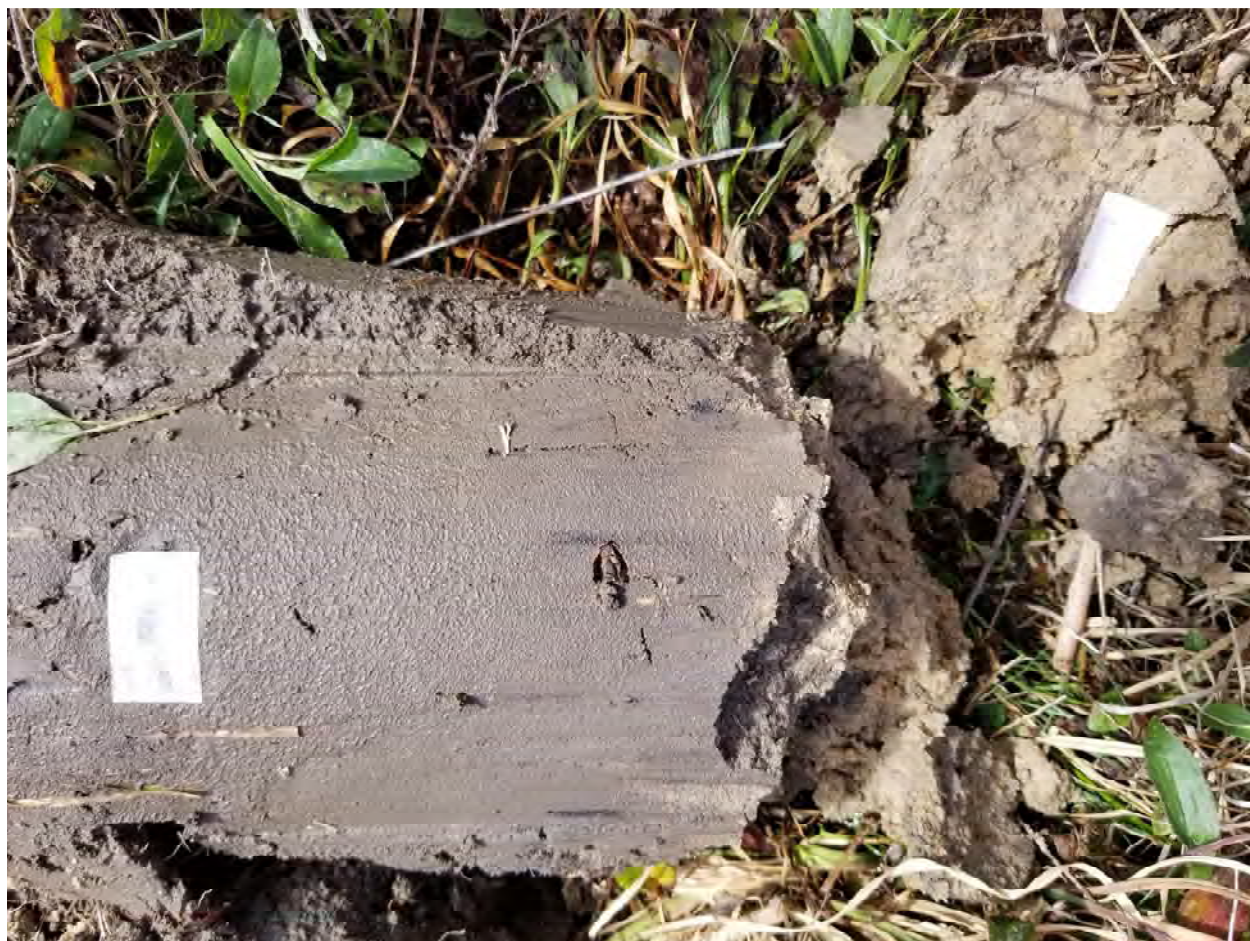
GW35 #2 Positive α , α' -dipyridyl (hard to see due to bright sunlight)
