MONITORING YEAR 1 ANNUAL REPORT

January 2023

DOUBLE H FARMS MITIGATION SITE

Alleghany County, NC
DEQ Contract No. 7608
DMS Project No. 100082

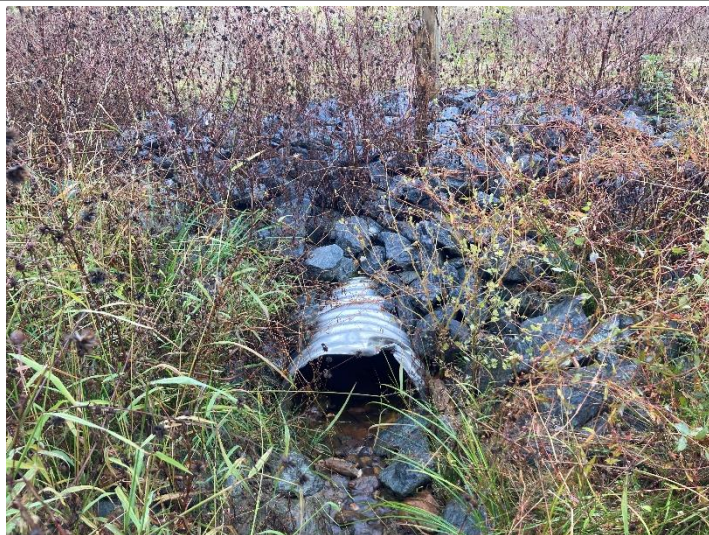
UT6 Crossing (605+26) – inlet (10/12/2022)

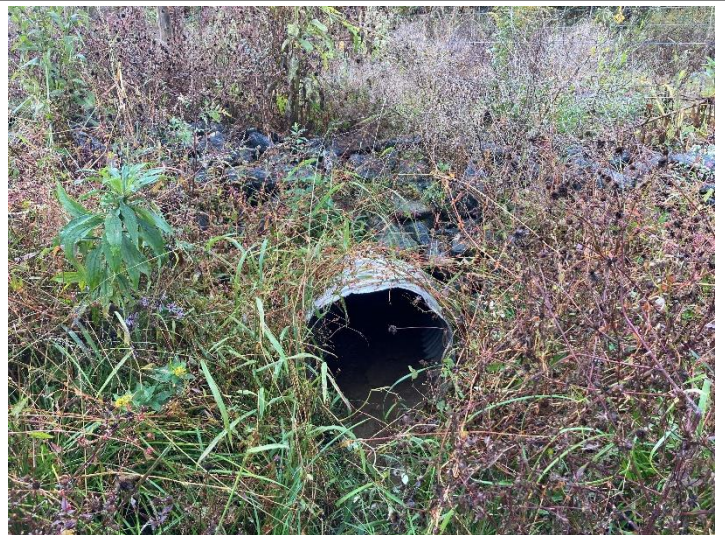
UT6 Crossing (605+71) – outlet (10/12/2022)

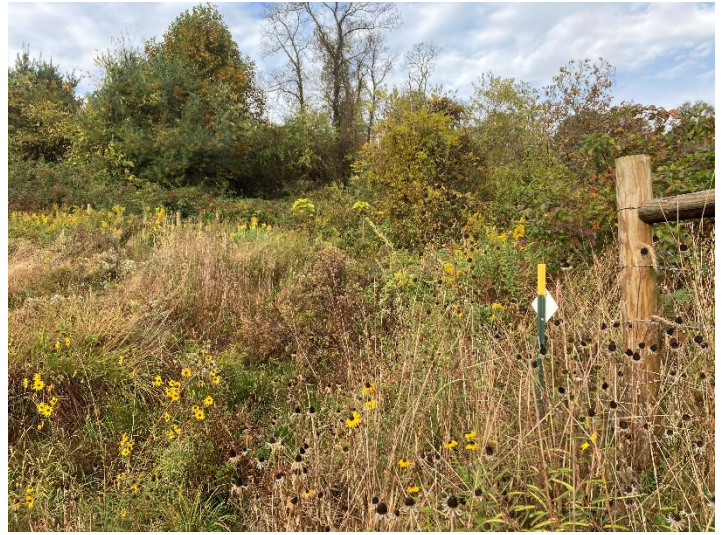
UT to Crab Creek R1 (Approximately Station 100+00 – 100+60) – Fence Removed from Inside Conservation Easement (10/12/2022)
