MONITORING YEAR 2 ANNUAL REPORT FINAL

DOUBLE H FARMS MITIGATION SITE

Alleghany County, NC
DEQ Contract No. 7608
DMS Project No. 100082

DOUBLE H FARMS MITIGATION SITE
Monitoring Year 2 Annual Report

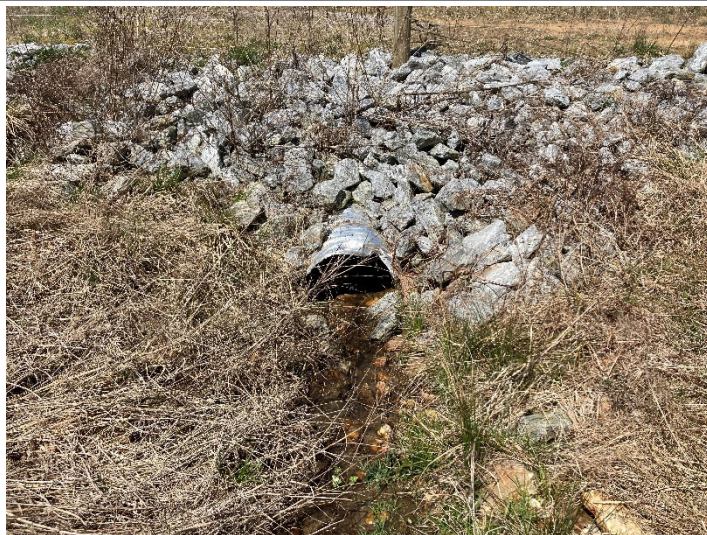
UT6 Crossing (605+26) – inlet (4/3/2023)

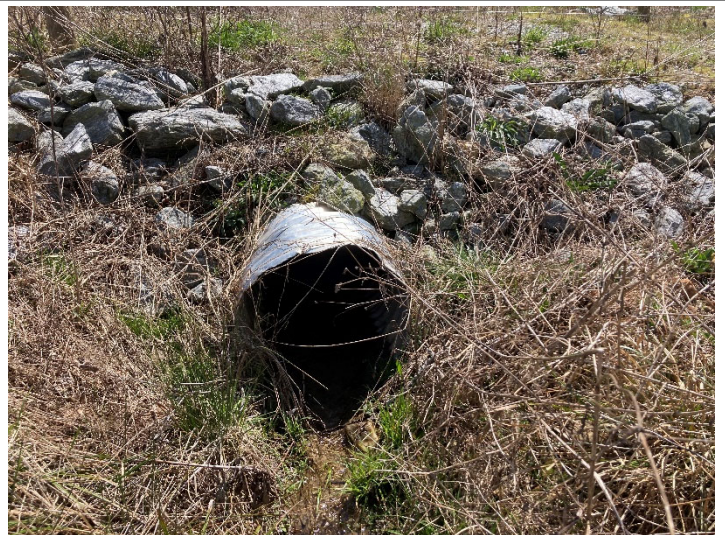
UT6 Crossing (605+71) – outlet (4/3/2023)

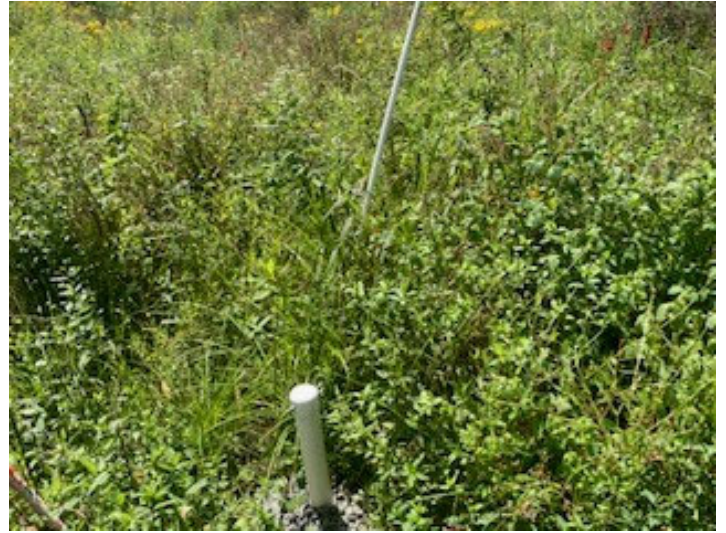
Area surrounding GWG 1. GWG1 is located on edge of wetland surrounded by wetland vegetation– (08/31/2023)
