# MONITORING YEAR 2 ANNUAL REPORT

## DRY CREEK MITIGATION SITE

Durham County, NC

DMS Project No. 97082

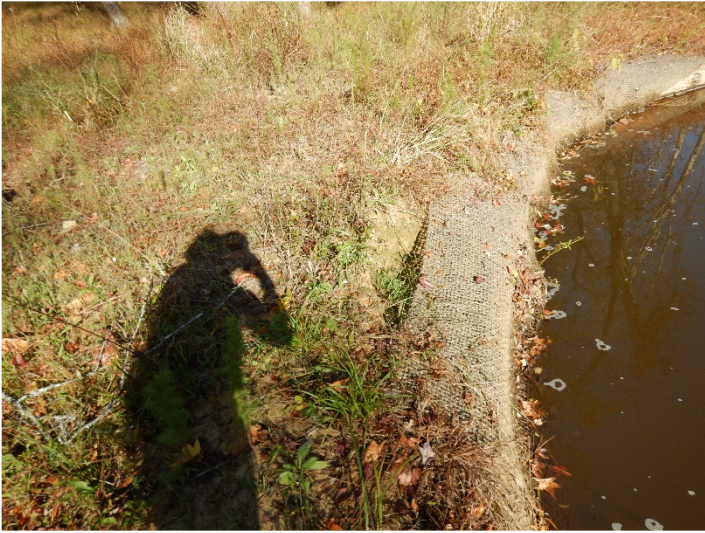
**Before – Localized Erosion (11/4/2020)**

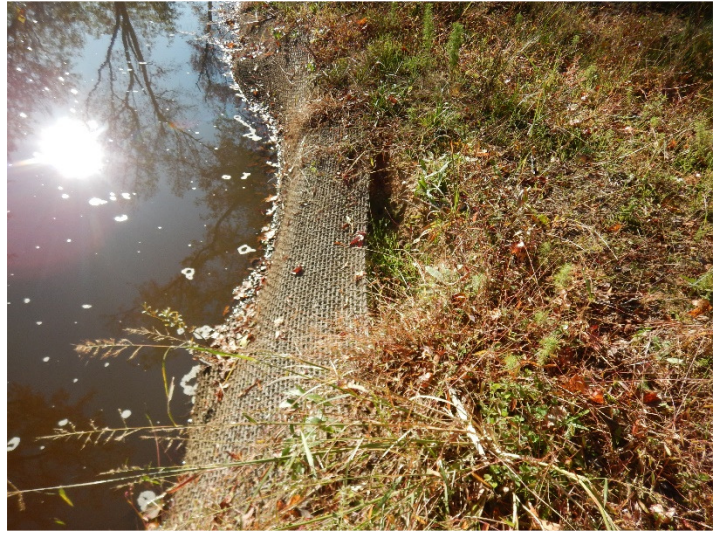
**Before – Localized Erosion (11/4/2020)**
