**MONITORING YEAR 3
ANNUAL REPORT
Final**

DRY CREEK MITIGATION SITE

Durham County, NC
Neuse River Basin
HUC 03020201010050

DMS Project No. 97082
NCDEQ Contract No. 6827
USACE Action ID No. SAW-2016-00880
DWR Project No. 2016-0369

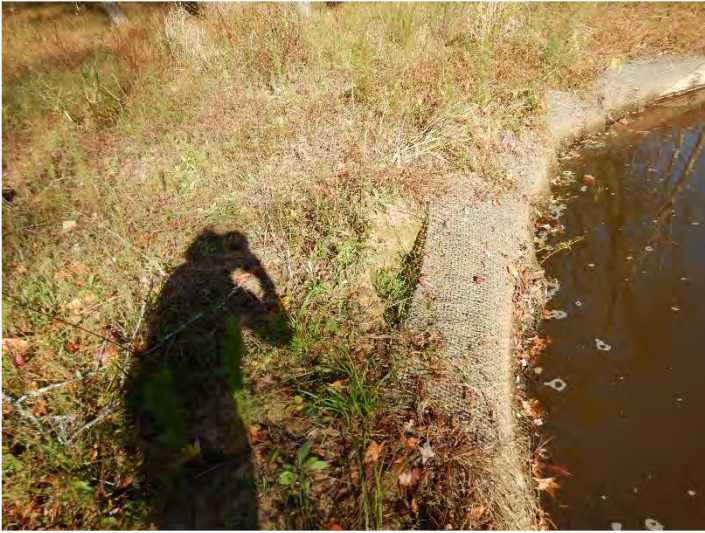
Localized bank erosion on the outside bend of a pool directly downstream of the culvert crossing along Dry Creek Reach 4, was identified during MY1. This area was repaired in March of MY2. After more than a year and several storm events, the repair is stable, and vegetation is establishing. See a timeline of before and after photos of the area in Appendix 2. This area will continue to be monitored to determine the success of the repair work.

Before – Localized Erosion (11/4/2020)

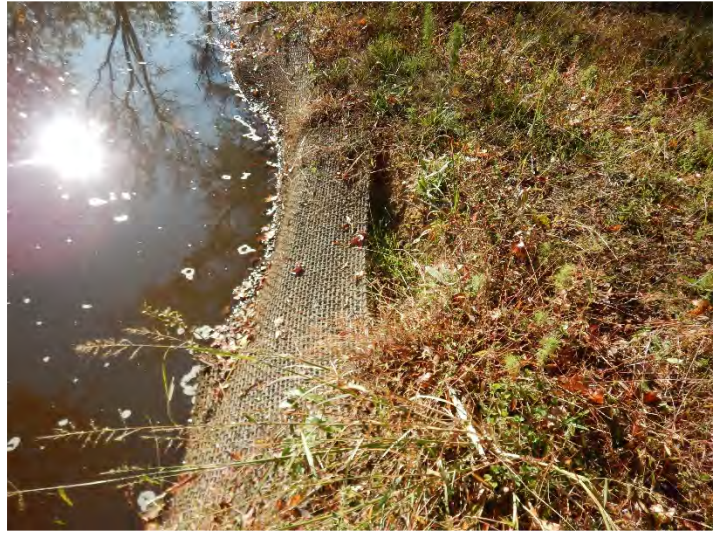
Before – Localized Erosion (11/4/2020)
