# **MONITORING YEAR 4 ANNUAL REPORT Final**

January 2024

## **DRY CREEK MITIGATION SITE**

Durham County, NC  
Neuse River Basin  
HUC 03020201010050  
DMS Project No. 97082  
NCDEQ Contract No. 6827  
USACE Action ID No. SAW-2016-00880  
DWR Project No. 2016-0369

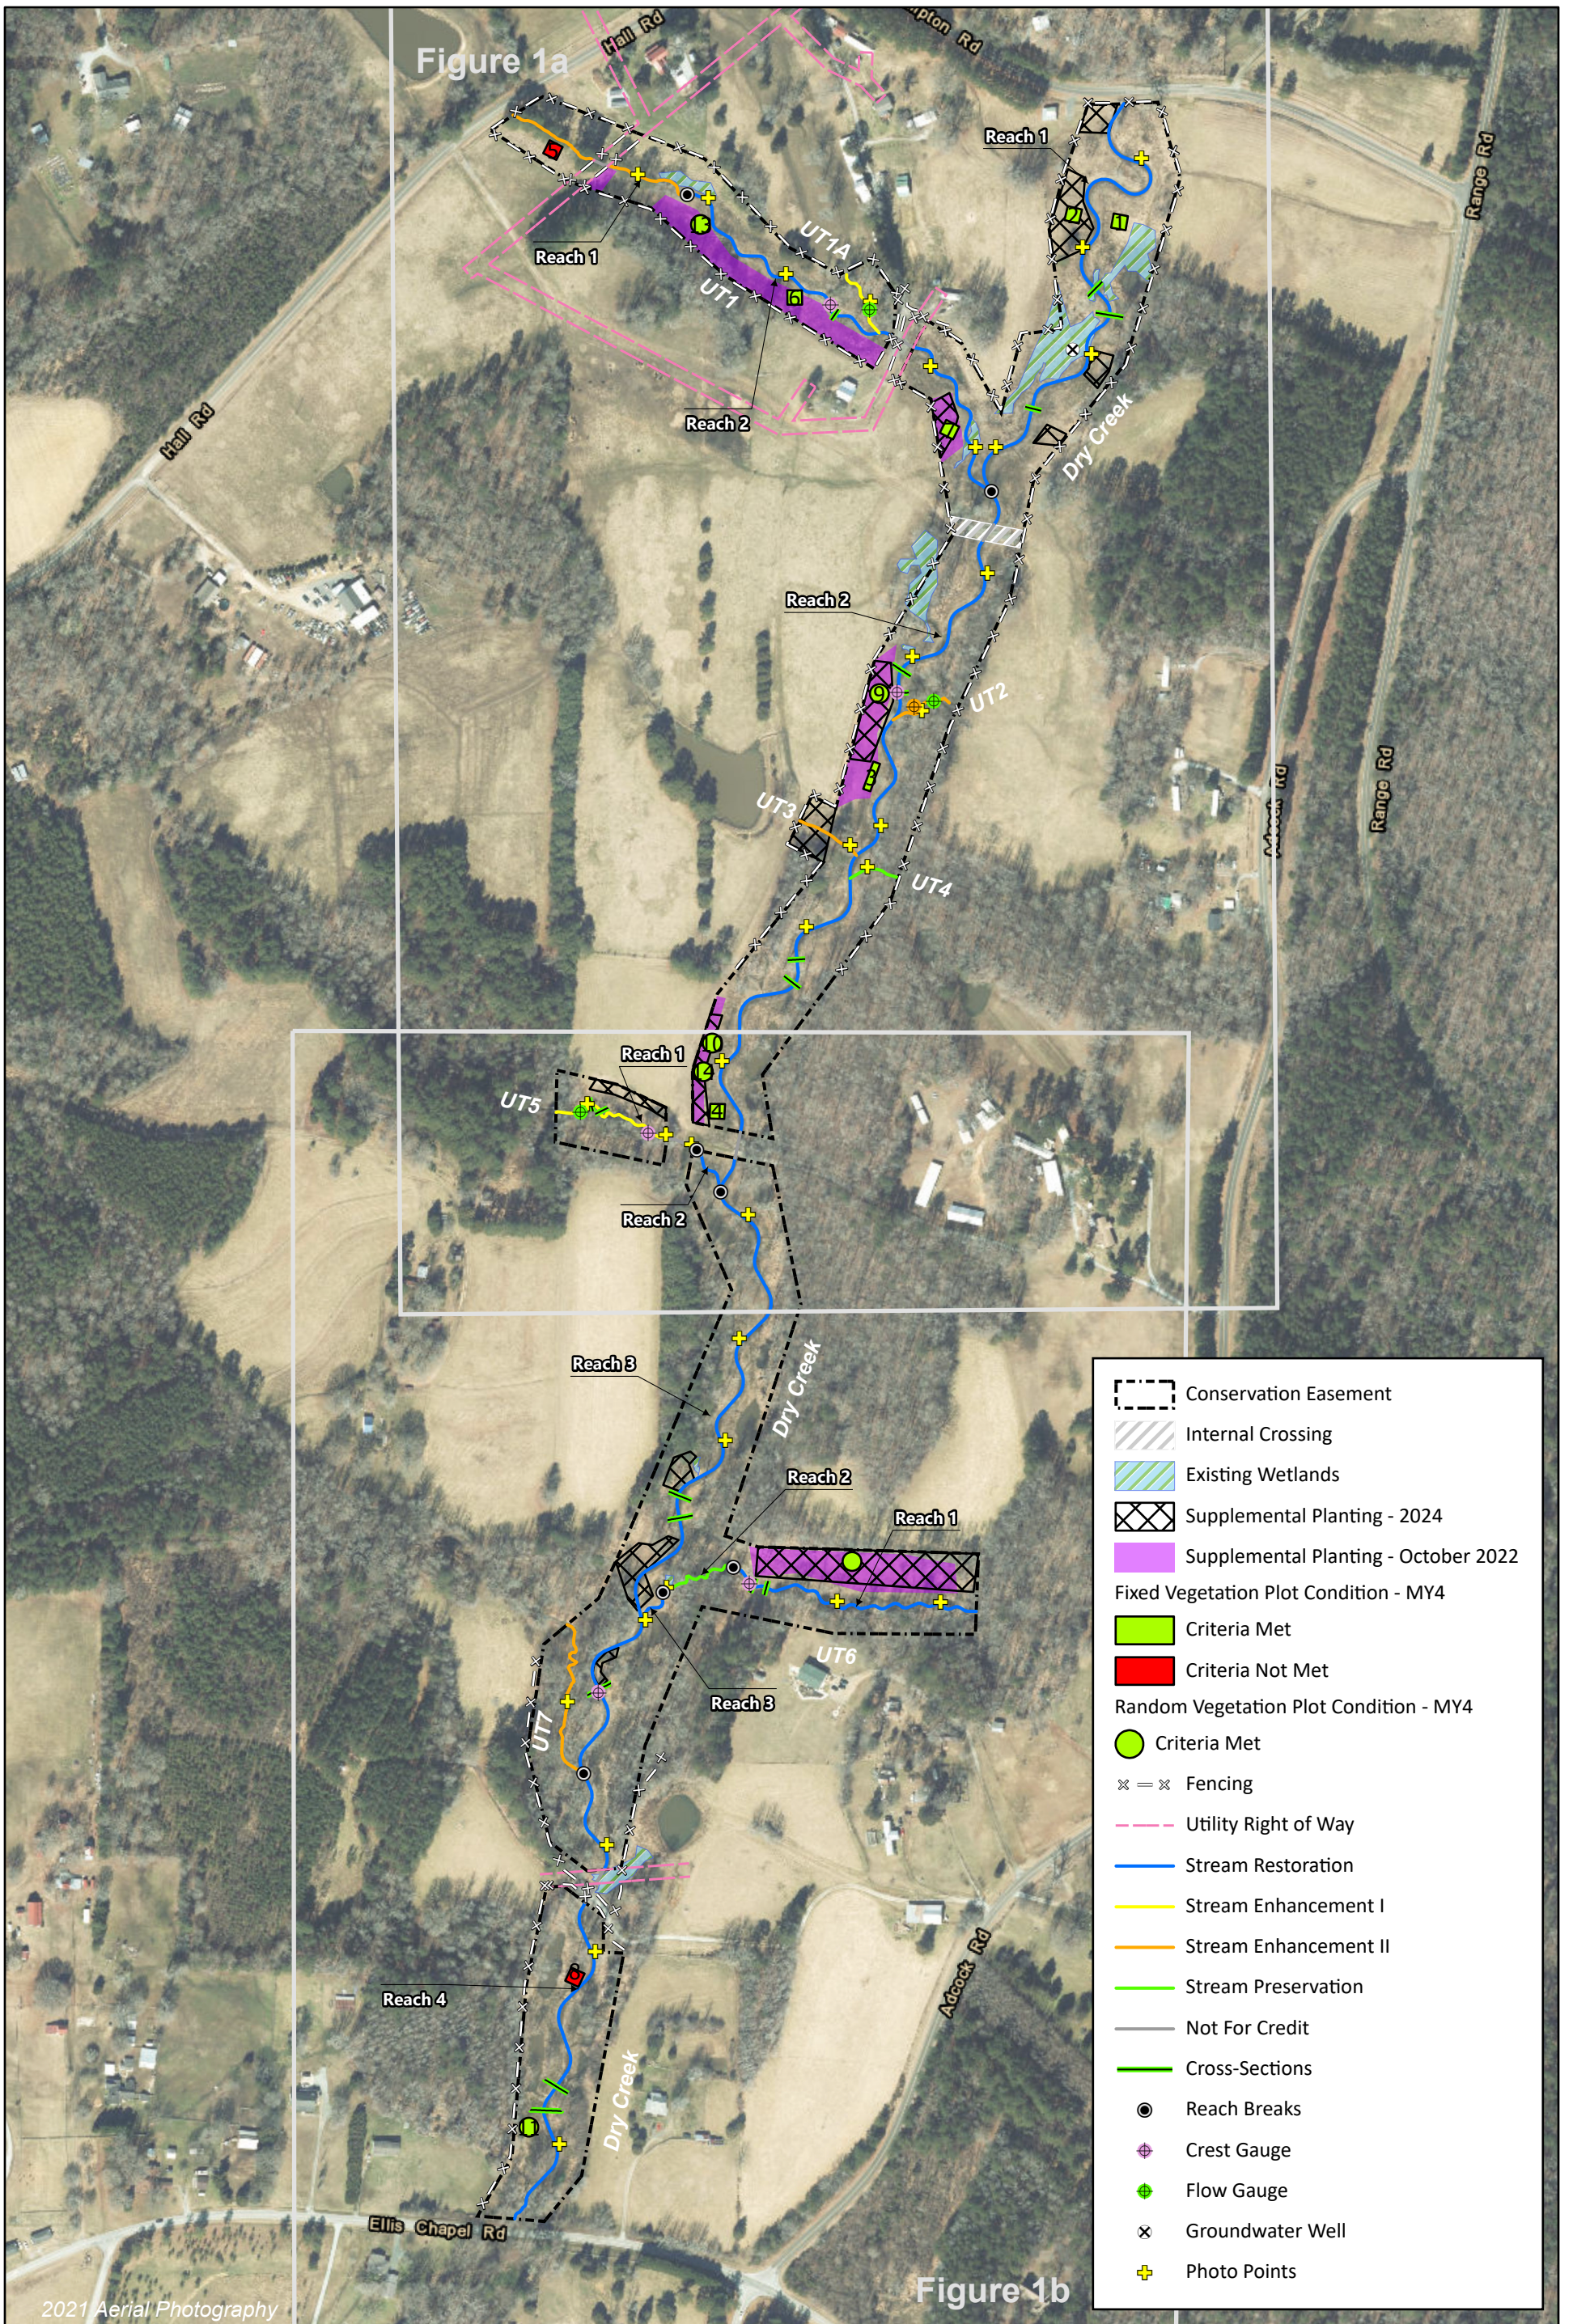
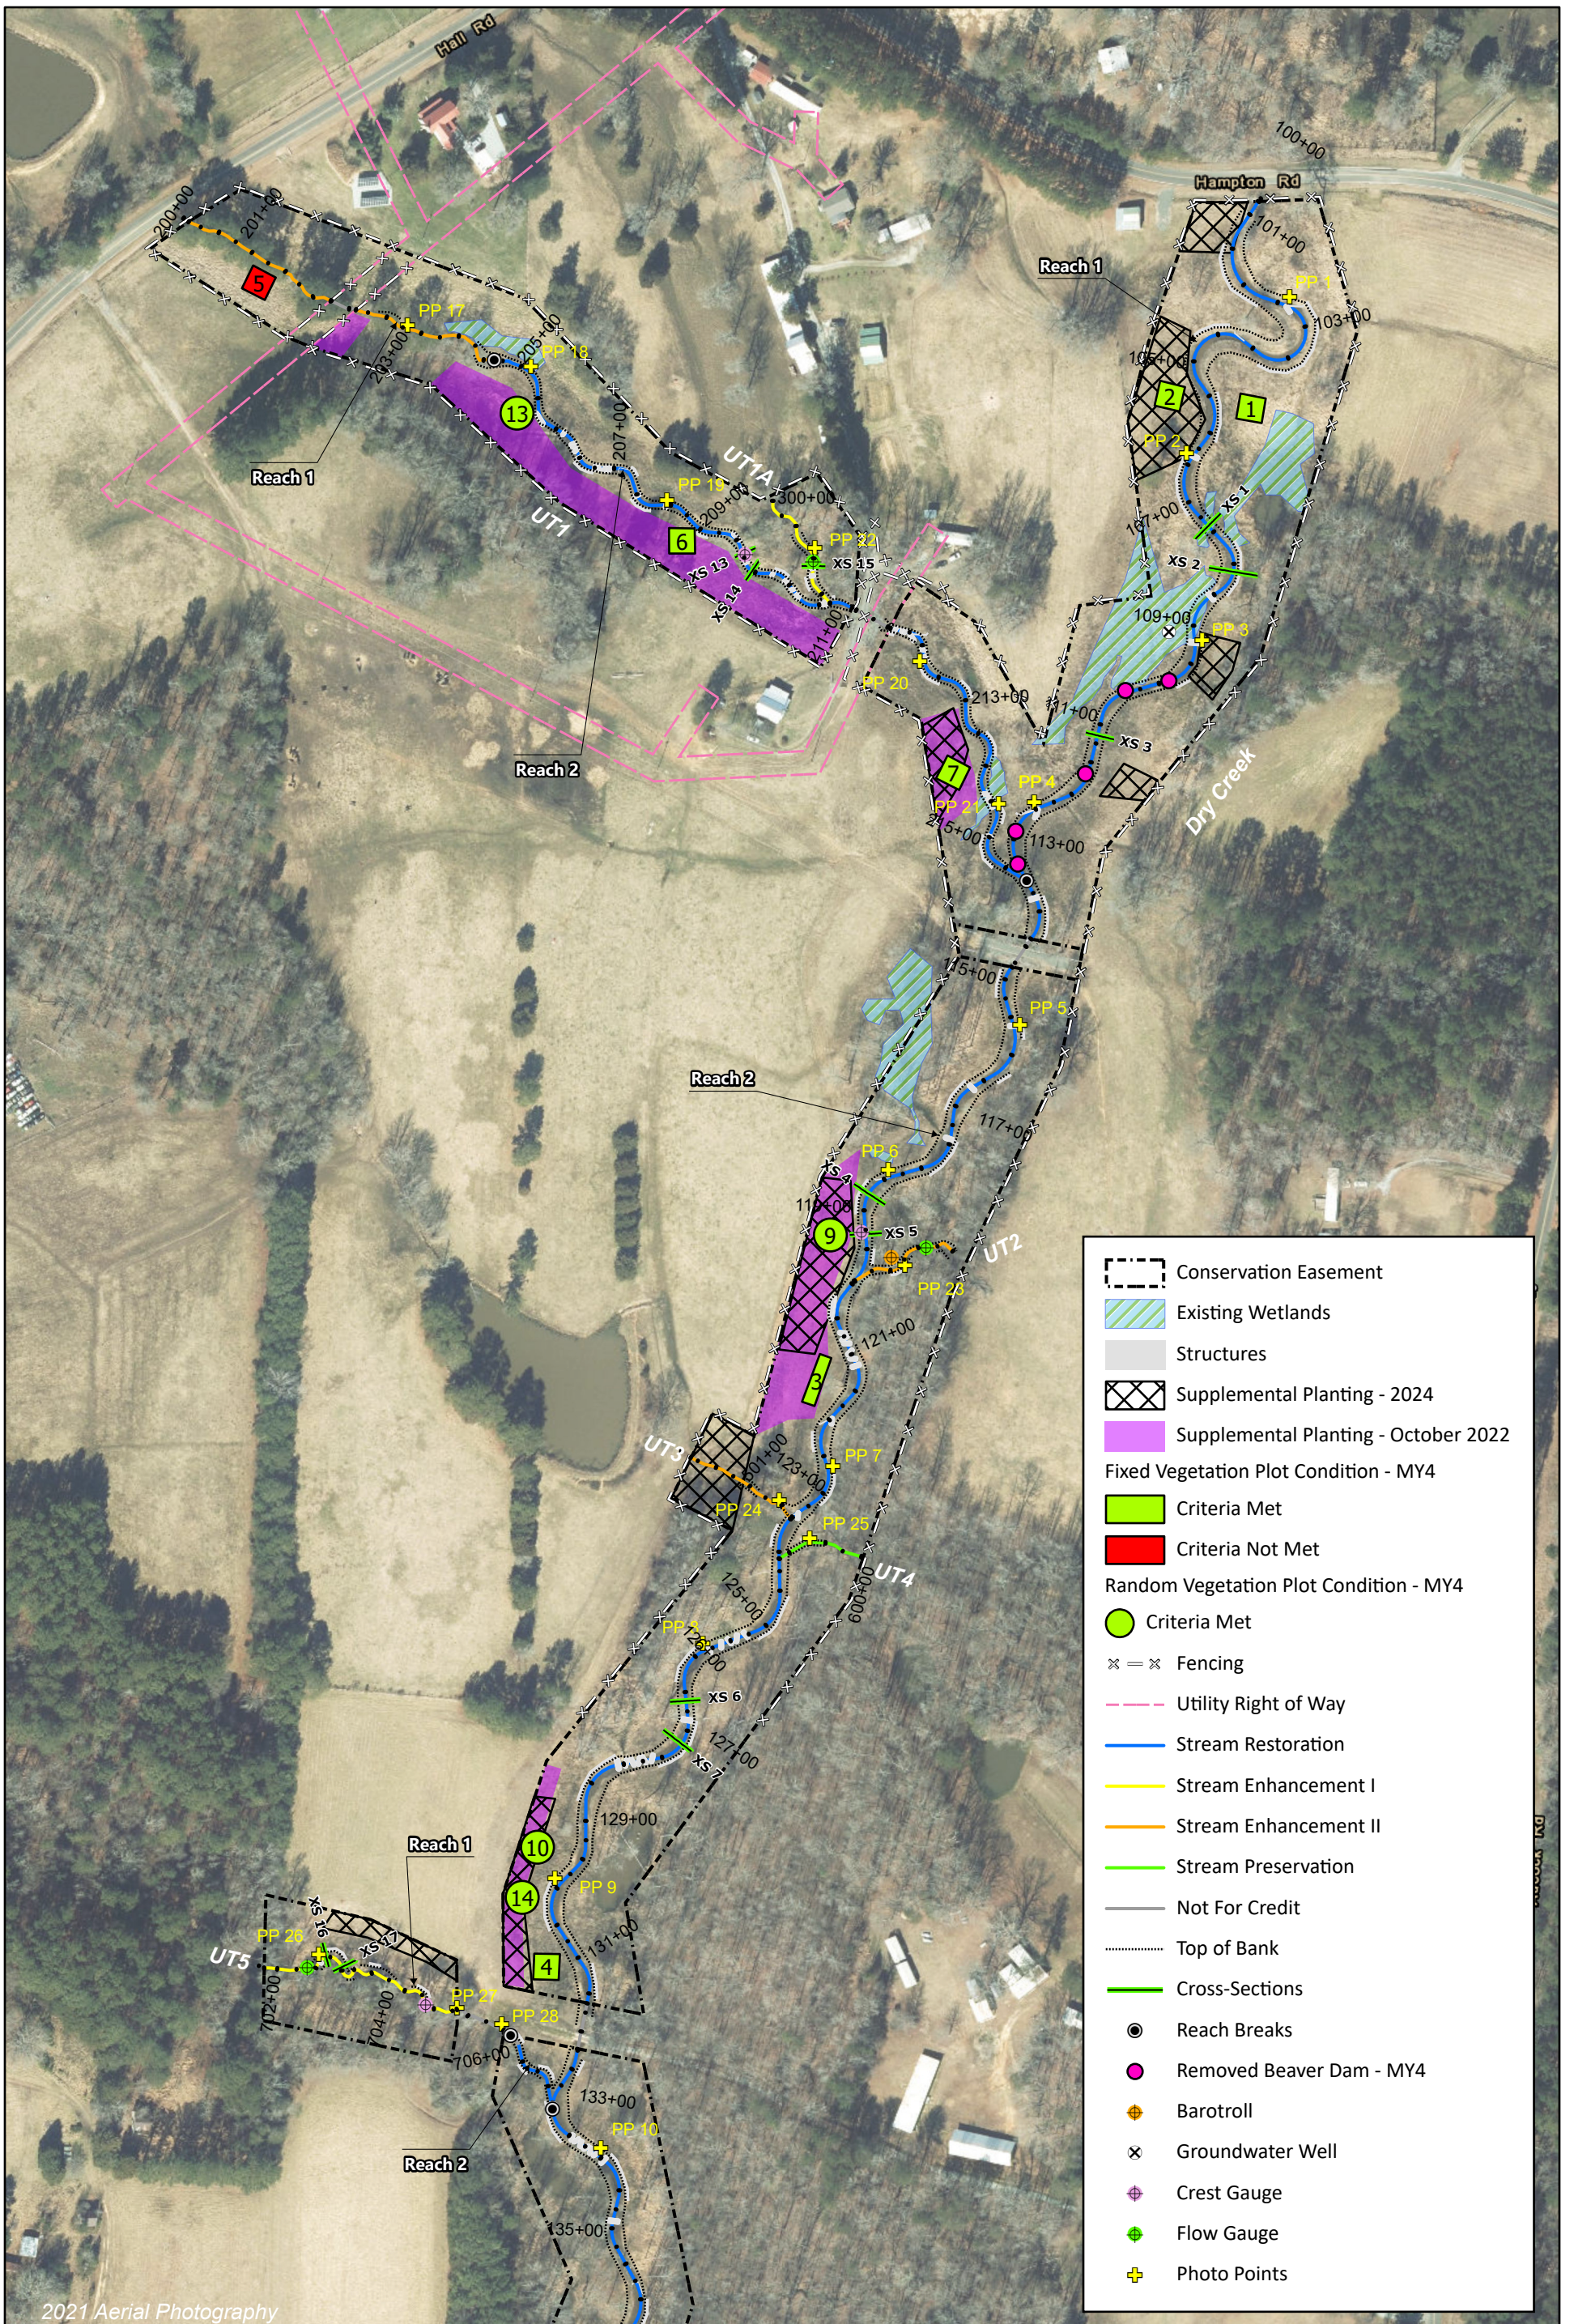
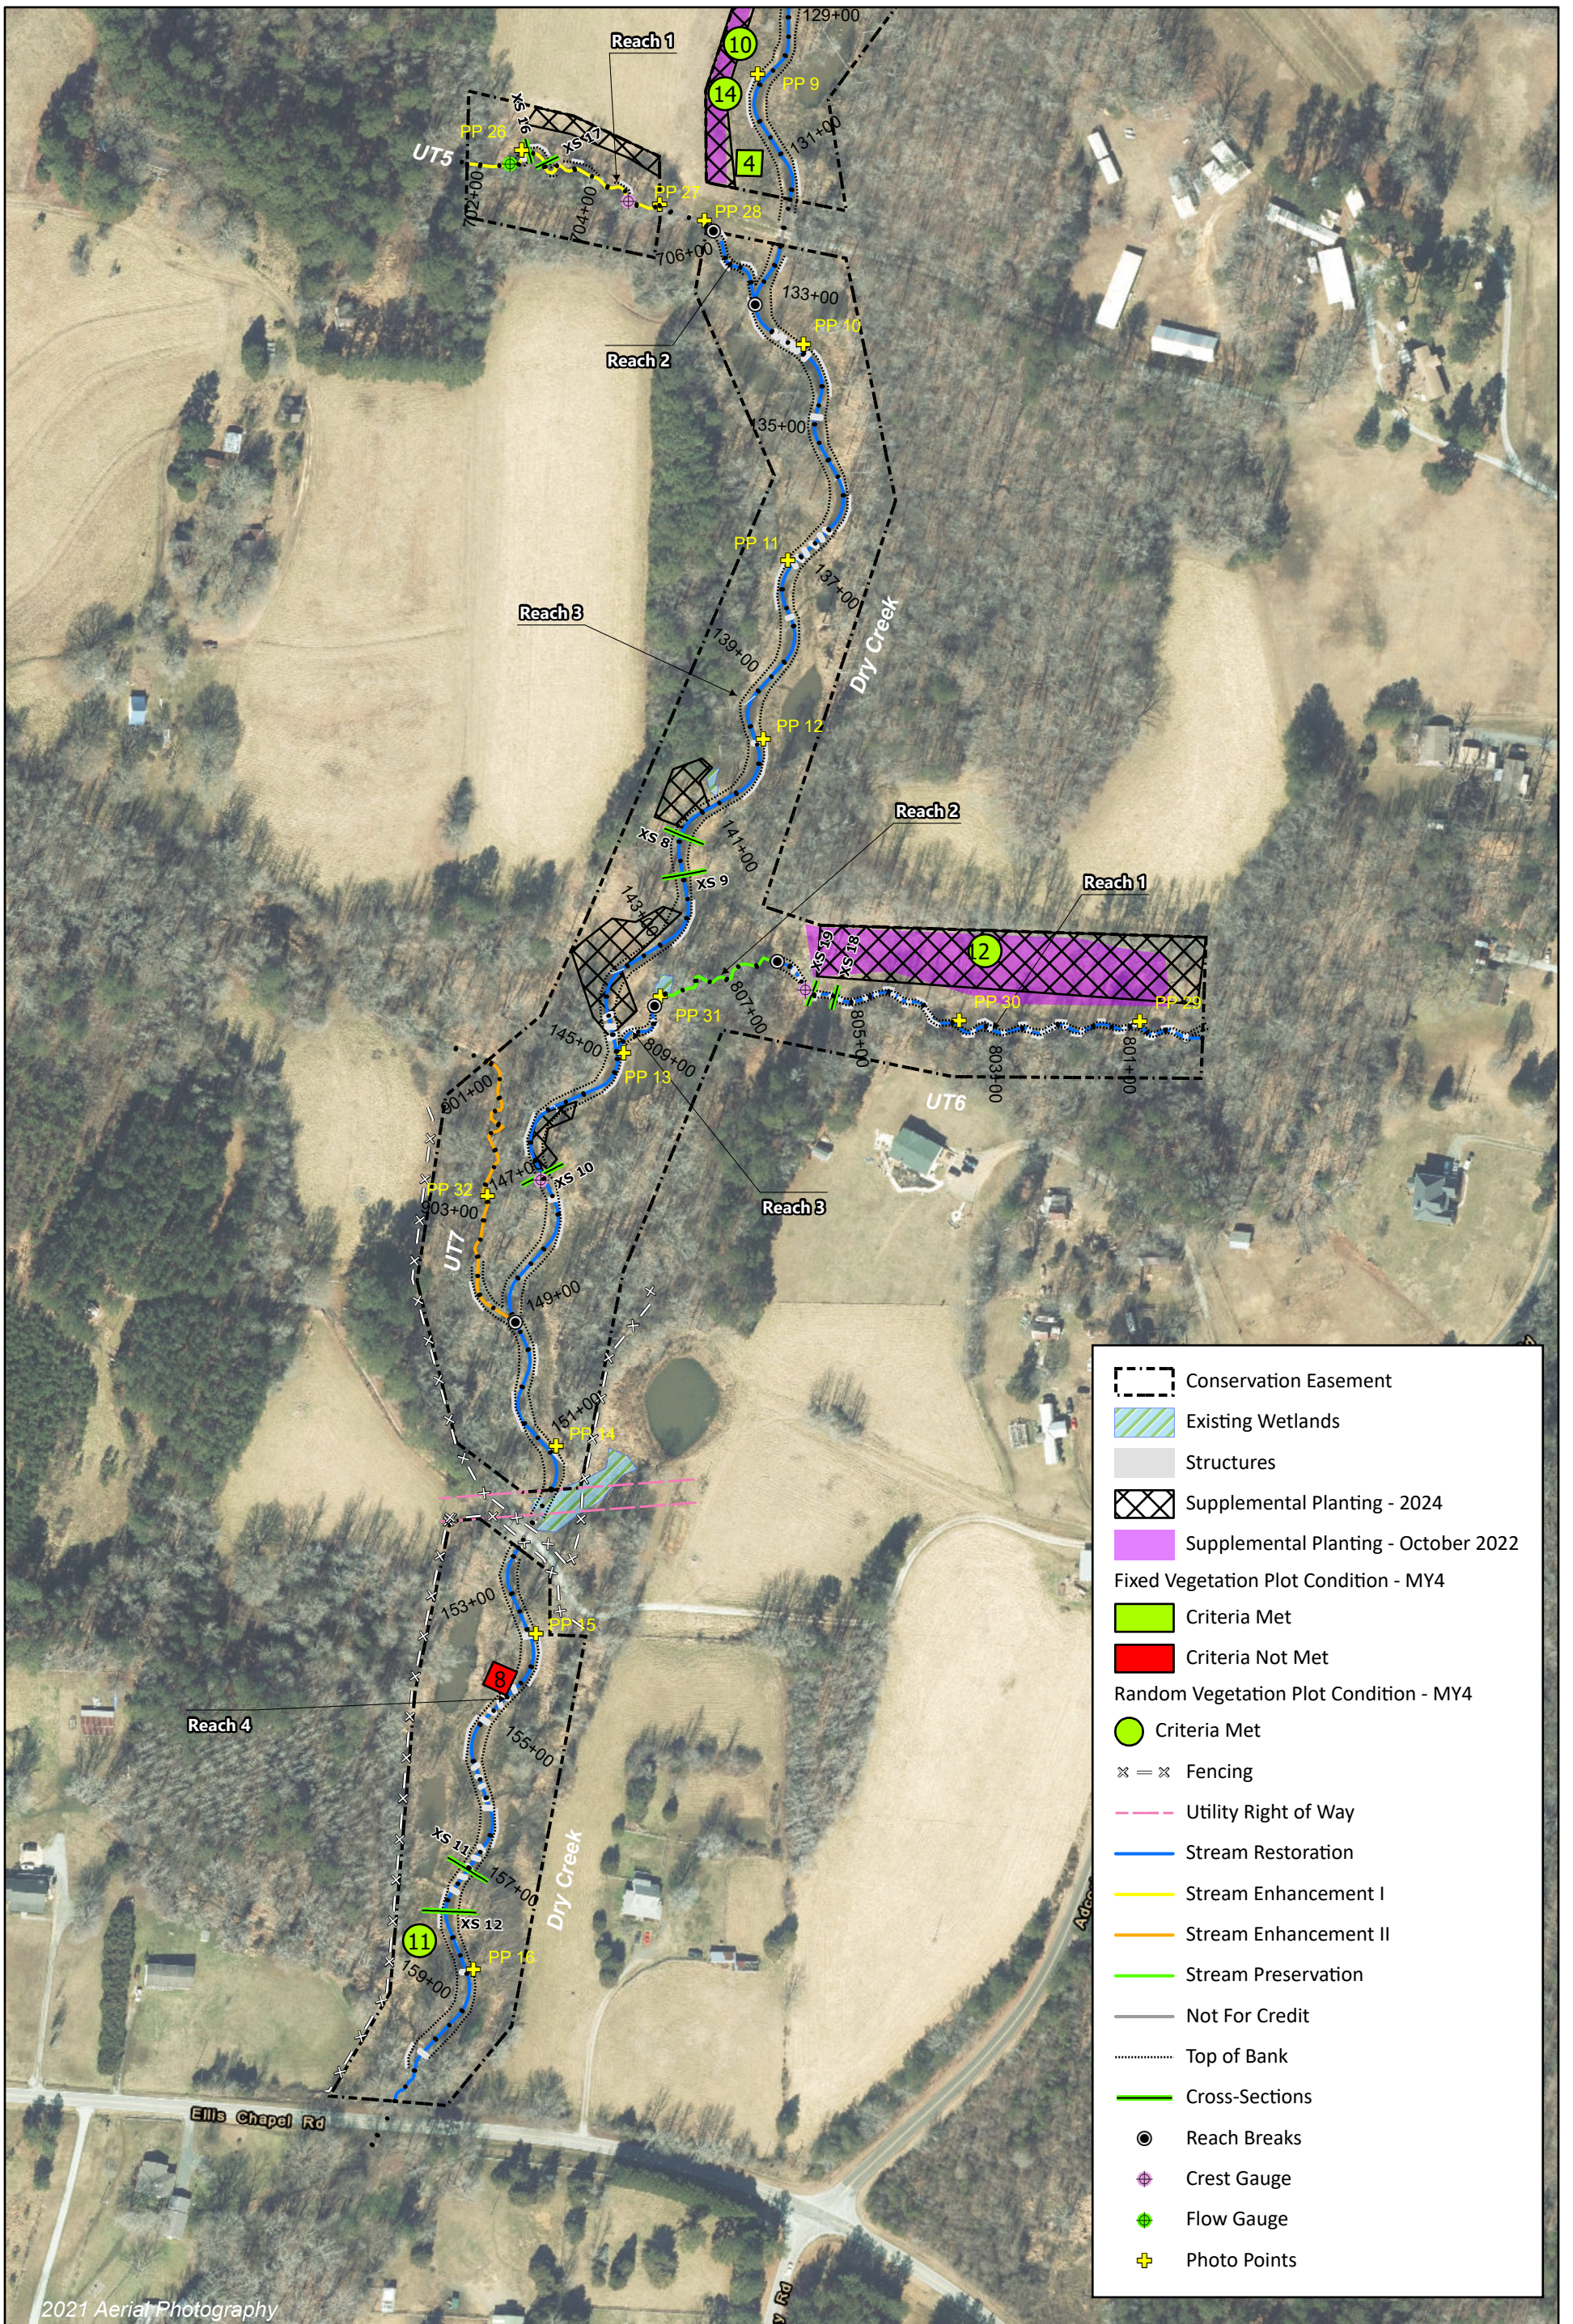
Figure 1. Current Condition Plan View (Key)  
 Dry Creek Mitigation Site  
 DMS Project No. 97082  
 Monitoring Year 4 - 2023  
 Durham County, NC

Areas of persisting low species diversity or stem density, as well as newly discovered areas of low species diversity, will be supplementally planted during MY5 (see Figures 1a-b). Wildlands is in the process of developing a supplemental planting plan. A memorandum will be sent to DMS and the IRT documenting areas supplementally planted and species utilized.

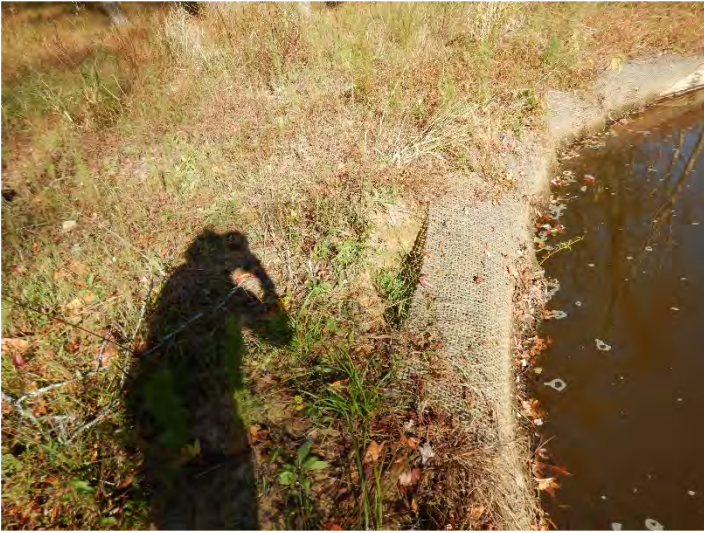
**Stream Area of Concern Photographs  
Dry Creek Reach 4**

Localized bank erosion on the outside bend of a pool directly downstream of the culvert crossing along Dry Creek Reach 4, was identified during MY1. This area was repaired in March of MY1. The repair has continued to be stable, and vegetation is establishing. See a timeline of before and after photos of the area in Appendix 2. This area will continue to be monitored to assess the continued stability of the repaired area.

**Before – Localized Erosion (11/4/2020)**
