# Duke Swamp Wetland and Stream Restoration Mitigation Report – Monitoring Year 0 of 5 Gates County, North Carolina

Date Submitted: March 2008

Project Number: D06065-A

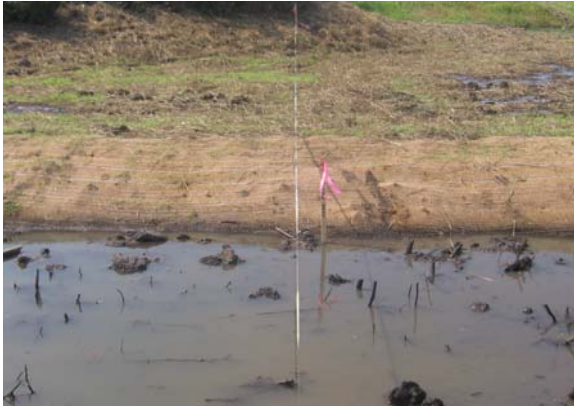
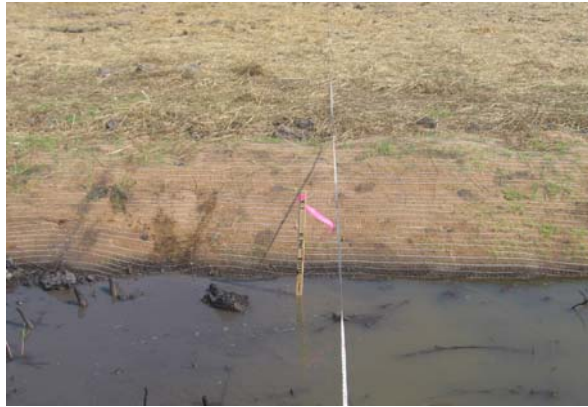
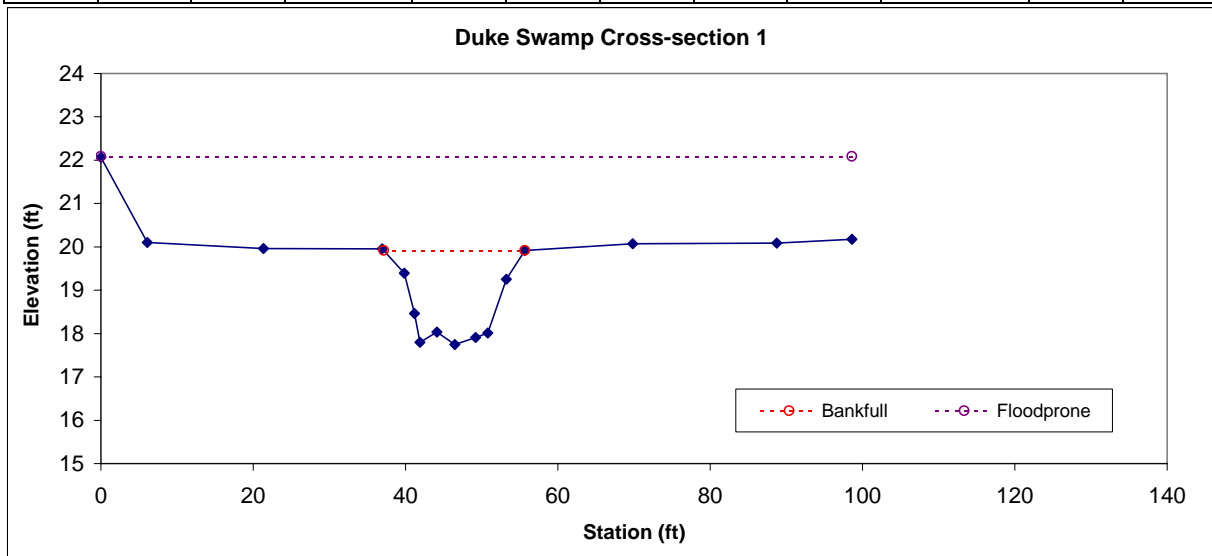
**Permanent Cross-section 1, Station 13+30**  
 (As-Built Data - collected Oct. 2007)

Feature	Stream Type	BKF Area	BKF Width	BKF Depth	Max BKF Depth	W/D	BH Ratio	ER	BKF Elev	TOB Elev	W-fpa
Riffle	Cc	25.3	18.54	1.37	2.17	13.56	1	5.3	19.92	19.92

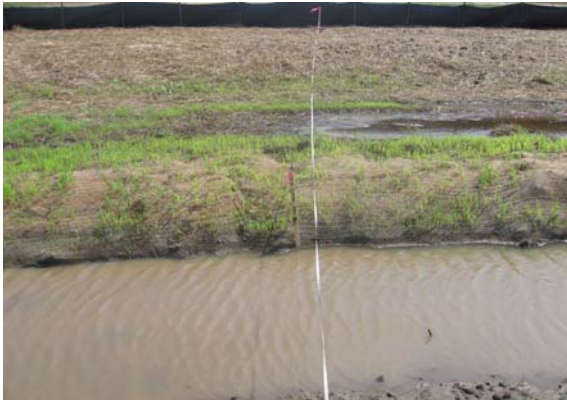
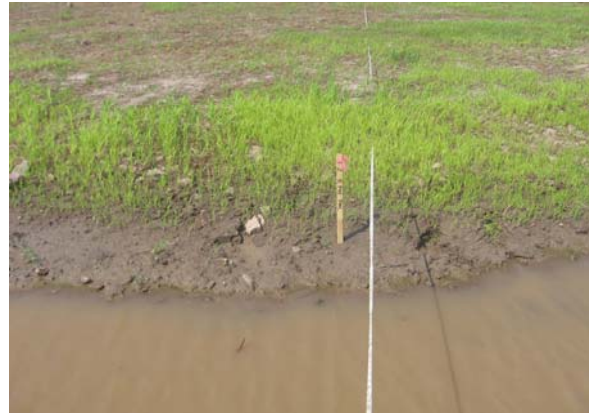
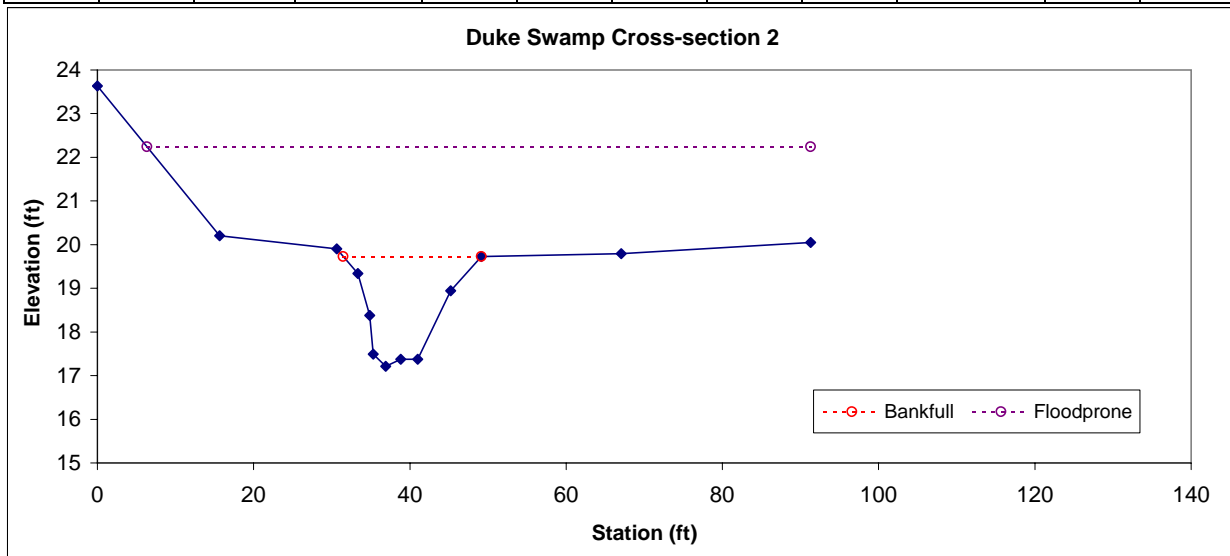
**Permanent Cross-section 2, Station 17+69**  
 (As-Built Data - collected Oct. 2007)

Feature	Stream Type	BKF Area	BKF Width	BKF Depth	Max BKF Depth	W/D	BH Ratio	ER	BKF Elev	TOB Elev	W-fpa
Pool		24.3	17.69	1.37	2.51	12.89	1	4.8	19.73	19.73

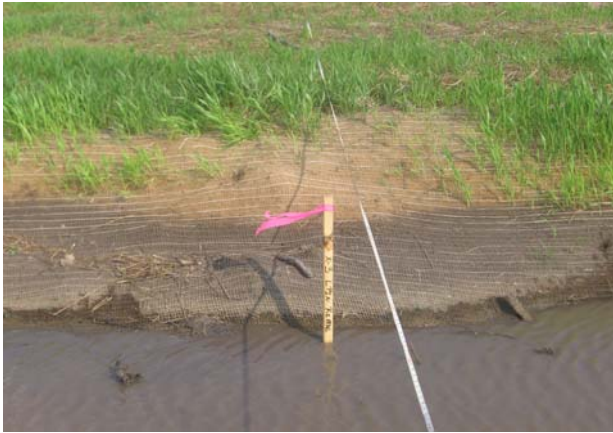
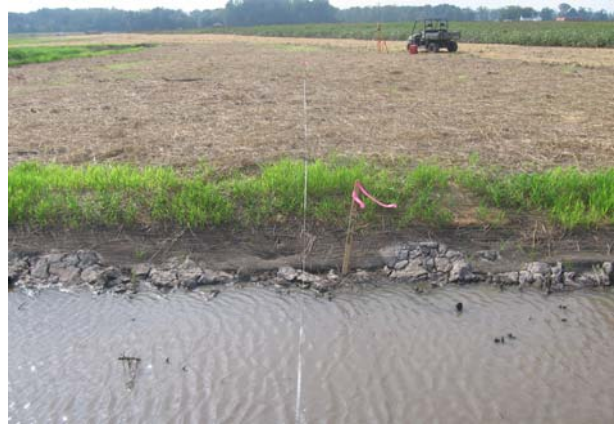
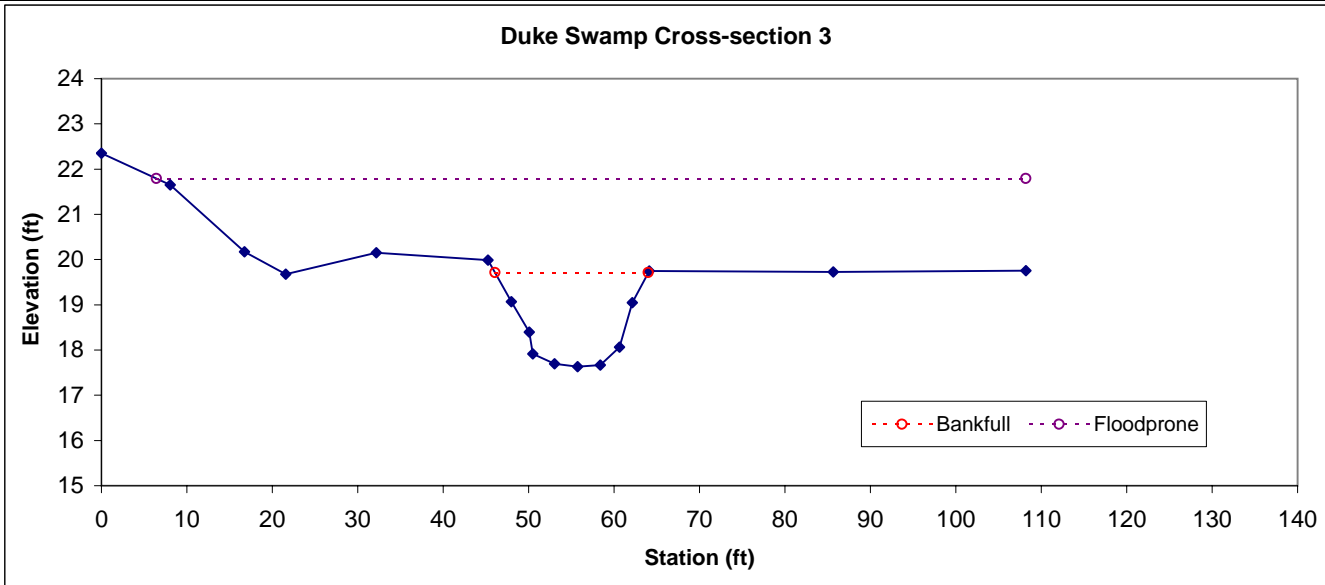
**Permanent Cross-section 3, Station 20+27**  
 (As-Built Data - collected Oct. 2007)

Feature	Stream Type	BKF Area	BKF Width	BKF Depth	Max BKF Depth	W/D	BH Ratio	ER	BKF Elev	TOB Elev	W-fpa
Riffle	Cc	25.6	17.94	1.43	2.08	12.55	1	5.7	19.71	19.75

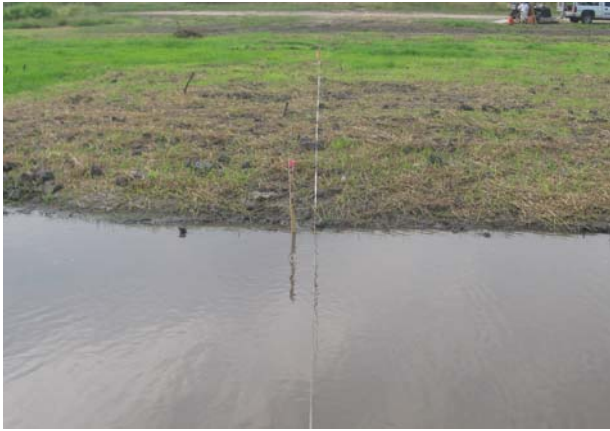
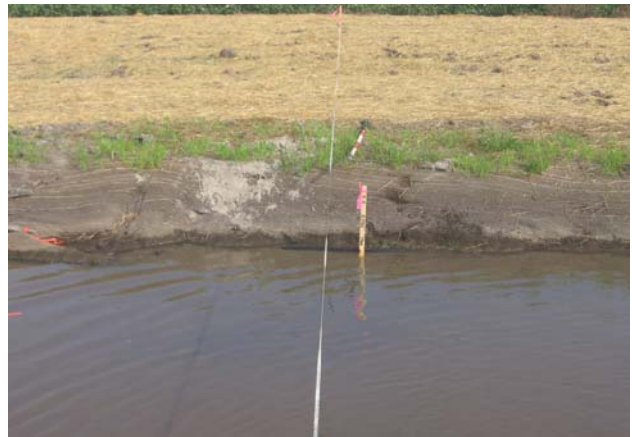
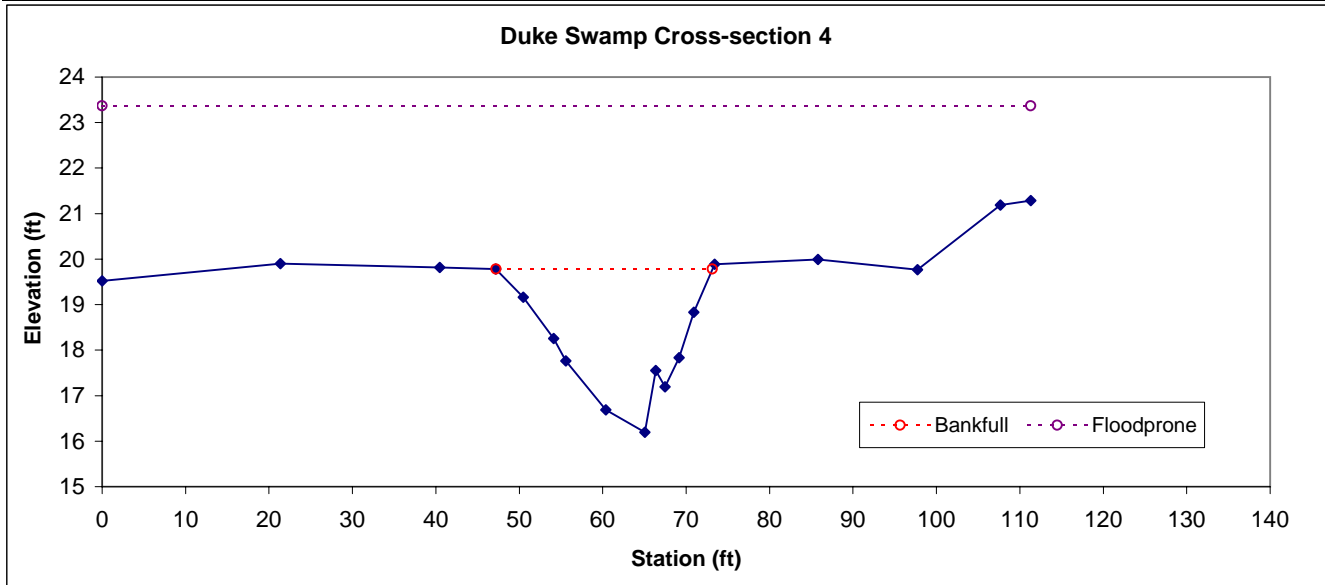
**Permanent Cross-section 4, Station 26+81**  
 (As-Built Data - collected Oct. 2007)

Feature	Stream Type	BKF Area	BKF Width	BKF Depth	Max BKF Depth	W/D	BH Ratio	ER	BKF Elev	TOB Elev	W-fpa
Pool		49.3	25.96	1.9	3.59	13.67	1	4.3	19.78	19.78

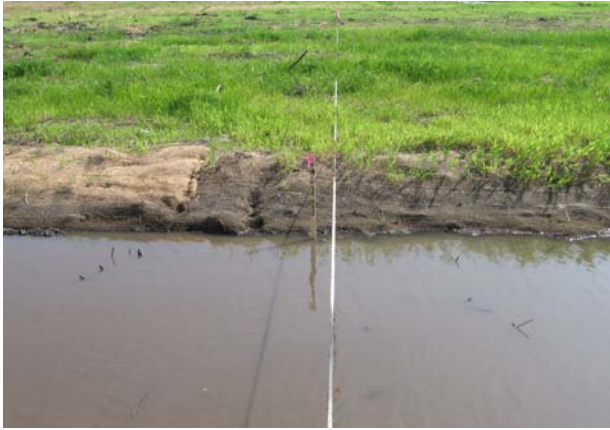
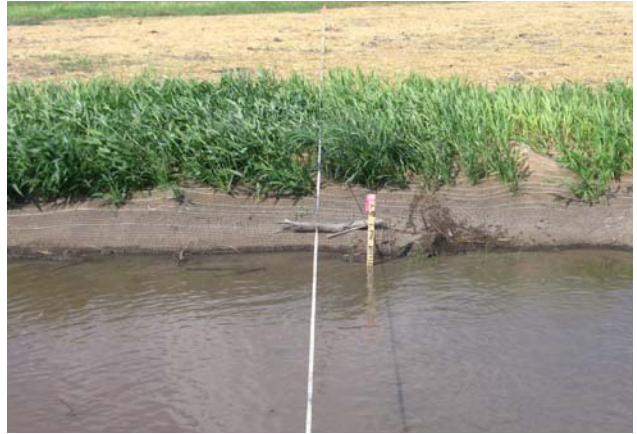
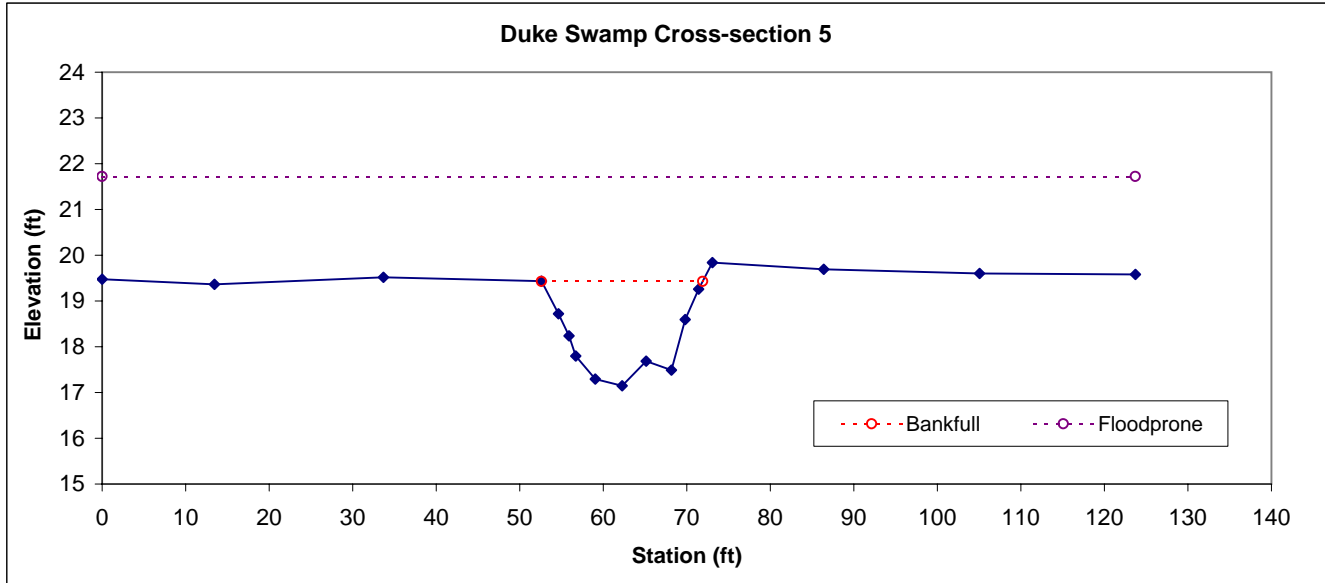
**Permanent Cross-section 5, Station 31+47**  
 (As-Built Data - collected Oct. 2007)

Feature	Stream Type	BKF Area	BKF Width	BKF Depth	Max BKF Depth	W/D	BH Ratio	ER	BKF Elev	TOB Elev	W-fpa
Riffle	Cc	29.1	19.3	1.51	2.29	12.81	1	6.4	19.43	19.43

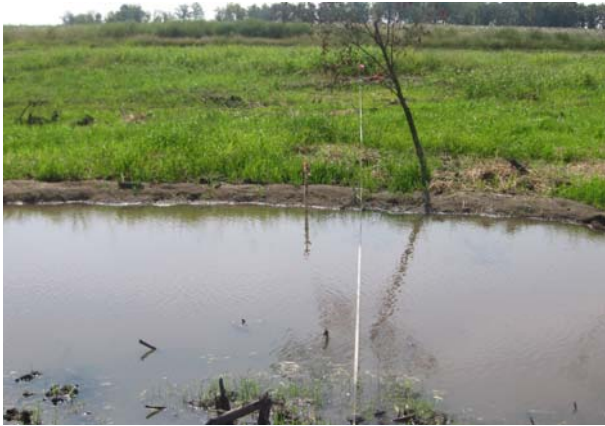
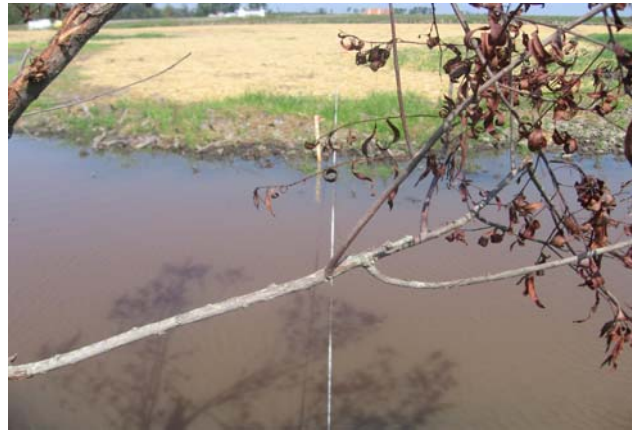
**Permanent Cross-section 6, Station 37+13**  
 (As-Built Data - collected Oct. 2007)

Feature	Stream Type	BKF Area	BKF Width	BKF Depth	Max BKF Depth	W/D	BH Ratio	ER	BKF Elev	TOB Elev	W-fpa
Pool		36.3	29.22	1.24	2.84	23.49	1	4.5	18.74	18.74
