**DUKE SWAMP WETLAND AND STREAM
RESTORATION PROJECT**
ANNUAL MONITORING REPORT FOR 2009 (YEAR 2)

Contract Number D06065-A

Prepared by: Michael Baker Engineering, Inc.

December 2009

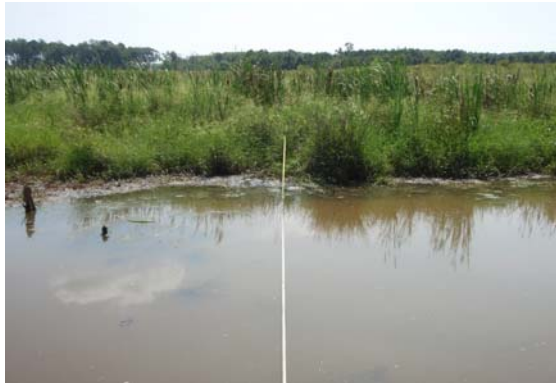
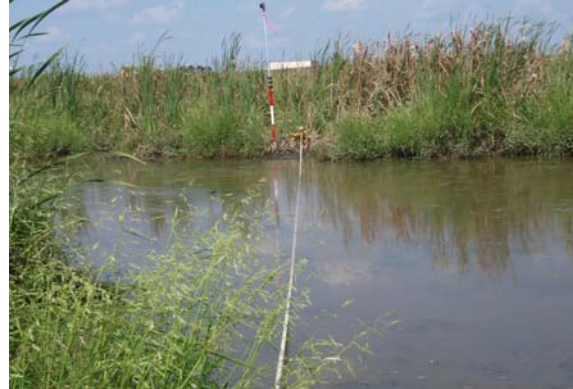
Permanent Cross-section 7, Station 42+05
 (Year 2 Data - Collected September 2009)

The area between station 38+00 and 40+00 has undergone subsidence on the right floodplain. The settling has allowed below bankfull flows to permanently flood the right floodplain near AW4, vegetation plot 10 and cross-section 7. The floodplain elevation of cross-section 7 has decreased since as-built conditions, but it has remained stable since Year 1 data collection. The subsided area between stations 38+00 and 40+00 has also remained stable and no significant changes have been noted. This area will continue to be closely observed during future site visits and any significant changes will be reported in future reports.
