**DUKE SWAMP WETLAND AND STREAM  
RESTORATION PROJECT**  
ANNUAL MONITORING REPORT FOR 2010 (YEAR 3)

**Contract Number D06065-A**

**Prepared by:** Michael Baker Engineering, Inc.

**December 2010**

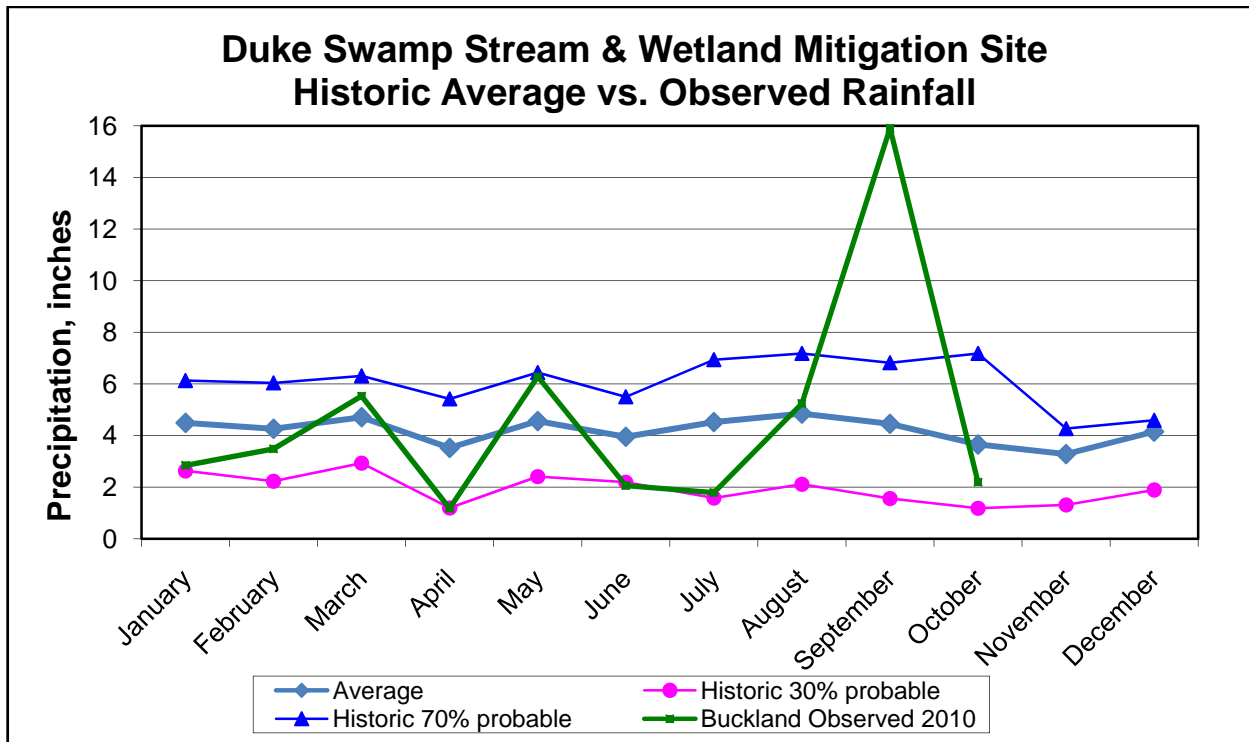
Figure 3. Historic Average vs. Buckland Observed Rainfall

Much of the rain that fell during the 2010 growing season was at or below normal amounts and occurred in the spring and fall. The summer months of June and July were relatively dry. However, in late September and early October a tropical system moved over the region and deposited a large portion of the 2010 growing season rain. Prior to this event, the Site had been relatively dry. According to the Buckland gauge the storm event deposited approximately 15.06 inches of rain from September 26 to October 1 (see Table 7 and Figure 3).

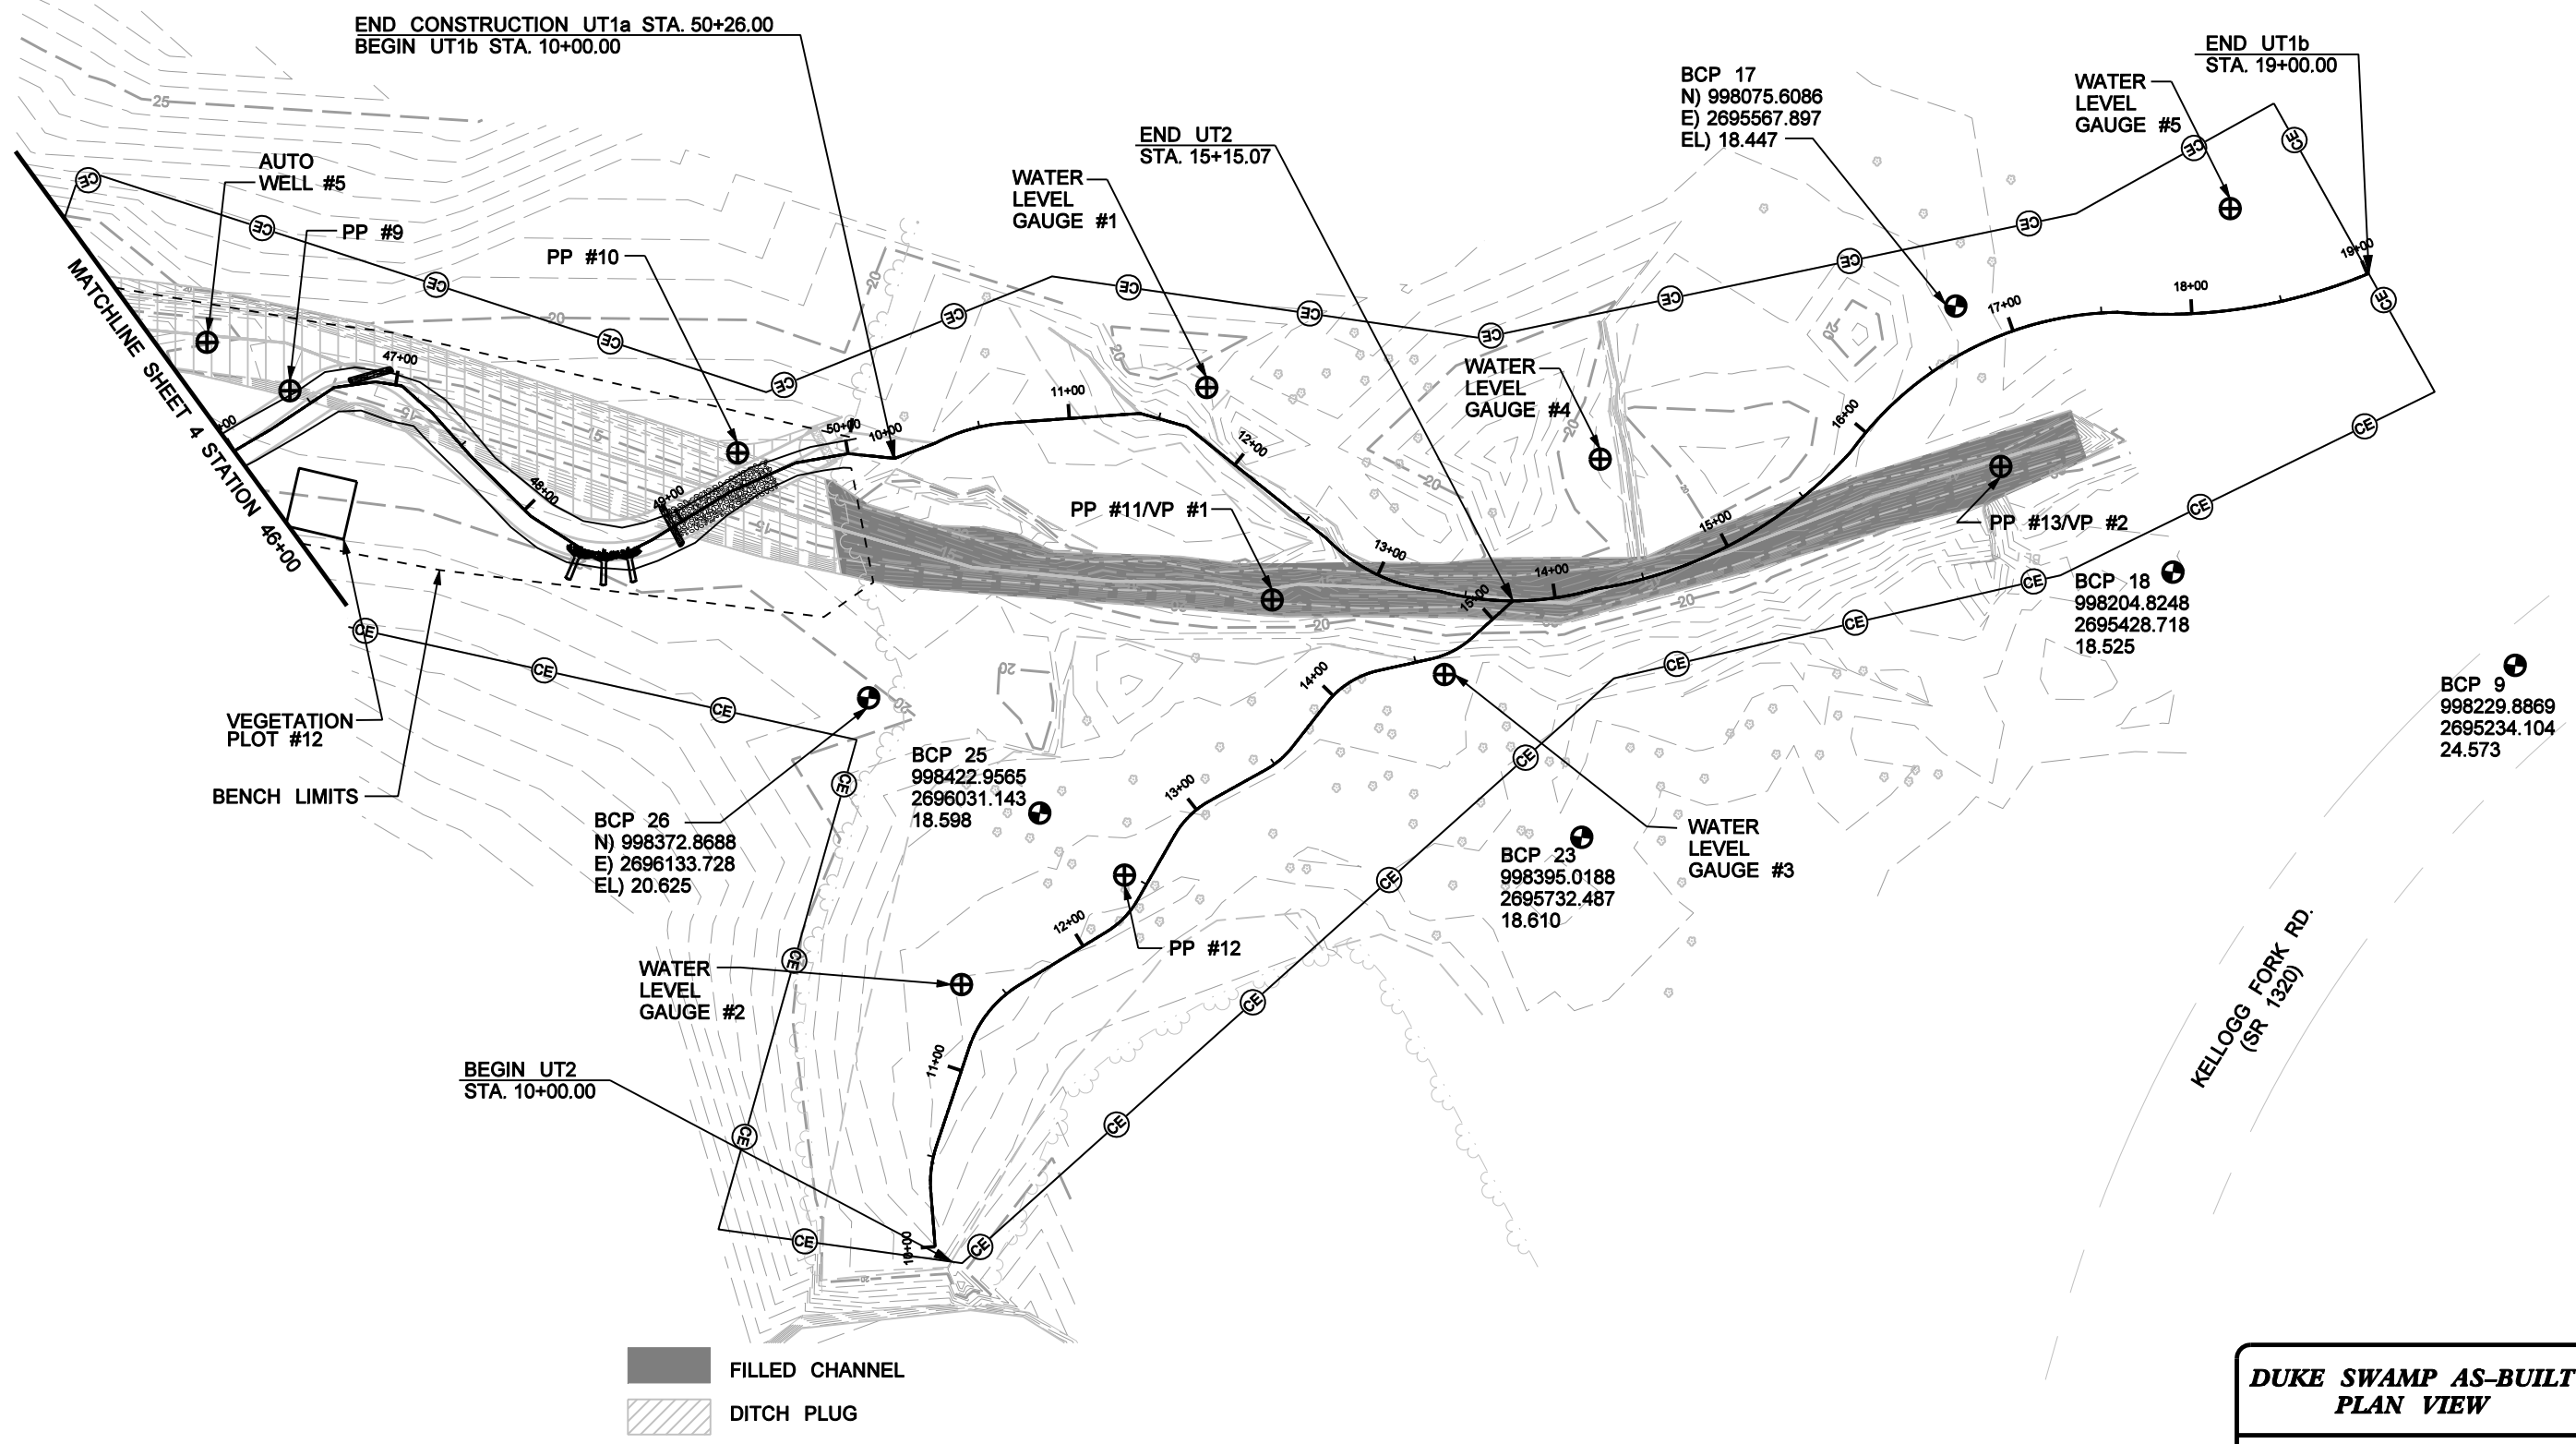
FIGURE 2D

One manual crest gauge was installed on the Site to document bankfull events. The gauge is checked regularly and records the highest out-of-bank flow between site visits. The gauge is located on the downstream portion of reach UT1a at station 45+50, which is presented in Figure 2D.

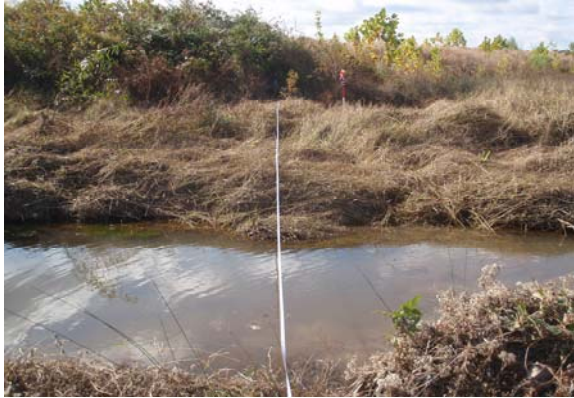
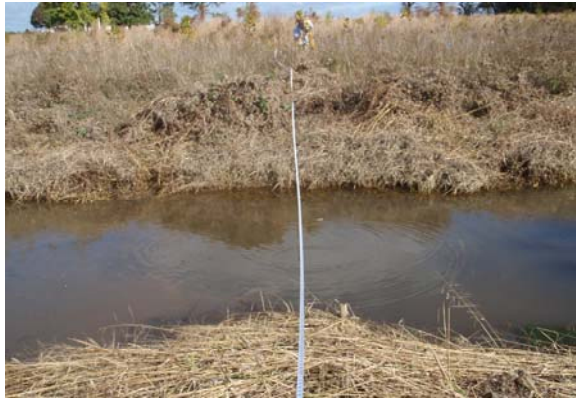
**Permanent Cross-section 1, Station 13+30**  
 (Year 3 Data - Collected November 2010)

Feature	Stream Type	BKF Area	BKF Width	BKF Depth	Max BKF Depth	W/D	BH Ratio	ER	BKF Elev	TOB Elev
Riffle	Cc	23.3	17.38	1.34	2.06	13	1	5.7	19.75	19.73

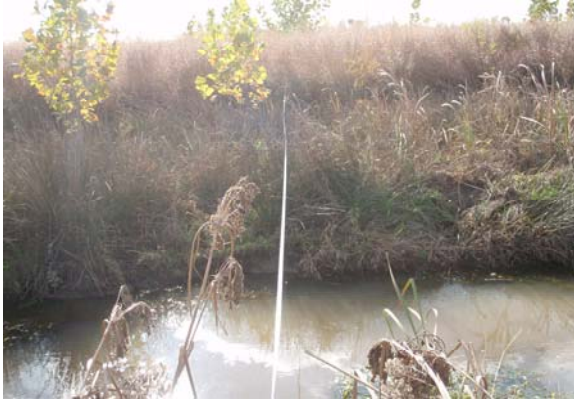
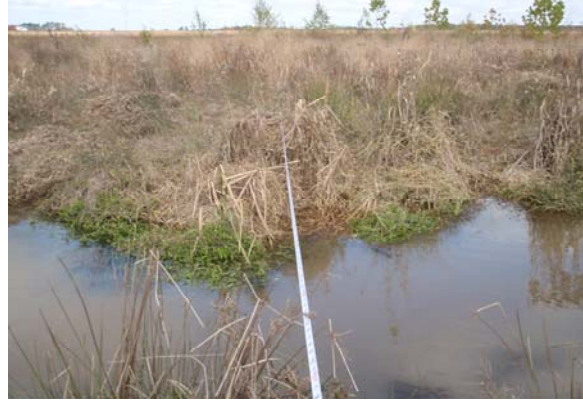
**Permanent Cross-section 2, Station 17+69**  
 (Year 3 Data - Collected November 2010)

Feature	Stream Type	BKF Area	BKF Width	BKF Depth	Max BKF Depth	W/D	BH Ratio	ER	BKF Elev	TOB Elev
Pool		18.8	12.7	1.48	2.21	8.58	1	6.5	19.55	19.58

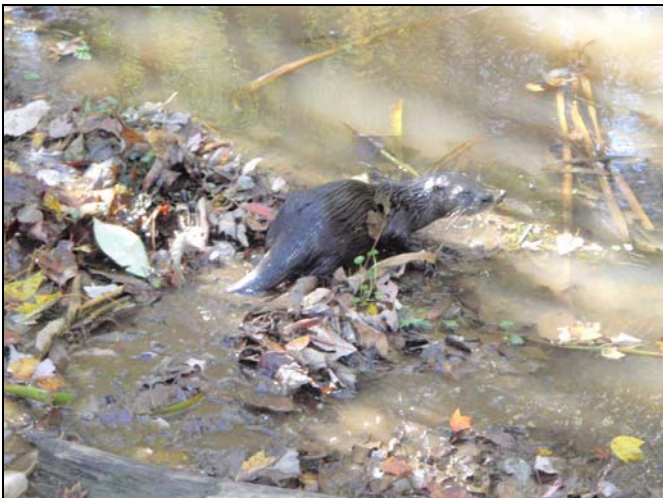
A visual confirmation of a Northern River otter was observed in UT1b during November 2010. A photo of the sighting is located at the end of the Photo Log in Appendix B.

Northern River Otter  
(Observed in UT1b, November 2010)

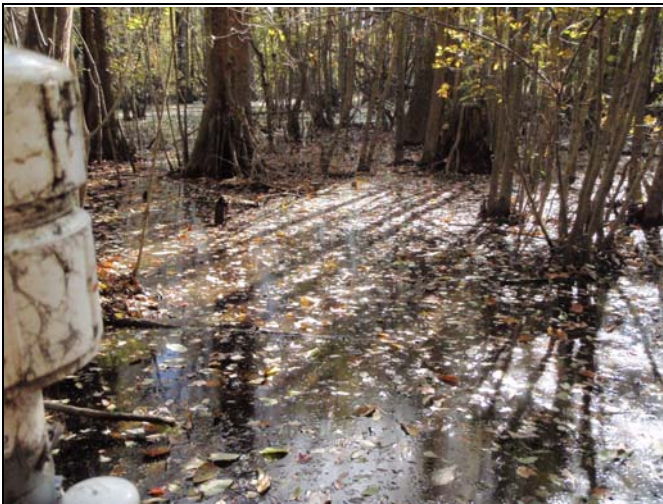
Flood Gauge 5 – South, November 2010  
(Note: Flood evidence on well cap)

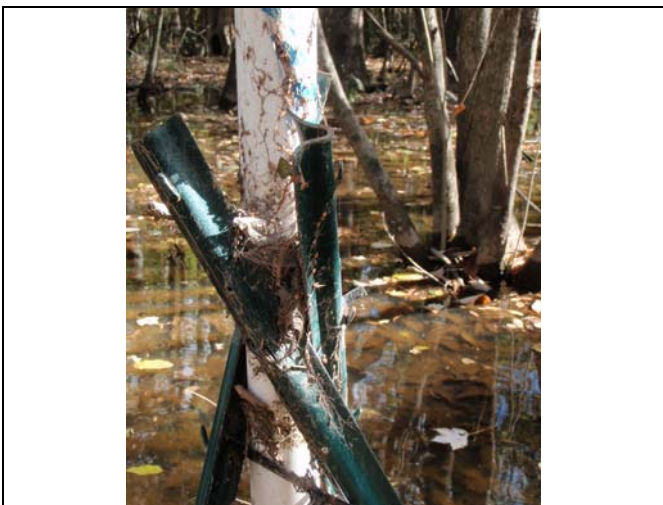
Flood Gauge 3 – South, November 2010  
(Note: Flood evidence on T-post)
